THM 4L60-E/4L65-E "UPDATE HANDBOOK"

INTRODUCTION

THM 4L60-E/4L65-E

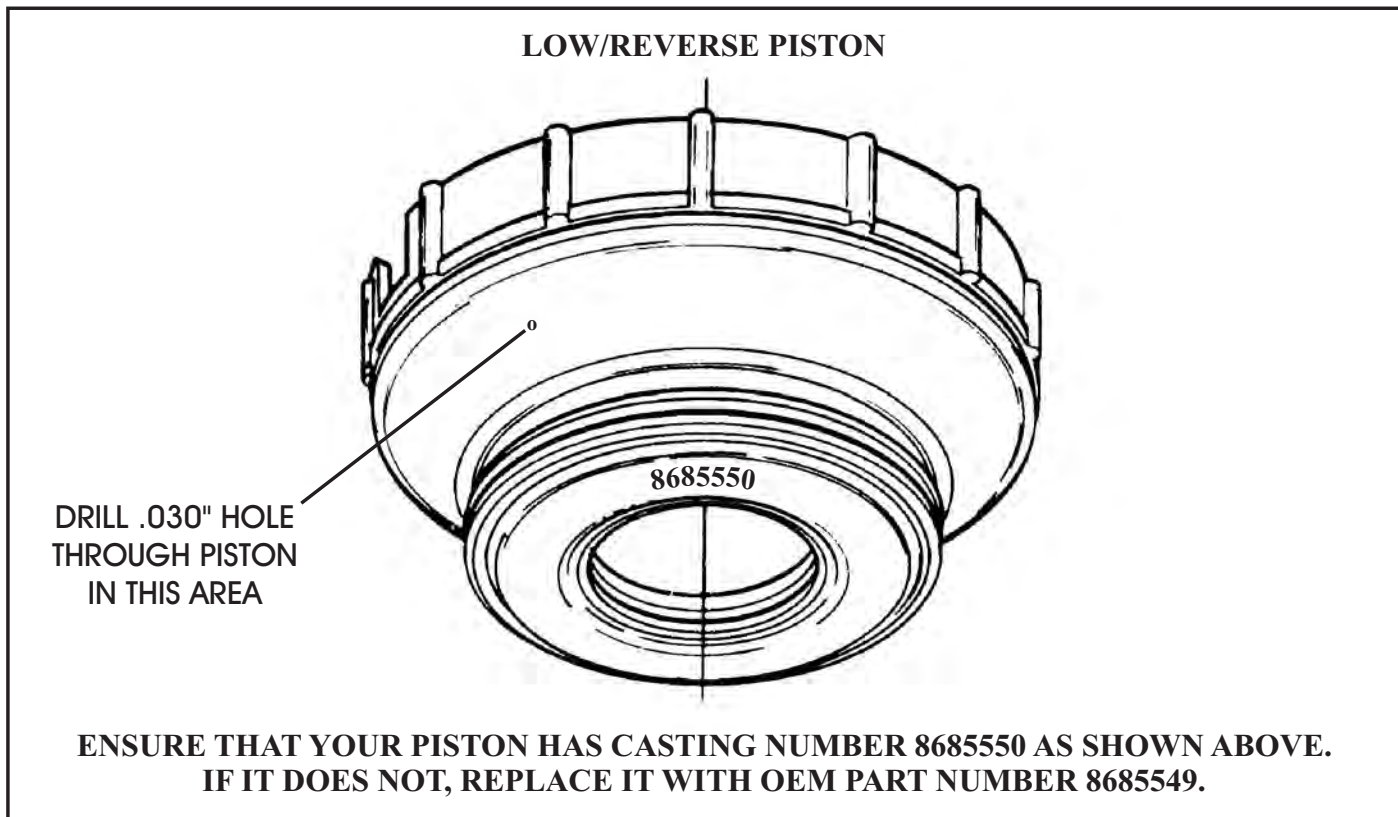
Figure 1

COMPLAINT: Premature and/or repeat failure of the Low/Reverse Clutch pack, on 1993-1995 models only, and may occur in as little as 5000 miles.

CAUSE: The cause may be, the Low/Reverse Clutch not totally exhausting the apply oil when the shift lever is moved from Park to the Drive position. On 1993-1995 models, the exhaust path for L/R apply oil is not large enough.

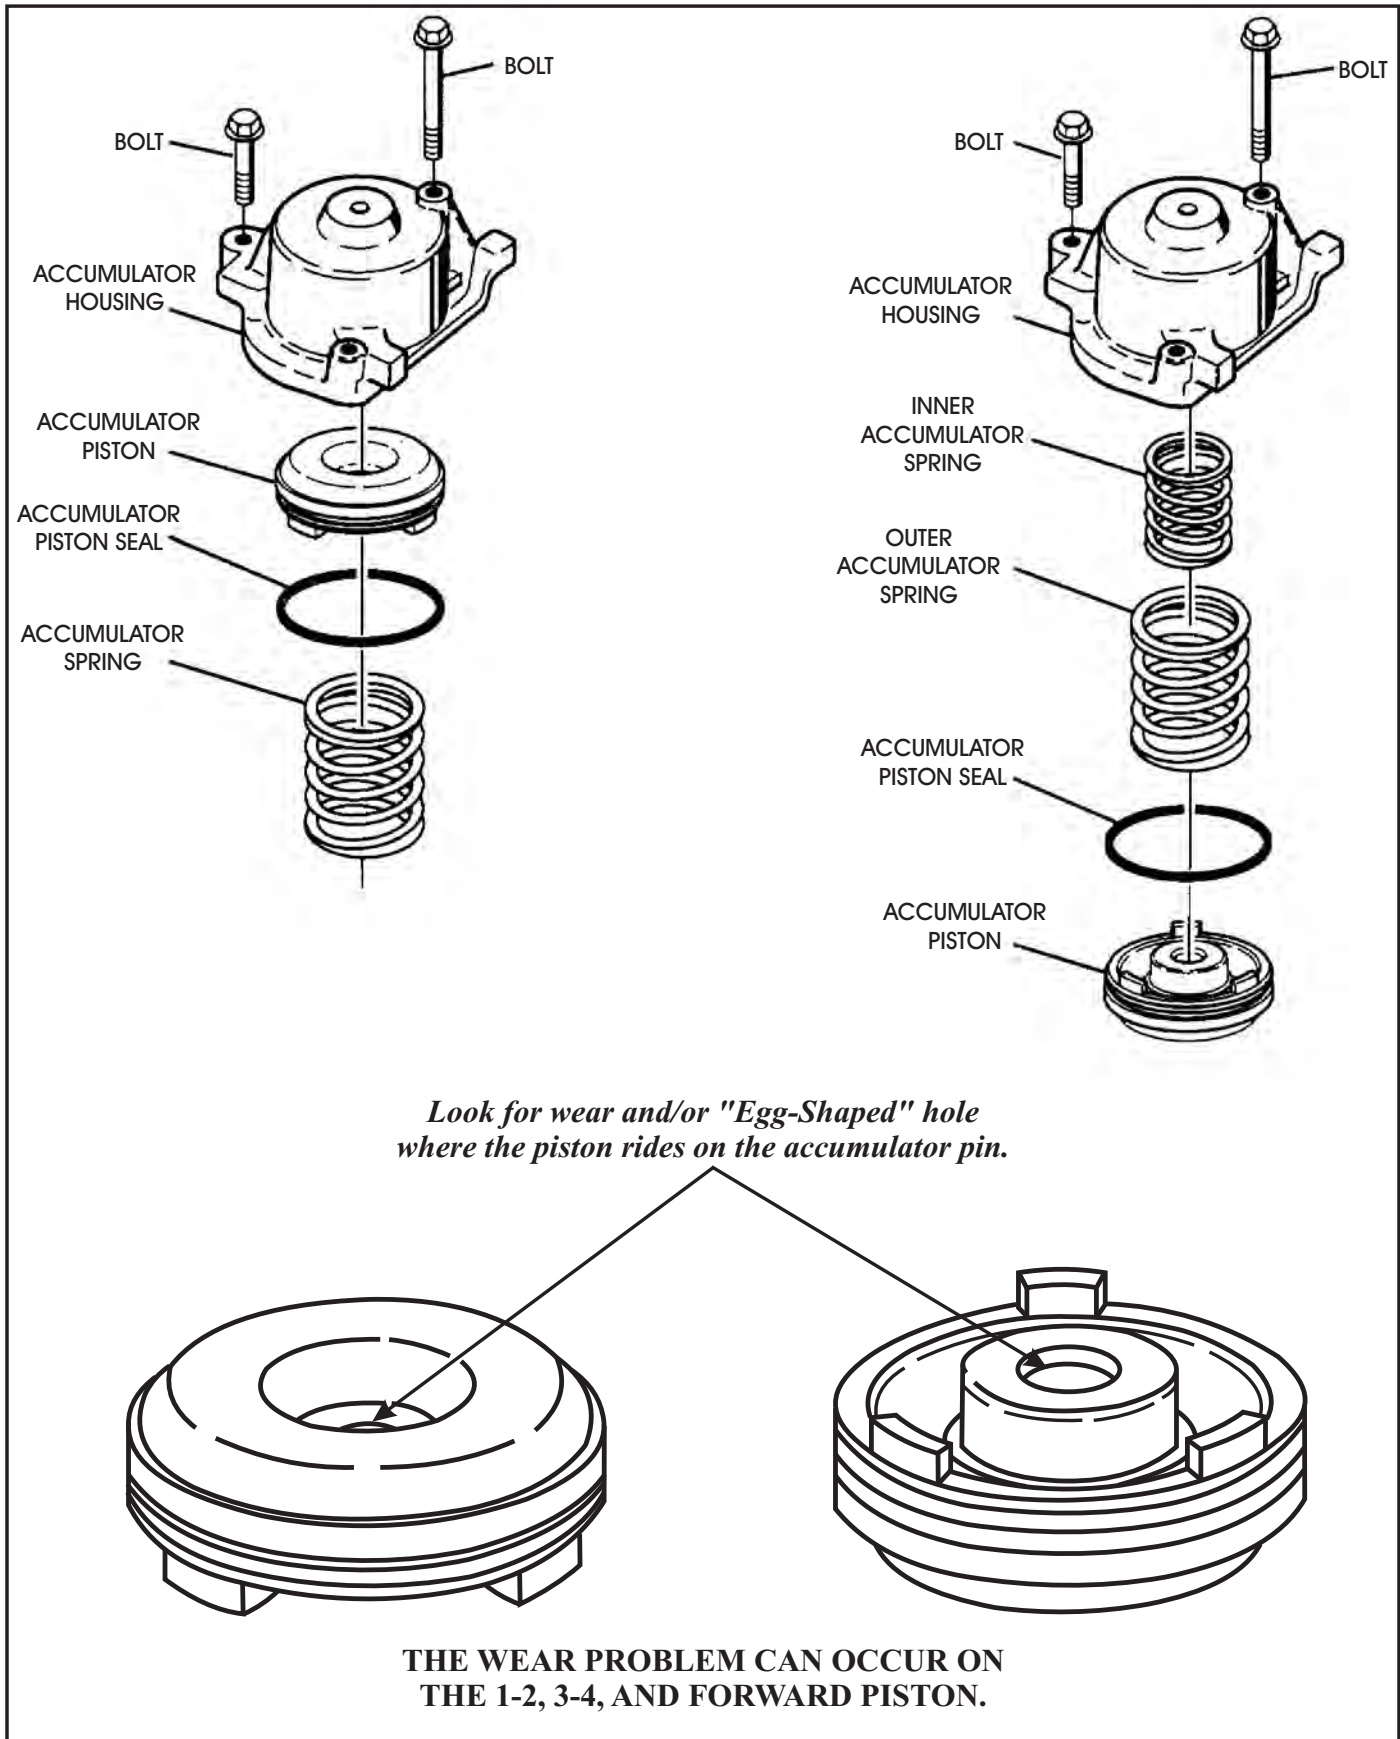
Figure 1

COMPLAINT: When the accumulator piston wears with an "Egg-Shaped" hole where the accumulator piston strokes, it can create a delayed engagement to drive, slipping condition in forward gears, slipping 1-2 shift, slipping 3-4 shift, depending on which accumulator piston is worn, and how bad it is worn.

CAUSE: The cause may be, a worn accumulator piston pin bore (See Figure 1).

CORRECTION: Replace the accumulator piston with the proper part number from "Service Information" as shown below.

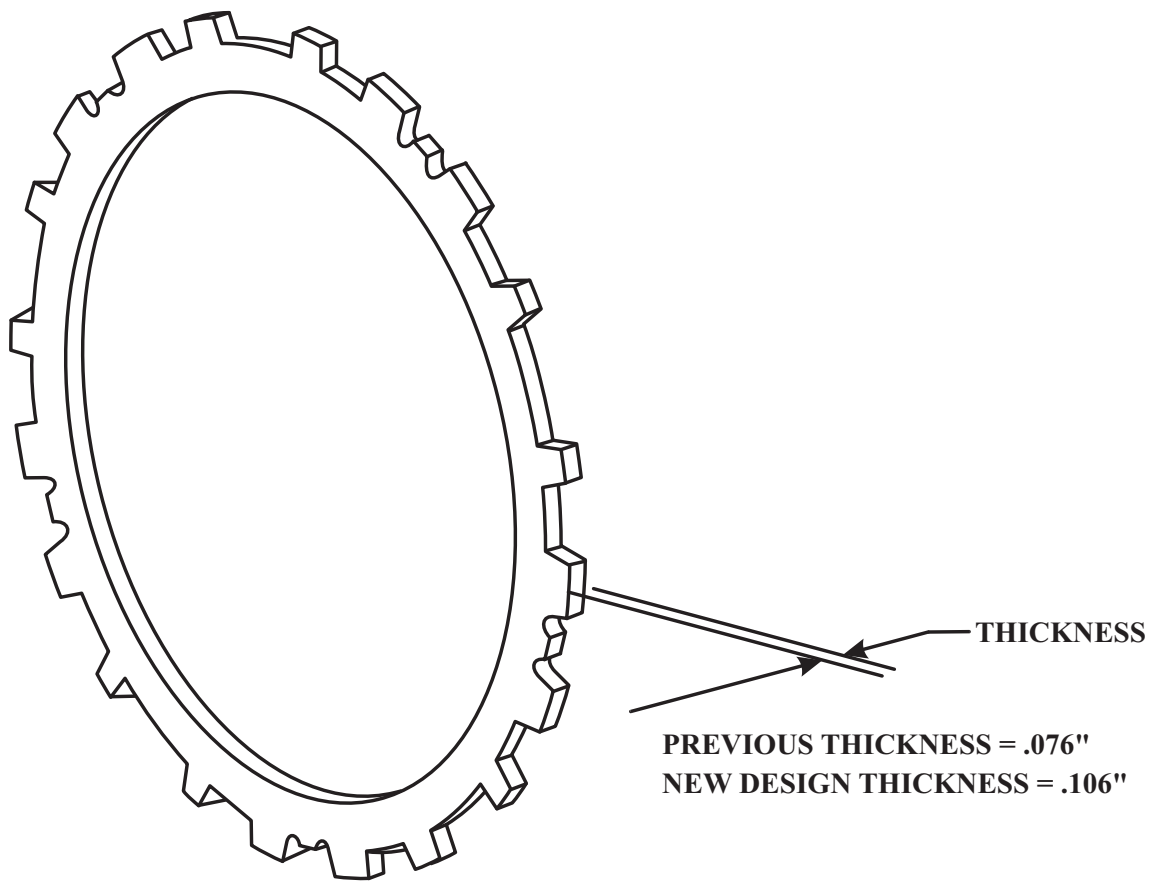
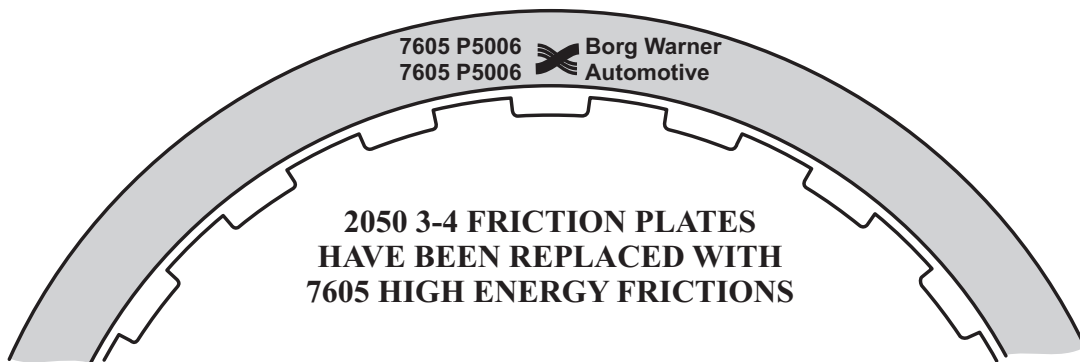
Figure 1

COMPLAINT: After rebuild, the vehicle exhibits premature 3-4 clutch failure, sometimes in as little as 2000 miles of use. Usually associated with Police, Taxi, or heavy duty use.

CAUSE: The cause may be, not using the high energy clutch plates, and the thick (.106") steel plates, or not enough line pressure rise with throttle opening.

The 2050 high energy friction plates normally associated with the above kit have been replaced with the 7605 high energy friction plates for increased durability. Refer to Figure 1. The 2050 high energy friction plates have been discontinued.

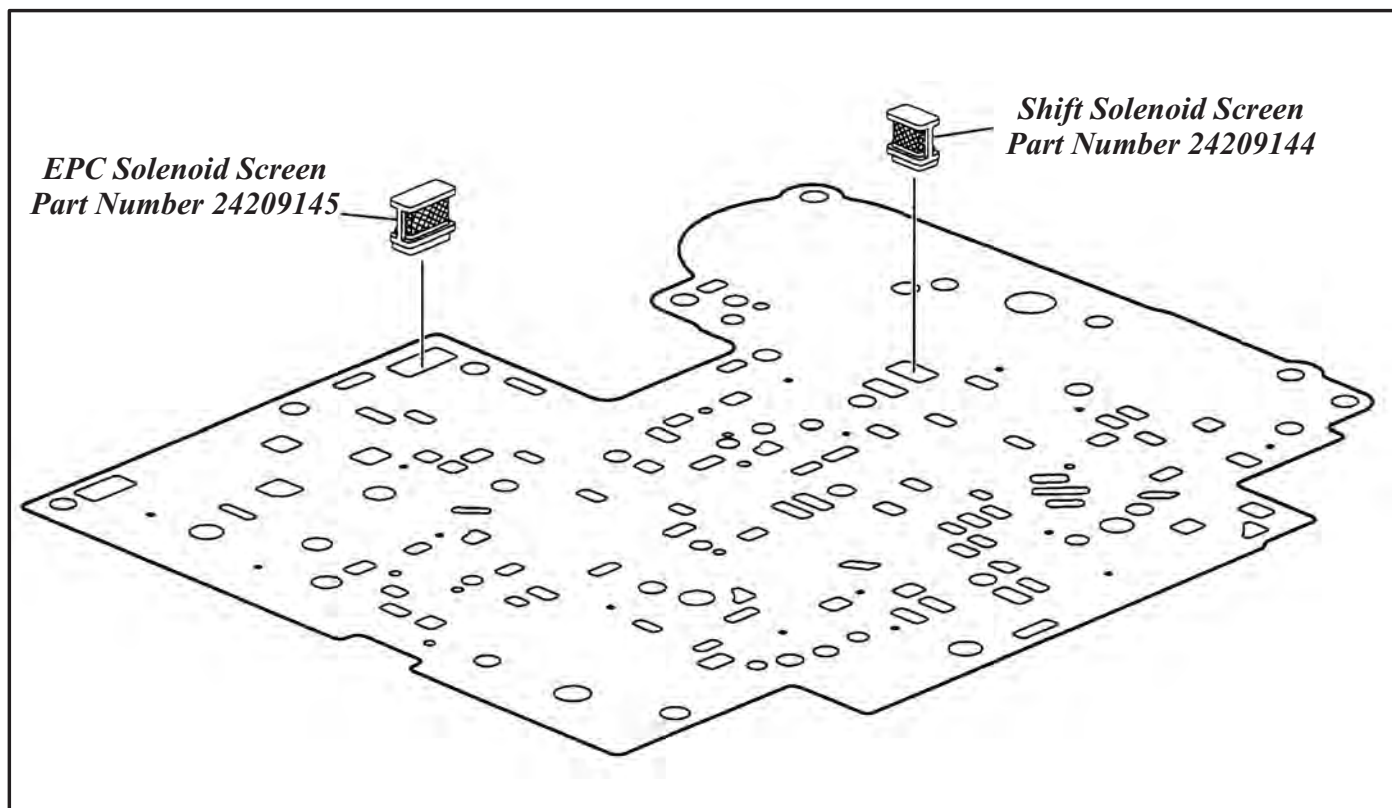
Figure 1

CAUSE: The cause may be, one or both of the screens in the spacer plate collapsed shut, and restricting solenoid feed oil or actuator feed oil to the Pressure Control Solenoid.

CORRECTION: Replace both screens in the spacer plate as shown in Figure 1, with the part numbers listed below. These *new part numbers* are screens with a larger micron screen that will pass more oil easier.

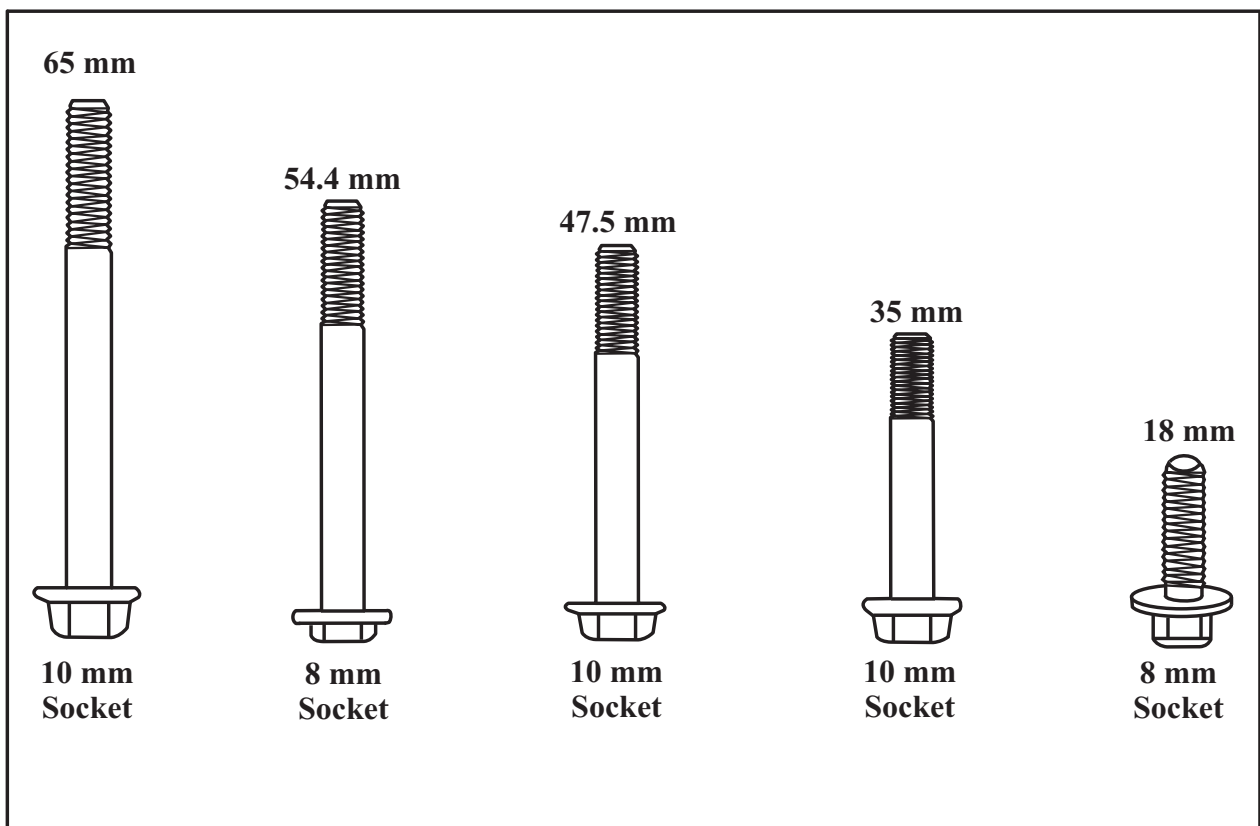
Figure 1

CAUSE: There are different length valve body bolts which can be easily mis-positioned (See Figure 1). A *common* error is placing a 54.4 millimeter length bolt into a location designed for a 47.5 millimeter length bolt (See Figure 2). The mis-located bolt will extend into the barrel of the case and into the sun shell. The bolt now being screwed into the sun shell inhibits the rotation of the shell causing the above complaint.

CORRECTION: Relocate the necessary valve body bolts to their proper location. Use figure 3 to locate the proper positions for the 47.5 and 54.4 millimeter bolt lengths. In severe cases, it may be necessary to remove the transmission in order to replace the damaged sun shell.

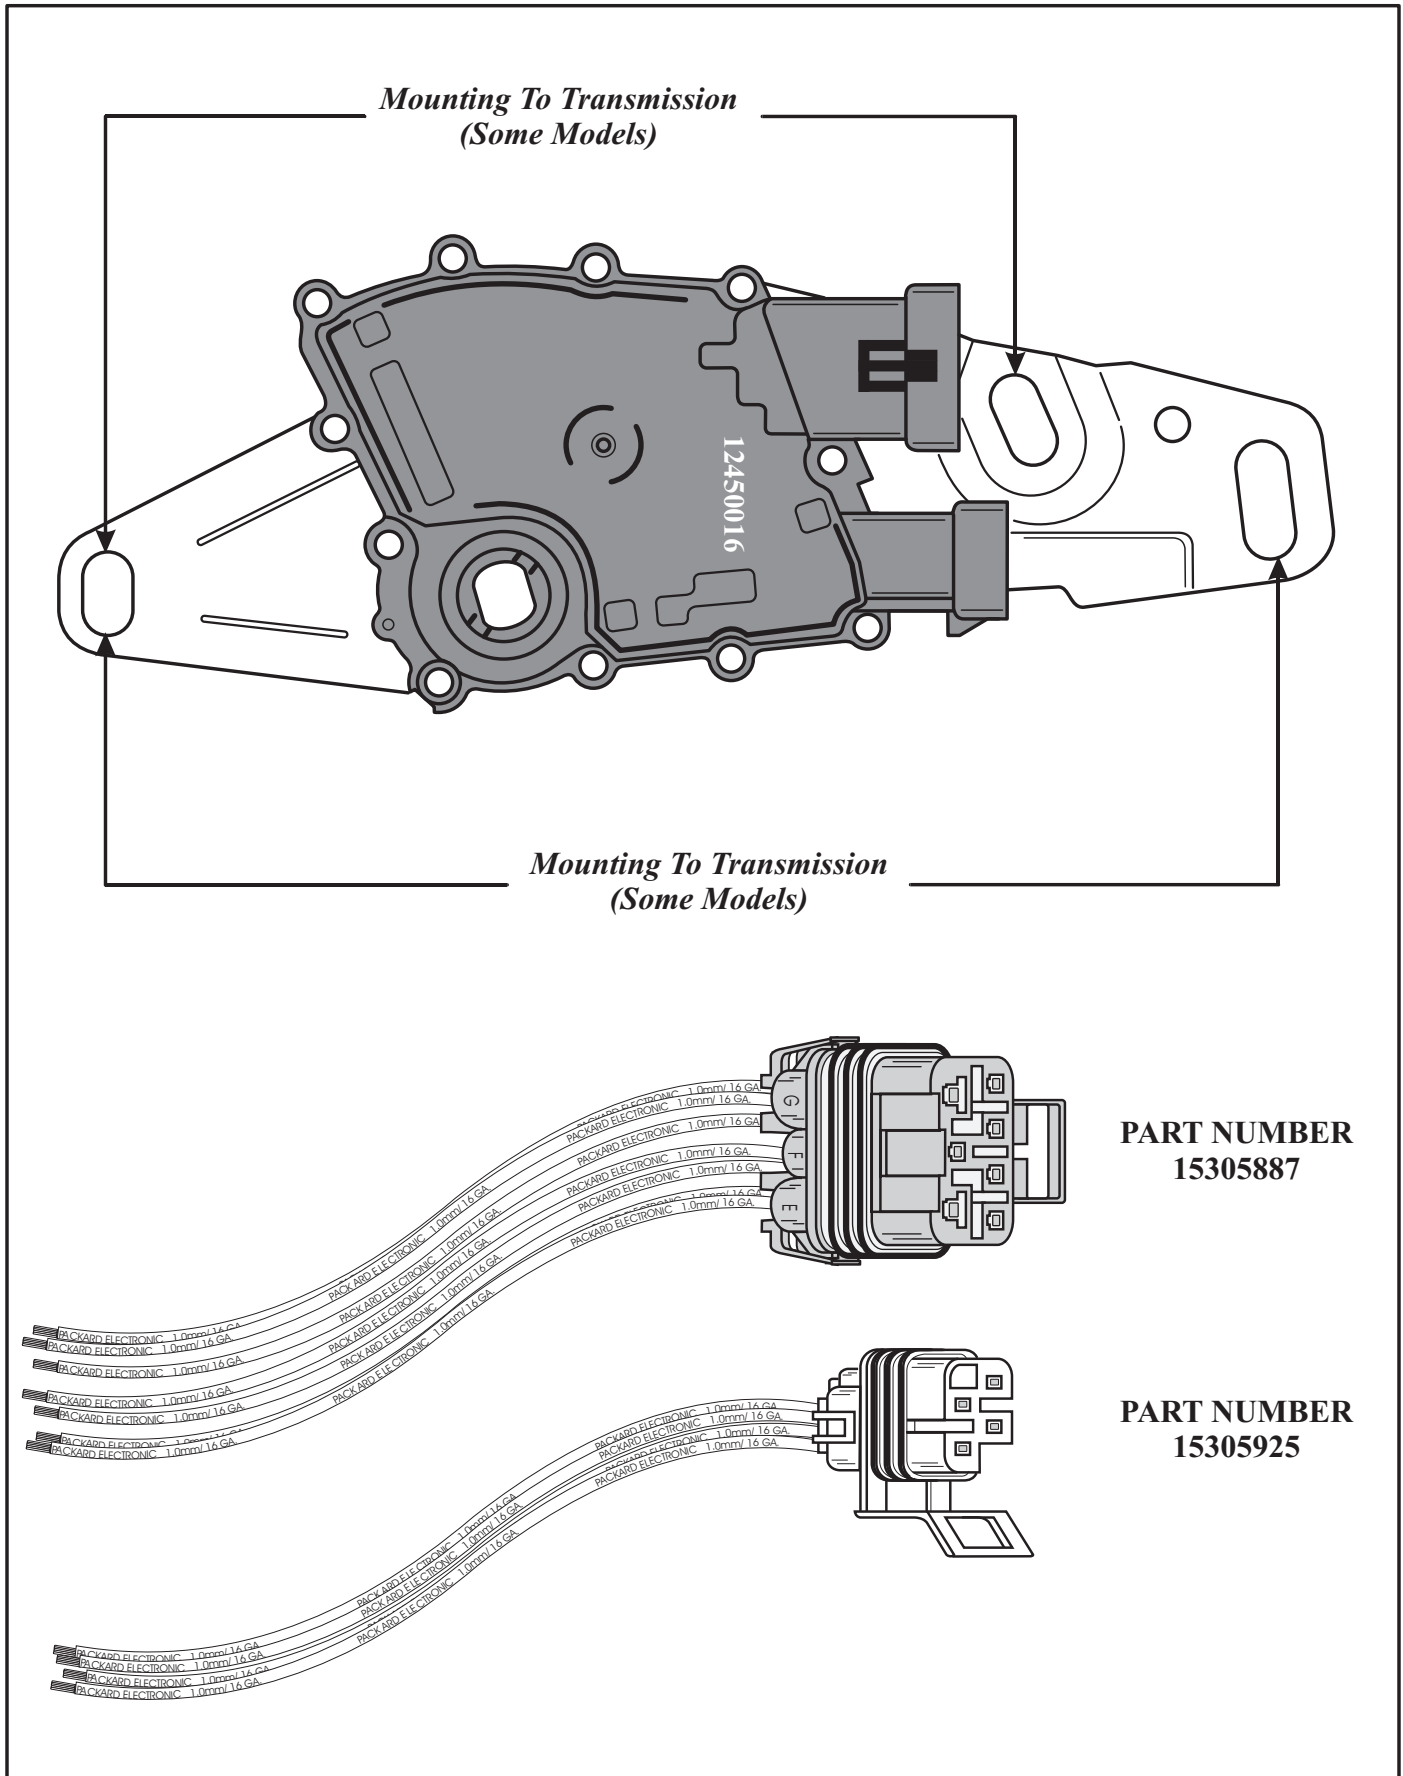
Figure 3

CAUSE: The cause may be high ambient heat causing the sealing compound in the switch to melt and flow into the connectors, sealing the connectors to the switch. This normally causes no customer concerns, but may cause an open electrical circuit in rare cases.

CORRECTION: If the switch is being removed as part of transmission service, *and there are no switch related concerns*, the switch can be removed without removing the connectors, and left hanging until time to be re-installed. However, some models have a mounting bolt directly behind the switch connectors, which requires removing the connectors, and the switch *will be damaged* in the process (See Figure 3).

There is now available from OEM sources, service repair connectors for both the 7-way and the 4-way connectors under part numbers 15305887 and 15305925 (See Figure 3).

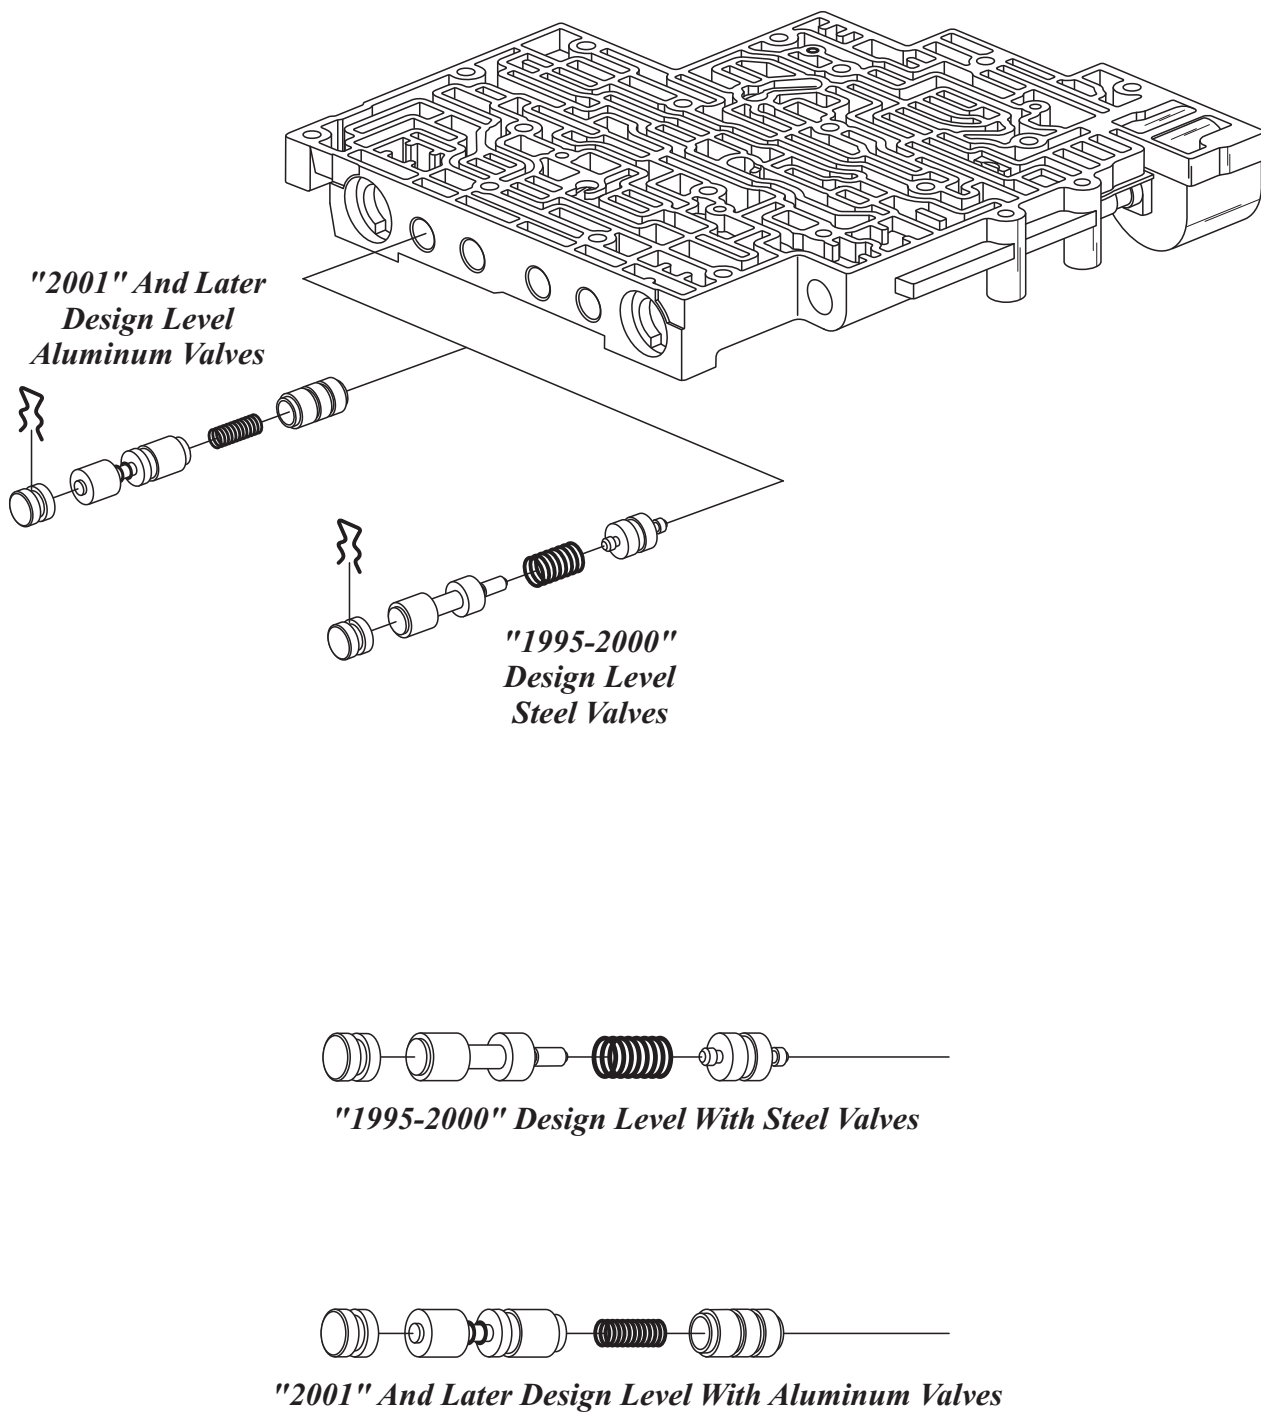
CAUSE: The cause is usually Torque Converter Clutch slippage, created by a badly worn valve body casting in the Converter Clutch Regulator Valve bore.

CORRECTION: Sonnax manufactures two different kits to repair the current valve body castings, both of which require a reamer, also available from Sonnax. One of the kits, Sonnax part number 77754-03K, fits 1993 thru 1997 model transmissions, but they require different assembly processes. Refer to Figure 1 for the 1994-1994 models and Figure 2 for the 1995-1997 models, for the proper assembly. The other kit, Sonnax part number 77754-04K, fits only the 1998 and later ECCC models, as it is a different calibration. Refer to Figure 3 for proper assembly of the 1998 and later models. The reamer required is the same for either kit and is available under Sonnax part number 77754-R2.
