AUTOMATIC TRANSMISSION SERVICE GROUP

INTRODUCTION THM 125C

Since the introduction of the THM 125 transaxle in model year 1980, there have been many major engineering changes. These changes have affected nearly every part used in the 125 and 125c.

This Update Handbook will explain each change, the parts affected by the change, any parts interchangeability problems created by the change. This Update Handbook will cover all of the changes from start of production up through and including model year 1987, along with common problems, and fixes, for the THM 125 transaxle.

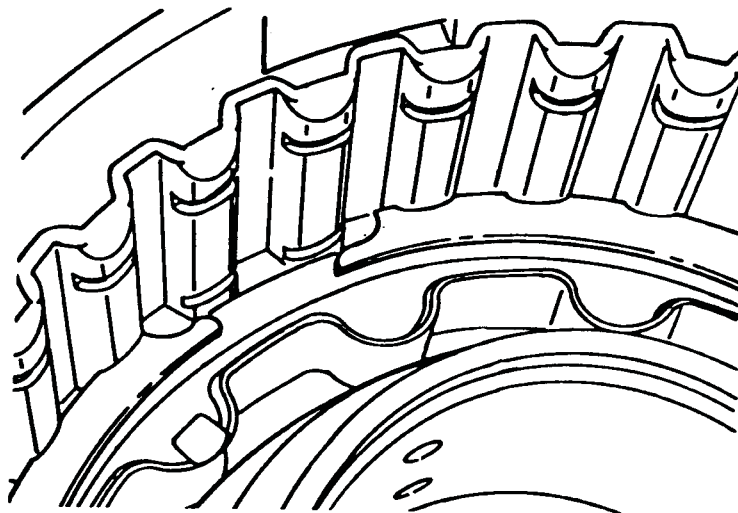
FIGURE B

SERVICE NOTE: THE SNAP RING THAT RETAINS THE APPLY RING AND RELEASE SPRING ASSEMBLY MAY NOT APPEAR TO BE FULLY SEATED IN THE SNAP RING GROOVE WHEN INSTALLED. THIS IS DUE TO THE GROOVE NOT BEING CUT AS DEEP AS PREVIOUS MODEL YEARS (SEE FIGURE B). WHEN INSTALLING THE SNAP RING USE A DOWNWARD AND OUTWARD PRESSURE TO ENSURE PROPER SEATING (SEE FIGURE A).
