THM 4L60-E/4L65-E "UPDATE HANDBOOK"

INTRODUCTION

THM 4L60-E/4L65-E

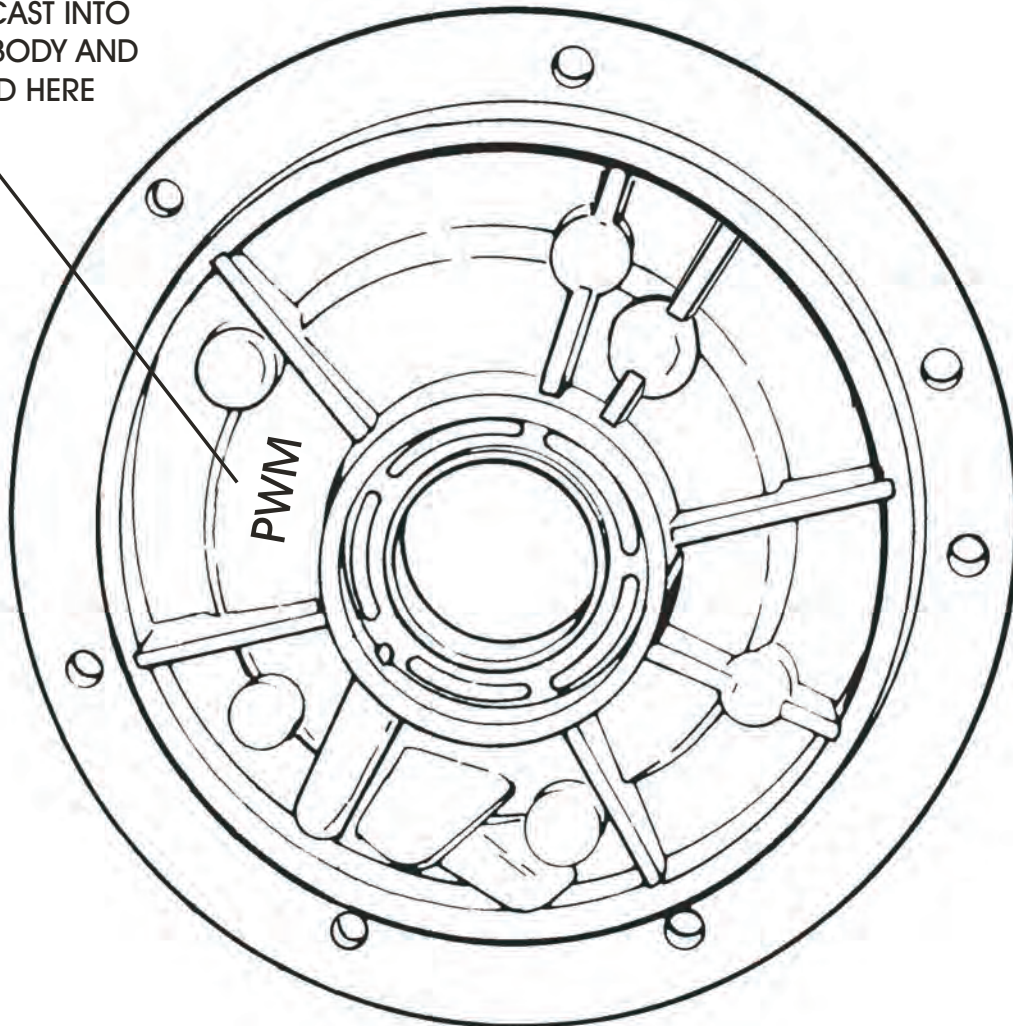
Figure 3

**1995 "PWM" PUMP BODY
IDENTIFICATION**

"PWM" IS CAST INTO
THE PUMP BODY AND
LOCATED HERE

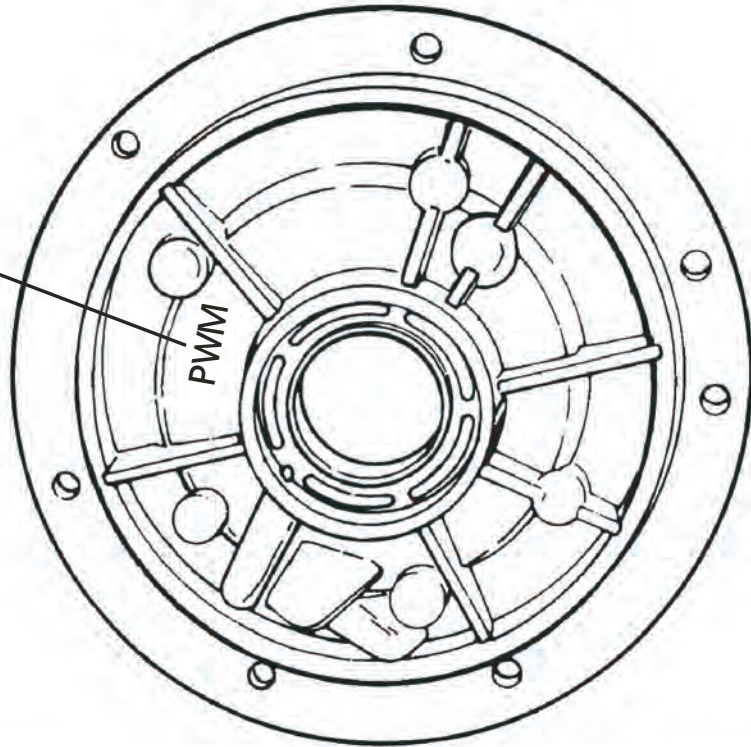
**1995-1996 "PWM" PUMP BODY
FOR REGULAR CASE**

"PWM" CAST INTO PUMP BODY
AND LOCATED HERE

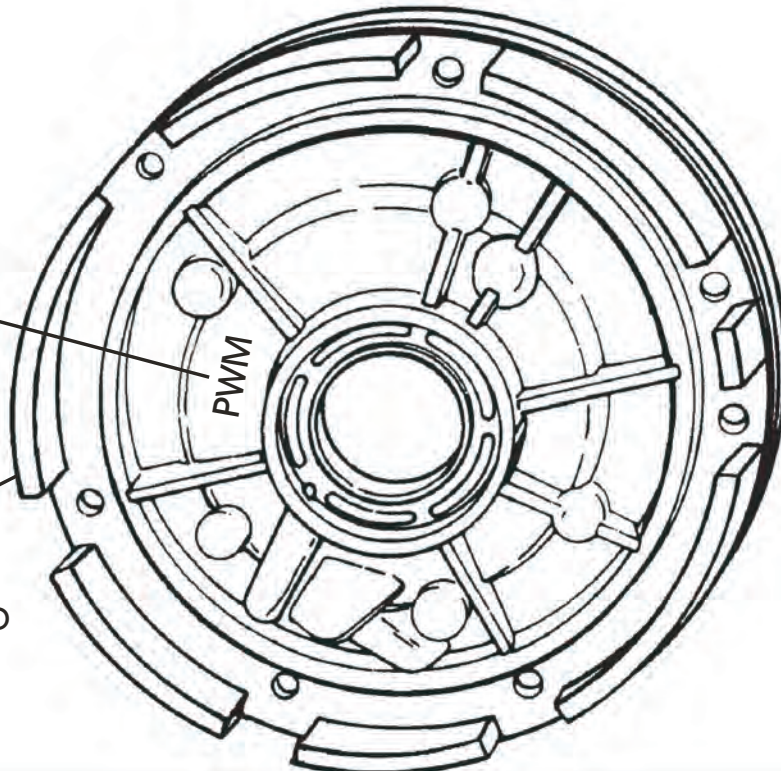
**1996 "PWM" PUMP BODY
FOR BOLT-ON BELL HOUSING**

"PWM" CAST INTO PUMP BODY
AND LOCATED HERE

ADDED MATERIAL AND MACHINED
TO CENTER THE BELLHOUSING

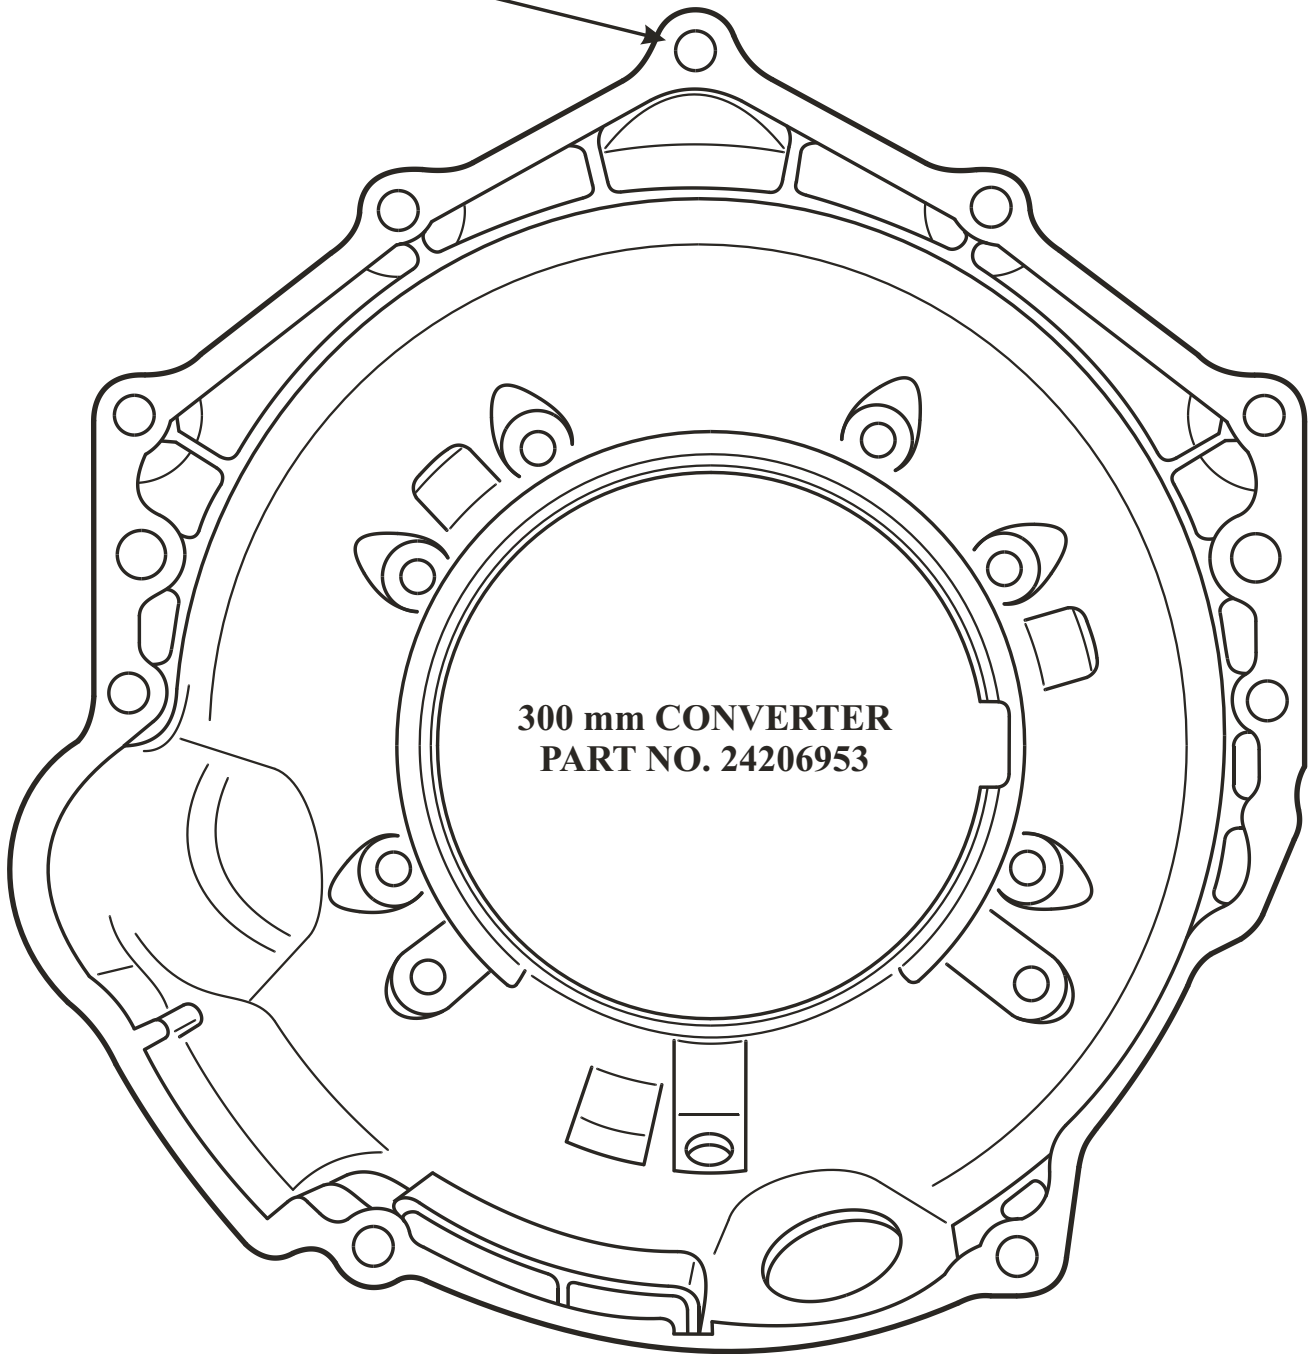
Figure 1

**ADDED BOLT HOLE AND
IS APPROX. 1/4" DEEPER**

This style bellhousing and the 300mm torque converter also require a new design turbine shaft and stator shaft that are approximately 1/4" longer than other models.

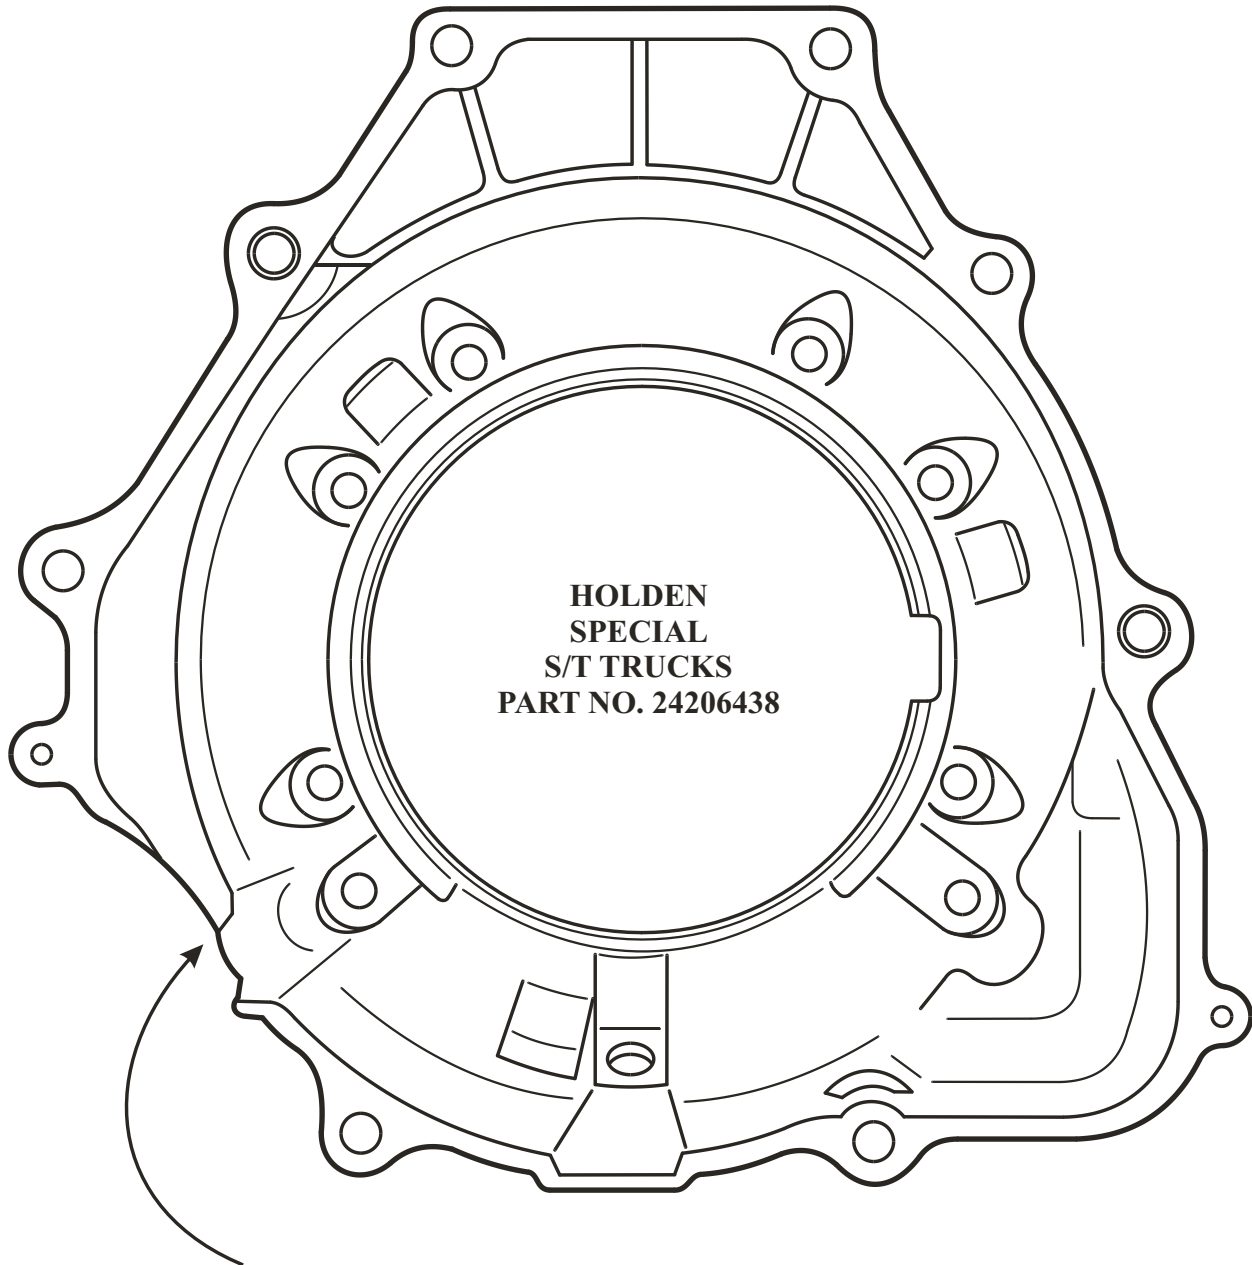
Figure 6

The Bellhousing shown in Figure 6, is the Holden "Special" S/T Truck bell that is export only and shipped mainly to Australia. This bell has part of the housing cast out as compared to the Regular S/T Truck bell that is shown in Figure 7.

**SECTION CAST OUT
OF BELLHOUSING**

Compare with Regular S/T Bell on next page.

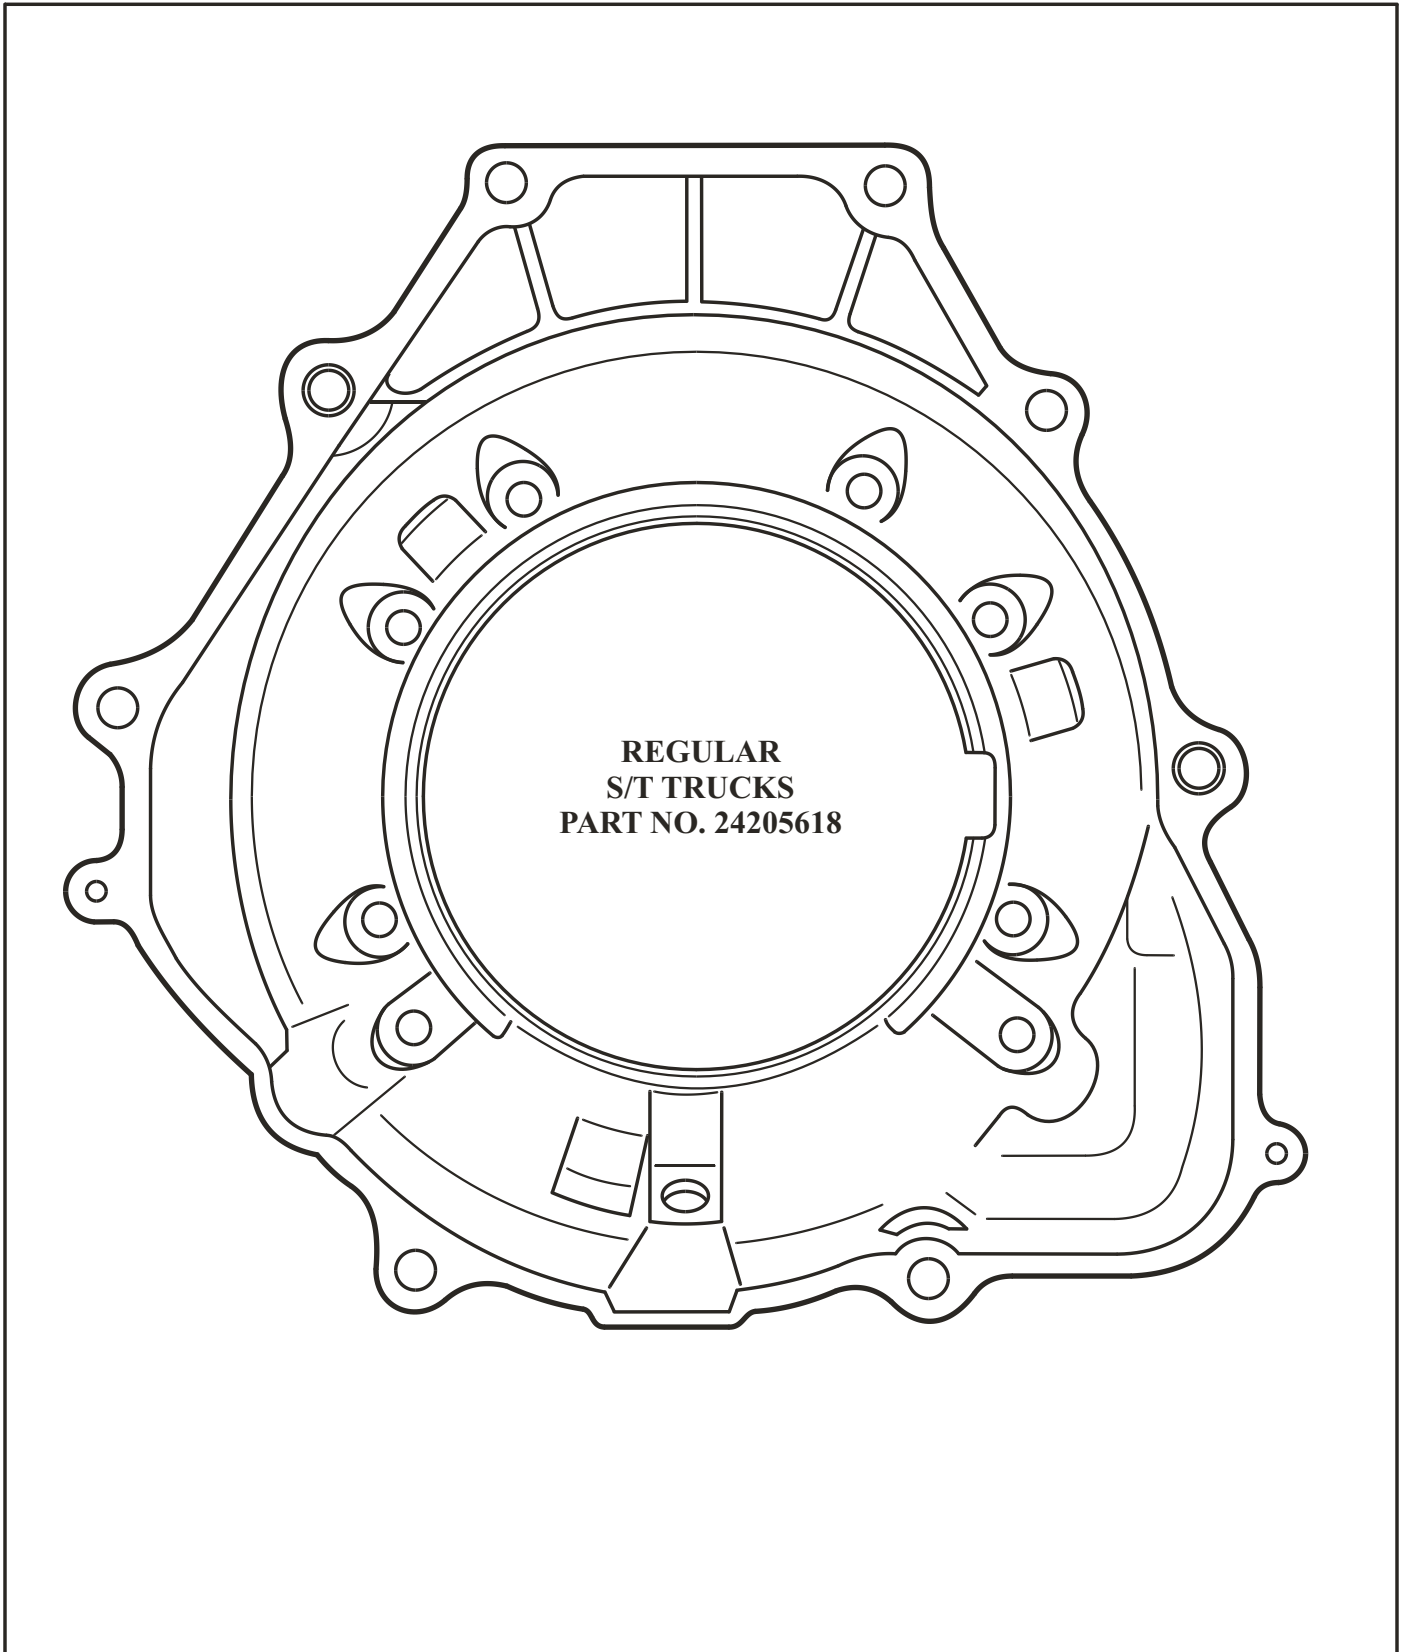
Figure 7

The Bellhousing shown in Figure 7, is the Regular S/T Truck bellhousing used in North America and is cast different than the export S/T Truck bellhousing shown in Figure 6.

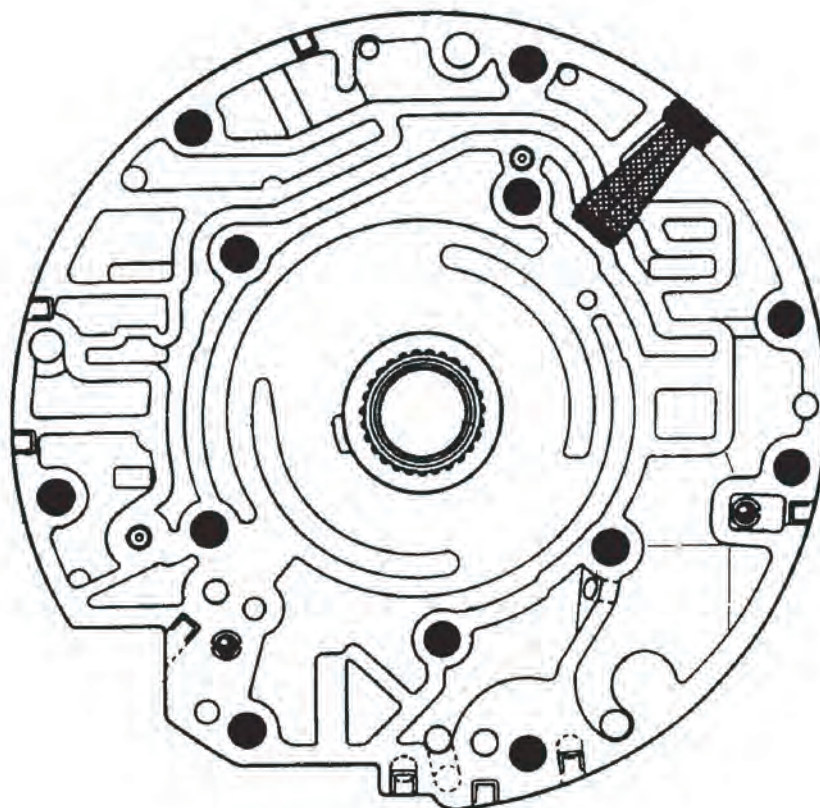
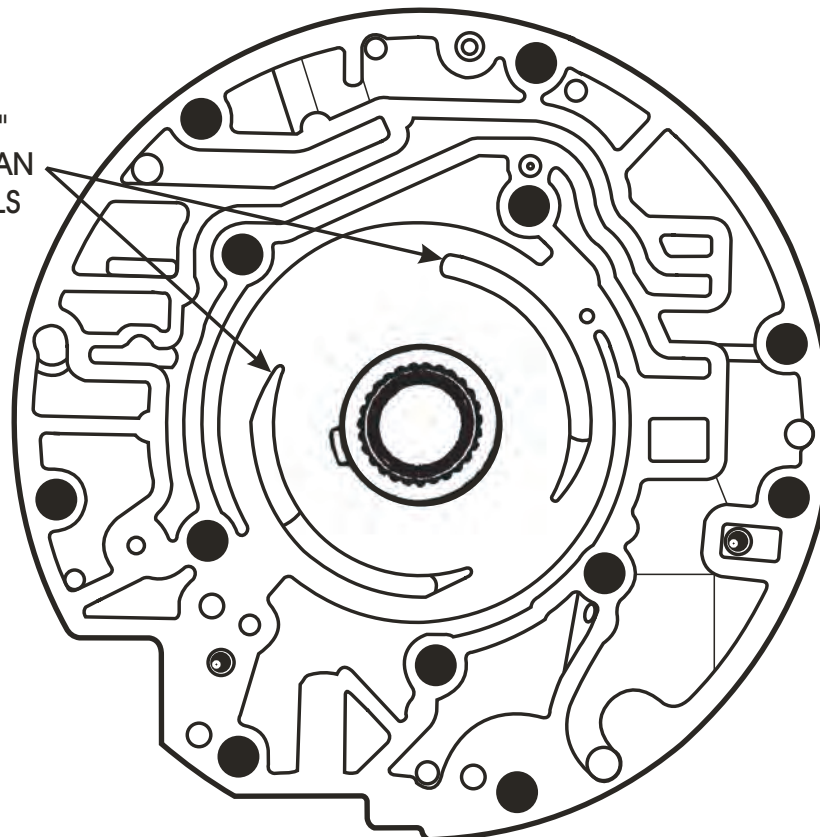
Figure 2

95-96 "PWM" PUMP COVER

1997 "13 V" PUMP COVER

"PORTING SLOTS"
ARE DIFFERENT THAN
PREVIOUS MODELS

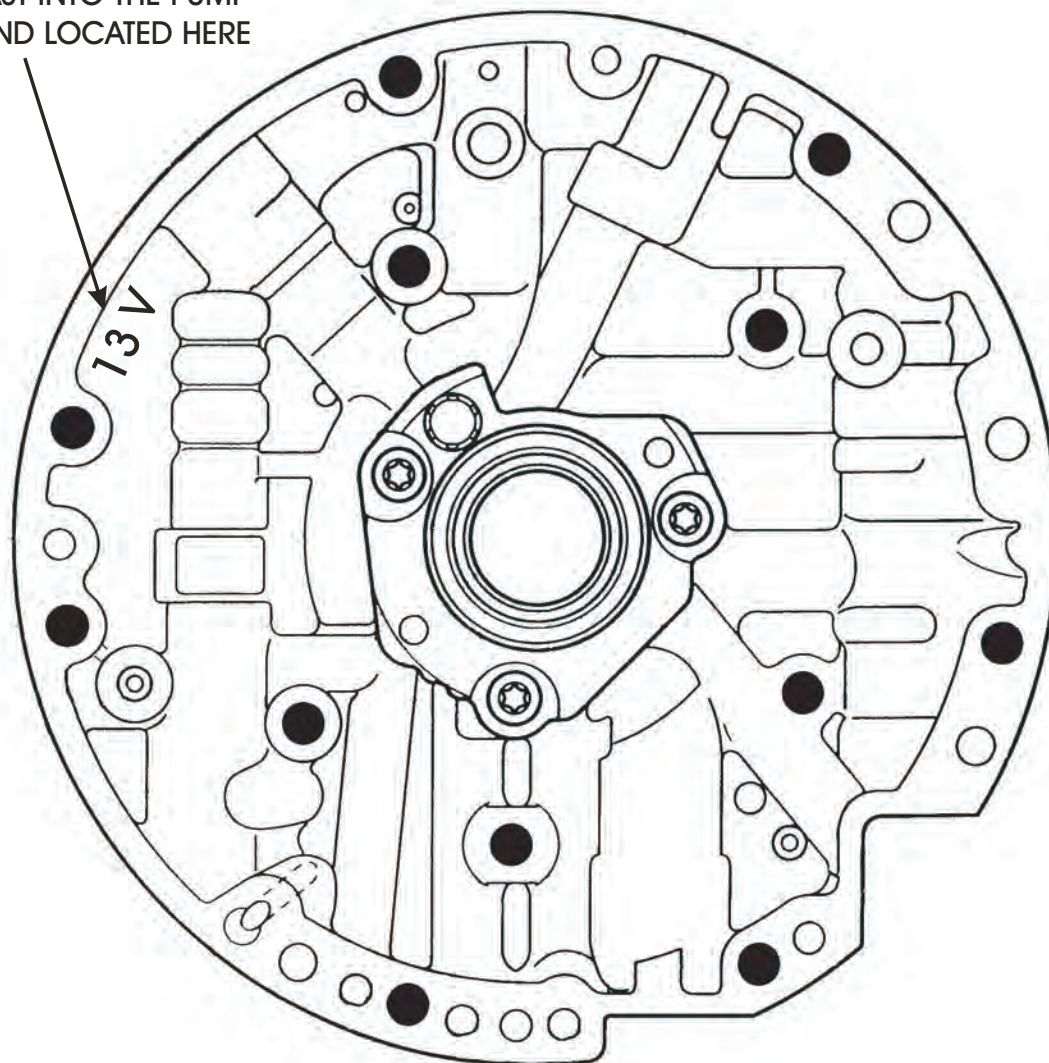
Figure 3

**1997 13-VANE PUMP COVER
IDENTIFICATION**

"13 V" CAST INTO THE PUMP
COVER AND LOCATED HERE

***THIS PUMP COVER WILL NOT INTERCHANGE WITH PREVIOUS MODELS.
IT MUST BE USED WITH THE 13 VANE ROTOR AND SLIDE.***

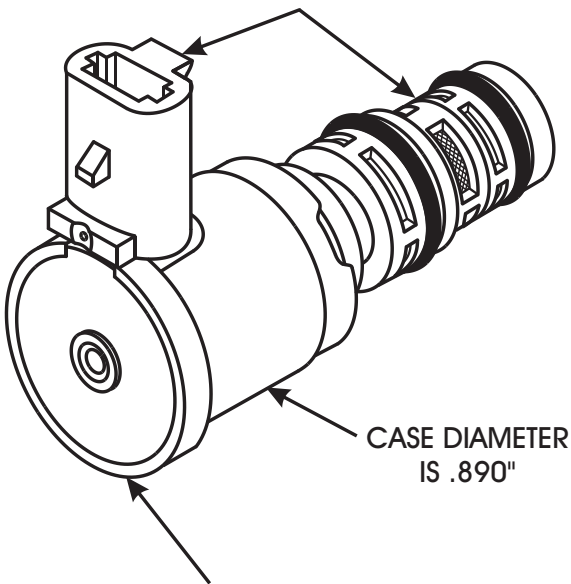
1993-1995 3-2 DOWNSHIFT (PWM) SOLENOID
AND 1995-1996 TCC/PWM SOLENOID
PART NUMBER 8683187
10-15 OHMS RESISTANCE

"WHITE PLASTIC" STEM
AND CONNECTOR

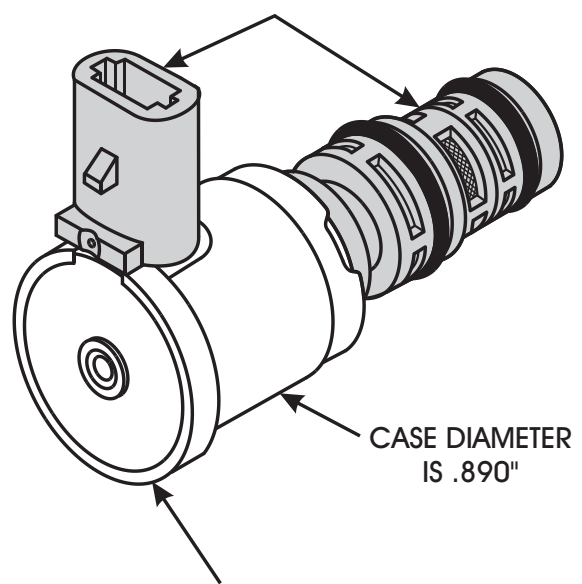
1996 AND 1997
3-2 DOWNSHIFT (ON/OFF) SOLENOID
PART NUMBER 24209121
20-31 OHMS RESISTANCE

"GRAY PLASTIC" STEM
AND CONNECTOR

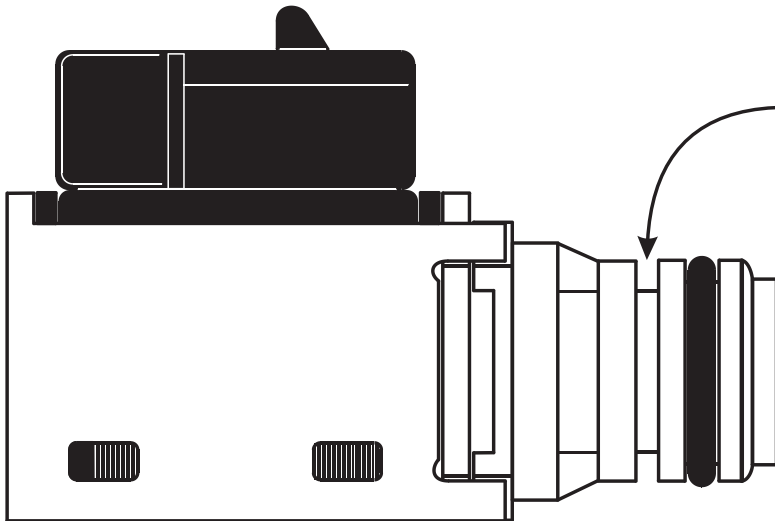
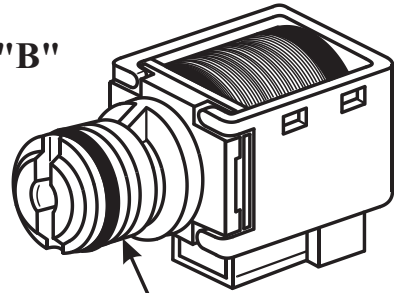
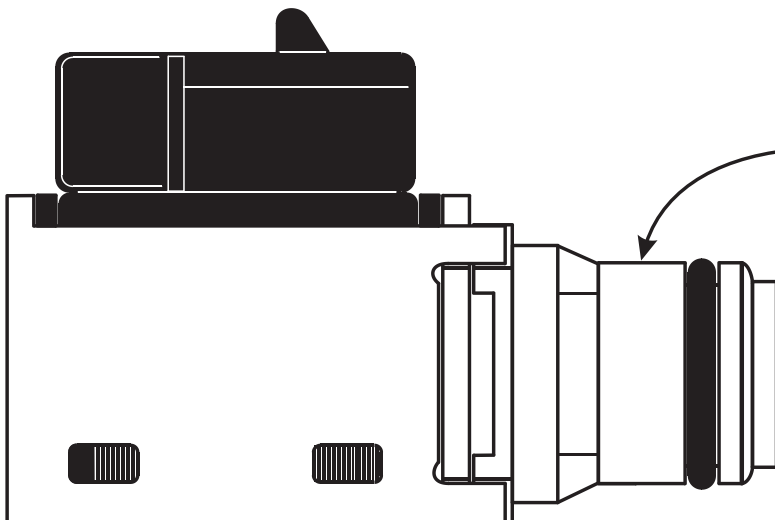
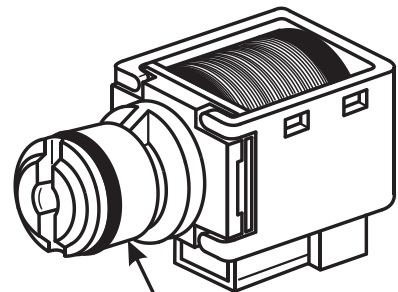
Figure 2

**THM 4L60-E
SHIFT SOLENOIDS "A" AND "B"
1993-1996 MODELS**

THIS GROOVE REMOVED
TO PREVENT MIS-ASSEMBLY,
AS RETAINING CLIP CAN BE
INSTALLED IN THIS GROOVE

**THM 4L60-E
SHIFT SOLENOIDS "A" AND "B"
1997 AND LATER MODELS
PART NO. 10478131**

GROOVE REMOVED
AND WILL RETRO-FIT
BACK TO ALL MODELS

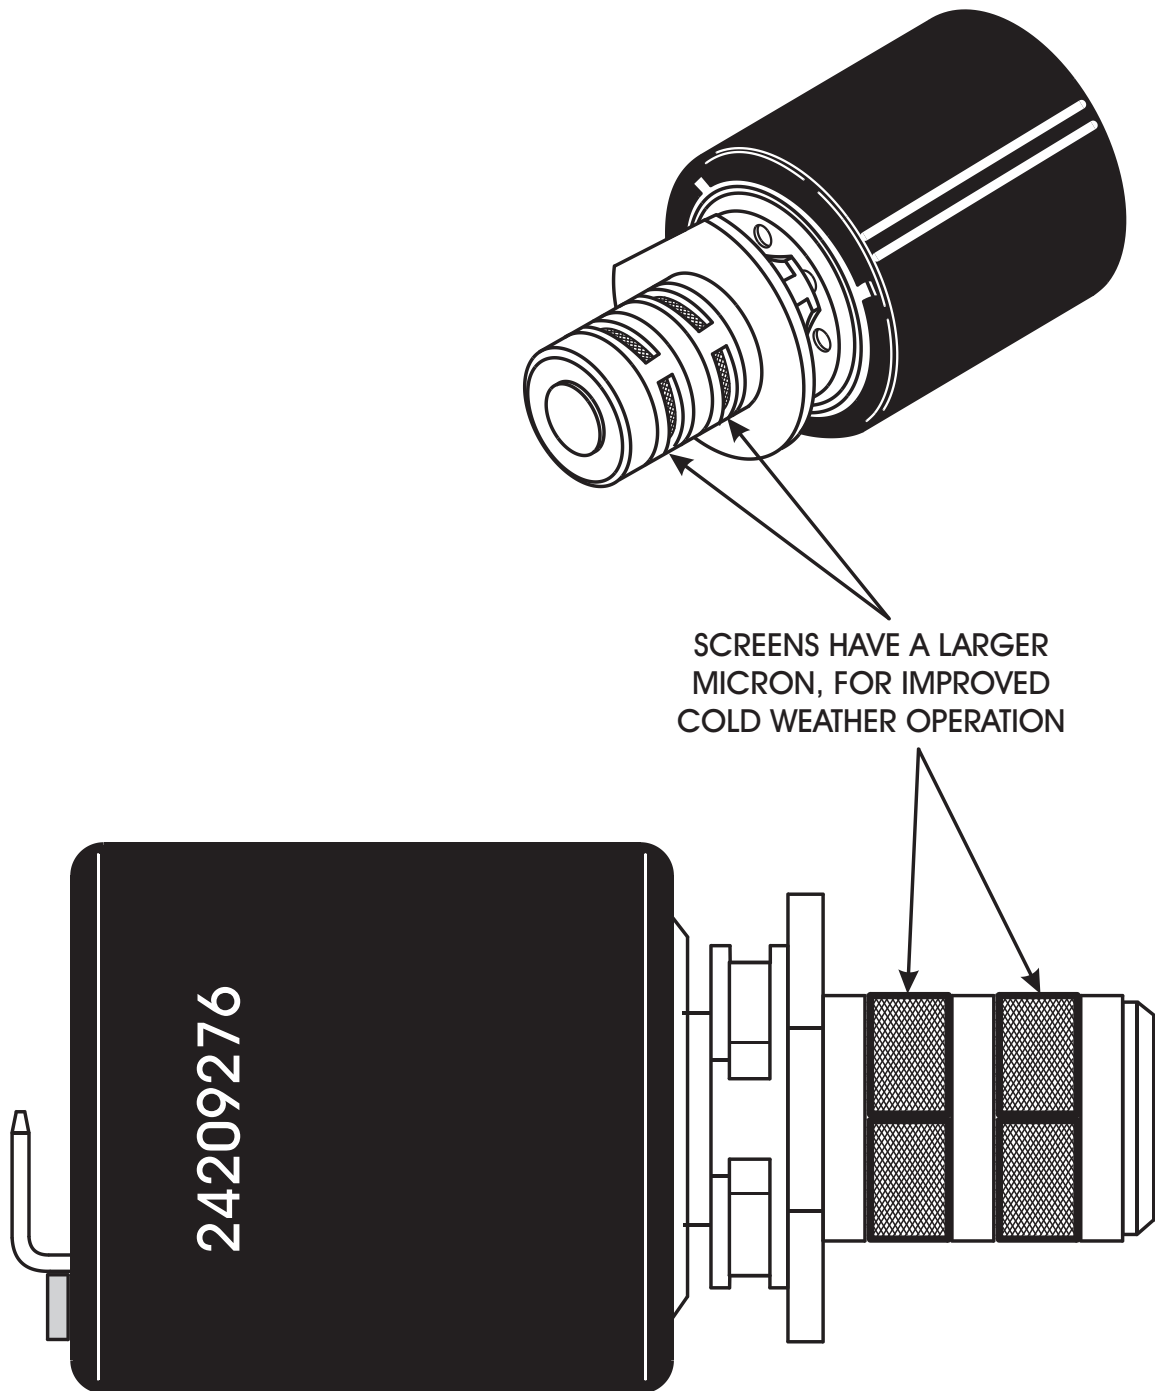
Figure 3

**NEW ELECTRONIC PRESSURE CONTROL SOLENOID
PART NUMBER 24209276**

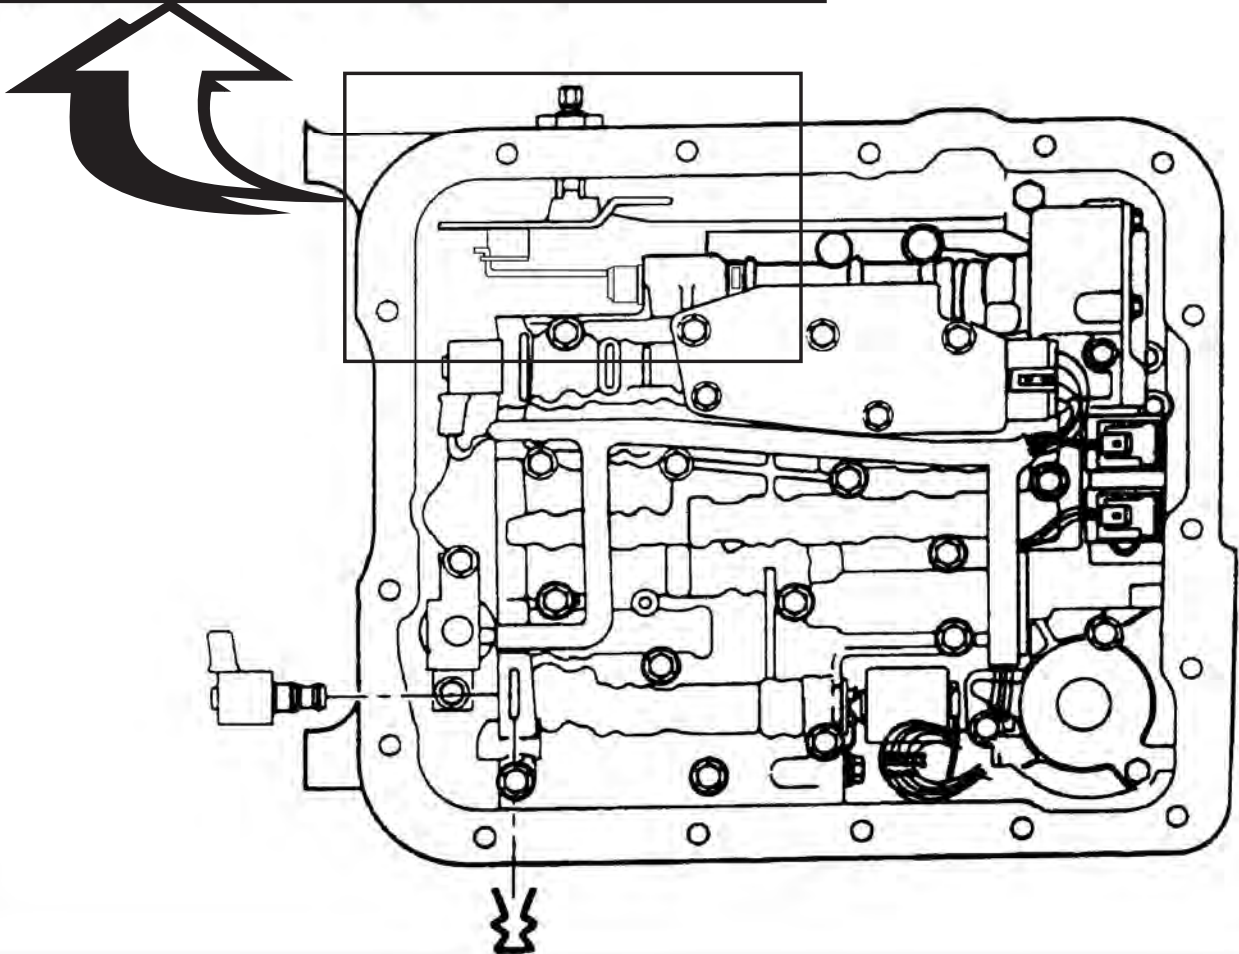
Figure 2

1996 parts must be used on 1996 models.

1995 MANUAL VALVE AND VALVE BODY CASTING

1996 MANUAL VALVE AND VALVE BODY CASTING

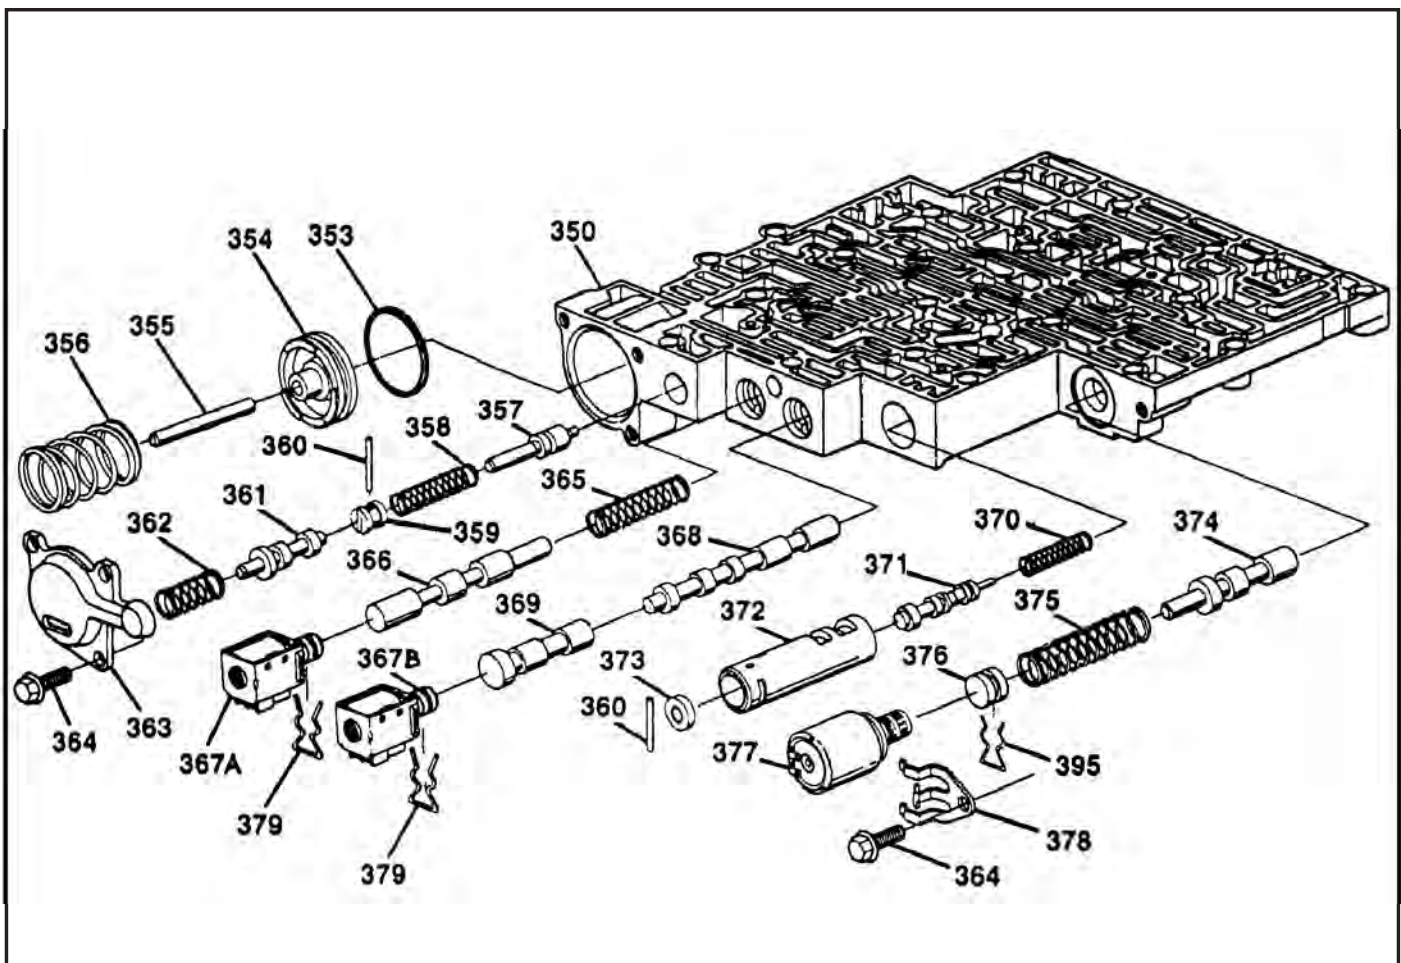
Figure 1

COMPLAINT: Some 1994 model vehicles, equipped with the THM 4L60-E transmission may exhibit a soft 1-2 upshift condition.

CAUSE: The cause may be, calibration of the 1-2 accumulator valve in the valve body.

1-2 Accumulator Valve Service Package 24202698

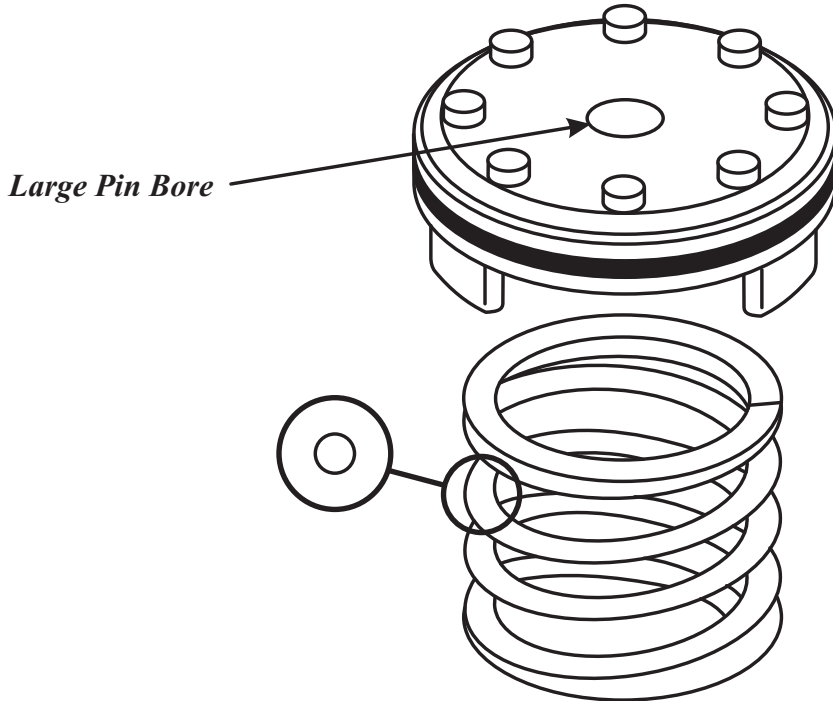
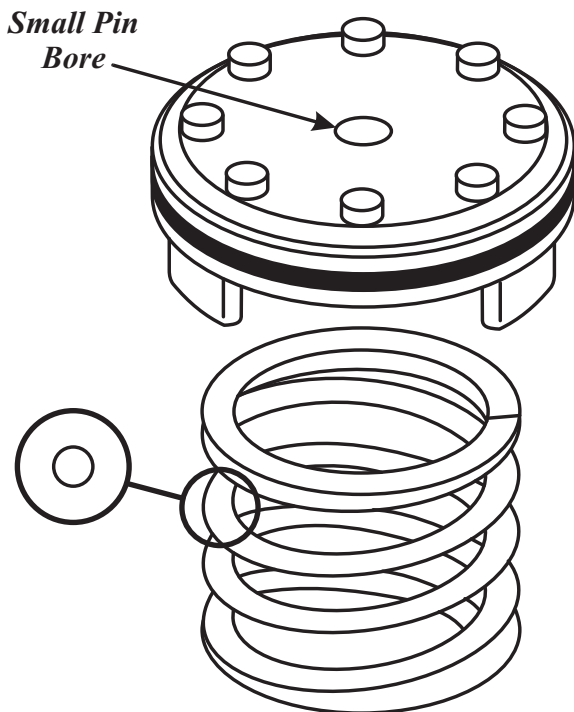
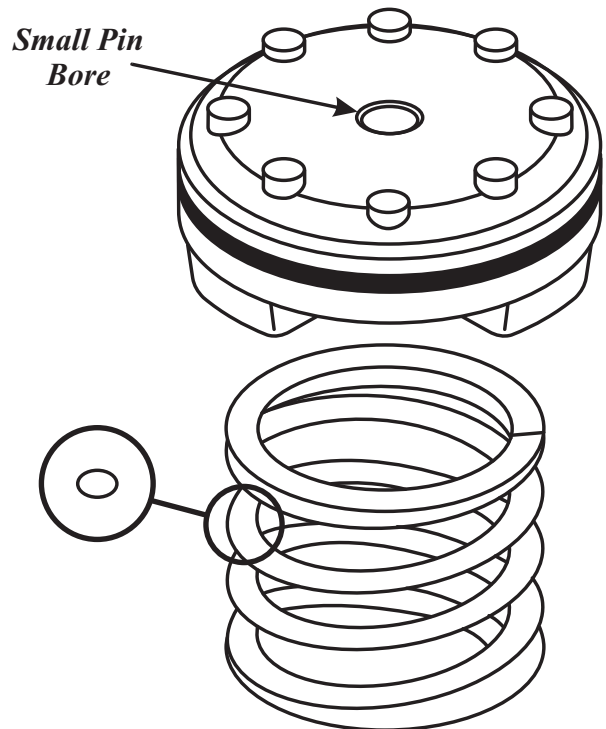
Figure 1

CHANGE: Beginning on May 11, 1998 (Julian Date 131) all THM 4L60-E transmissions were built with a new design plastic 1-2 Accumulator Piston, and an ovate (oval) wire outer accumulator spring, to replace the previous design aluminum piston and round wire outer accumulator spring, as shown in Figure 1.

*Aluminum 1-2 Accumulator Piston
"Round Wire" Outer Spring
1982-1993 Only
Part Number 24204495*

*Aluminum 1-2 Accumulator Piston
"Round Wire" Outer Spring
1984-1997 Only
Part Number 24204496*

*Aluminum 1-2 Accumulator Piston
"Round Wire" Outer Spring
1998-1999 Only
Part Number 24214343*

Refer to "Service Information" below for the proper service package part numbers if replacement is necessary.

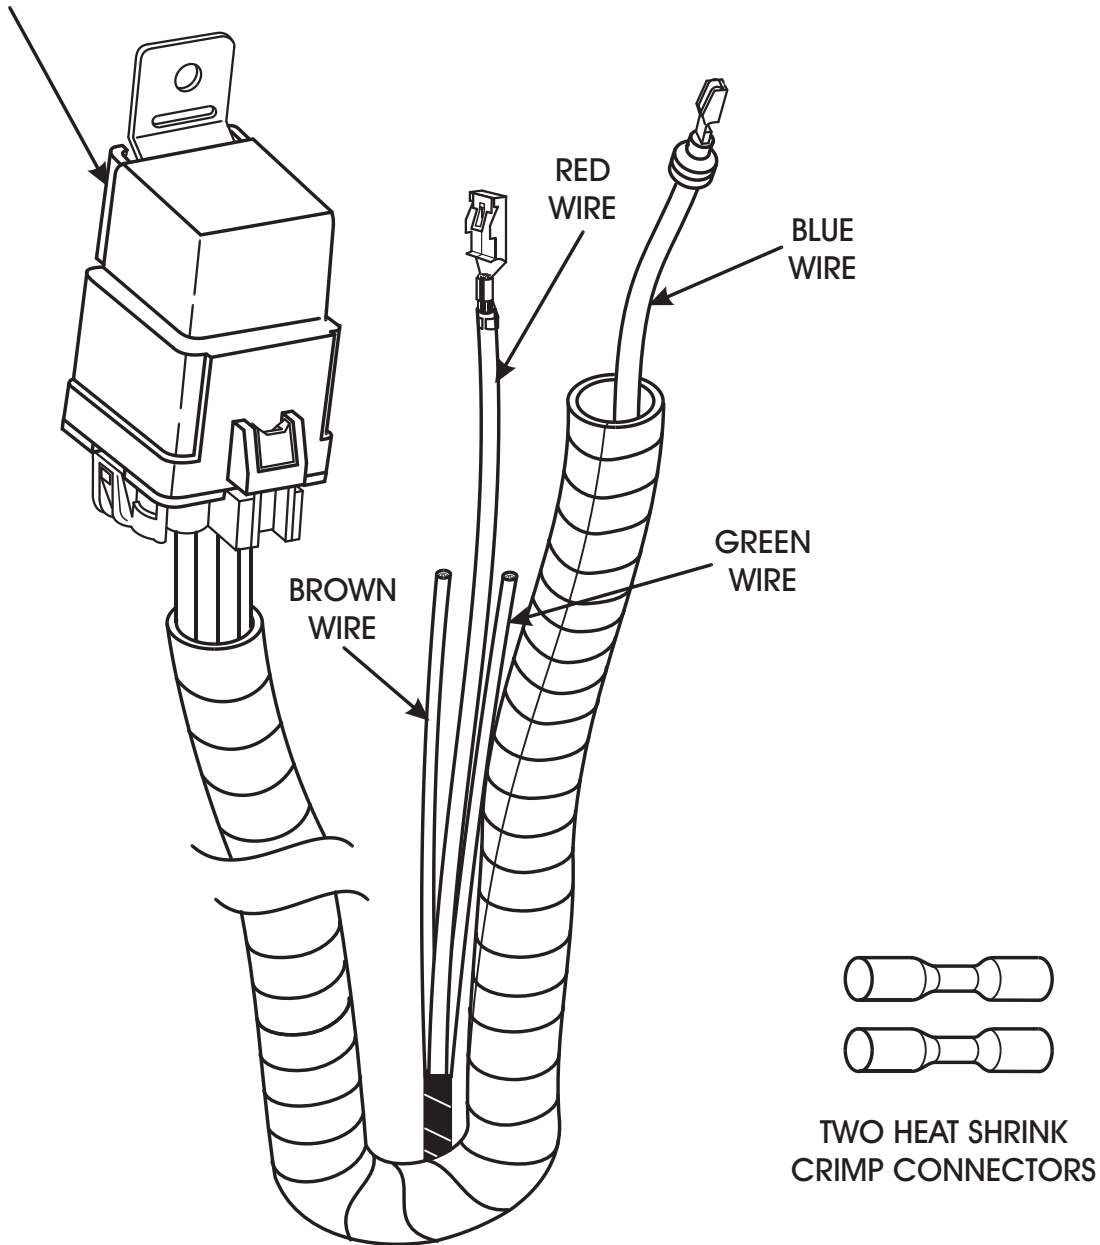
Figure 1

CAUSE: The Primary Cooling Fan Relay may overheat and fail, rendering the cooling fan inoperative and resulting in the overheat condition. The Secondary fan may operate, but will not provide enough cooling air to prevent the overheat condition.

NEW DESIGN
RELAY ASSEMBLY

CONTENTS OF SERVICE PACKAGE PART NUMBER 12167644

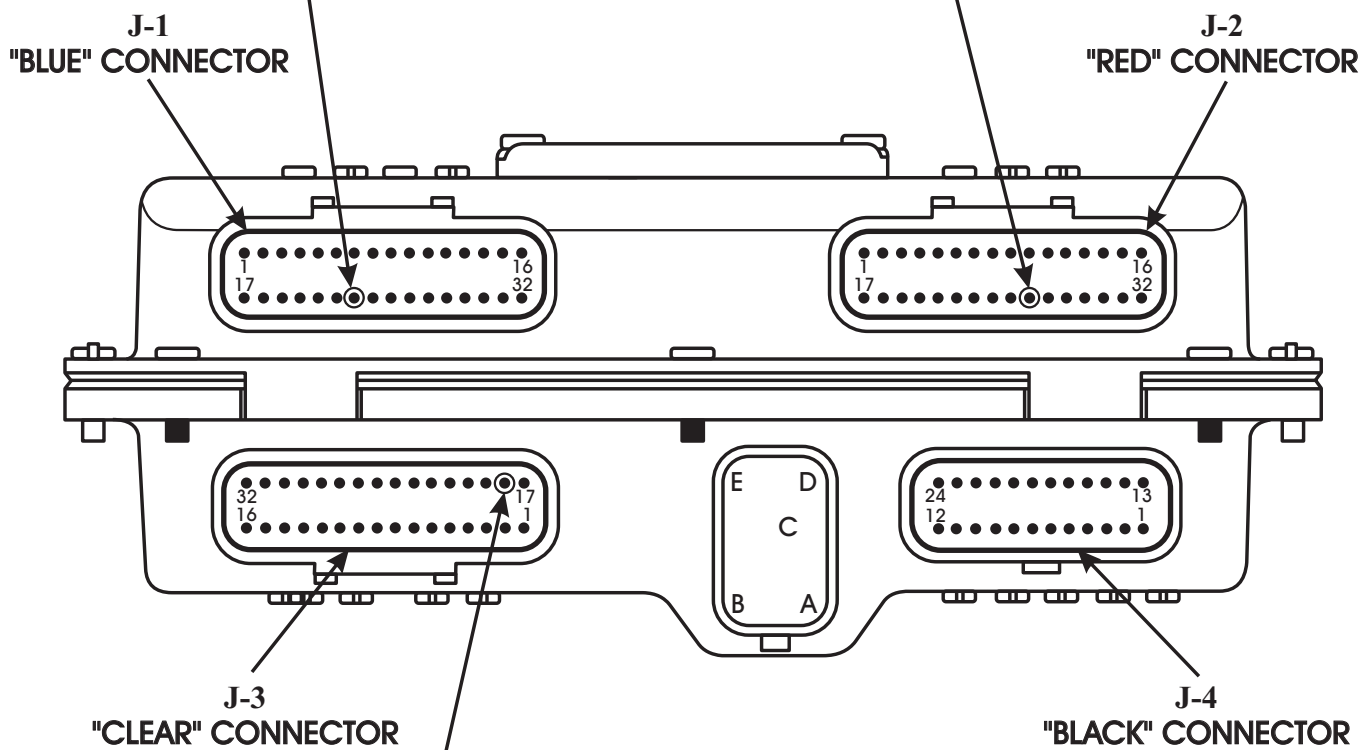
CAUSE: Bad ground connection from one printed circuit board to the other.

Step Number Three

INSTALL THE OTHER END OF THE INCLUDED JUMPER WIRE THAT WAS PREVIOUSLY INSTALLED INTO THE CLEAR CONNECTOR, INTO CAVITY LOCATION 26 OF THE RED CONNECTOR.

Step Number One

REMOVE THE WIRE AND TERMINAL FROM LOCATION 18 ON THE CLEAR CONNECTOR, AND INSTALL ONE END OF THE INCLUDED JUMPER WIRE INTO LOCATION 18 ON THE CLEAR CONNECTOR.

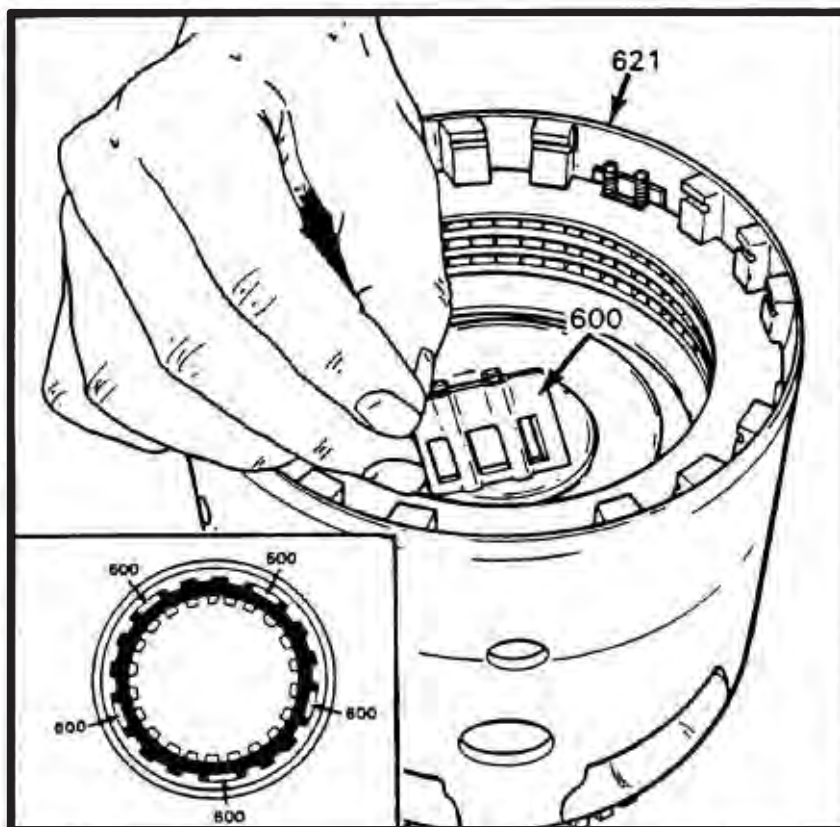
Figure 2

RE-USE THE 3-4 LOAD RELEASE SPRINGS IN THE NEW DESIGN CLUTCH PACK ONLY

Re-install the 3-4 load release springs when you are using the .106" thick steel plates, 7605 high energy lined plates, new design 3-4 apply ring, new design one piece apply plate and new design backing plate.
