THM 4L60-E/4L65-E "UPDATE HANDBOOK"

INTRODUCTION

THM 4L60-E/4L65-E

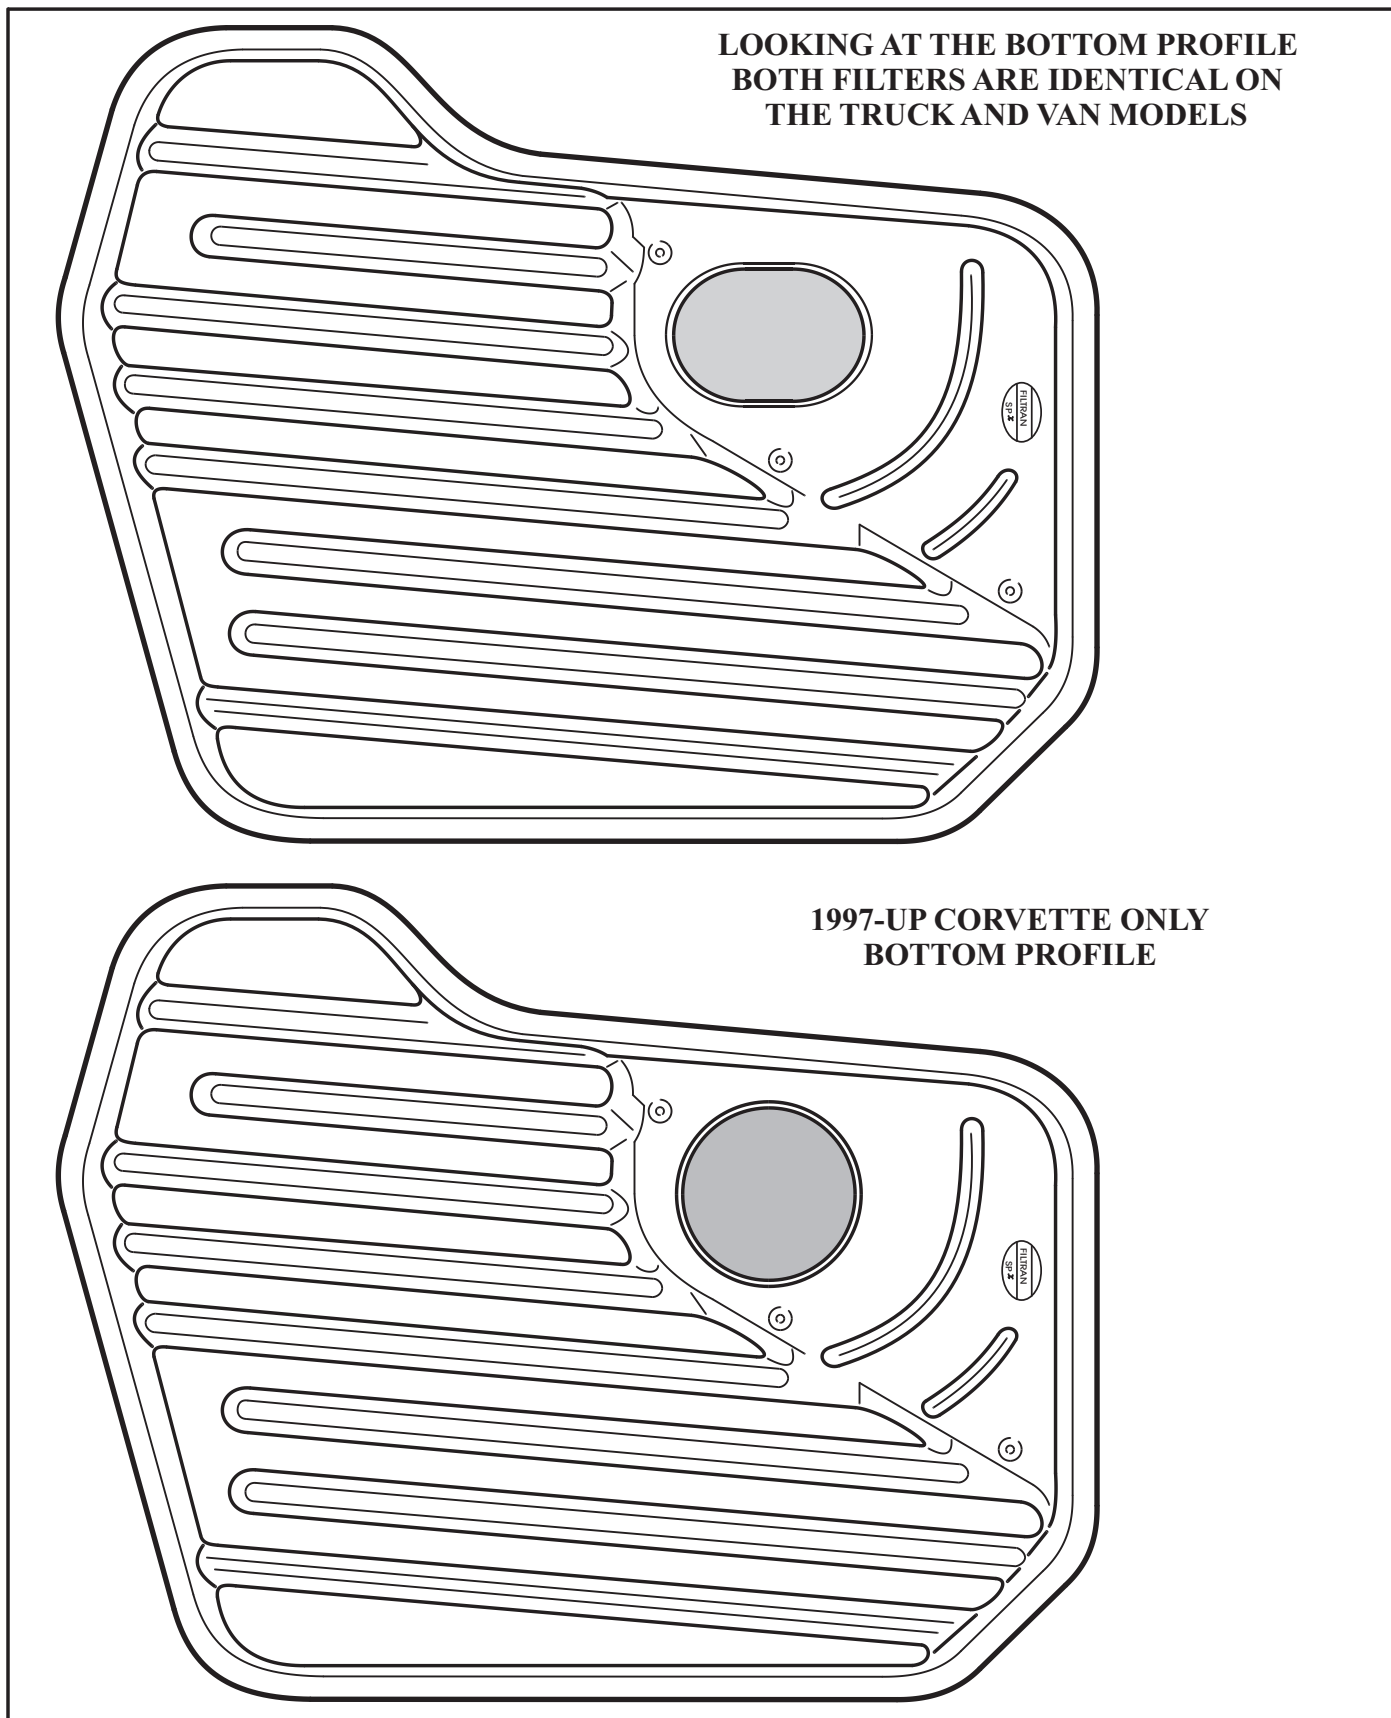
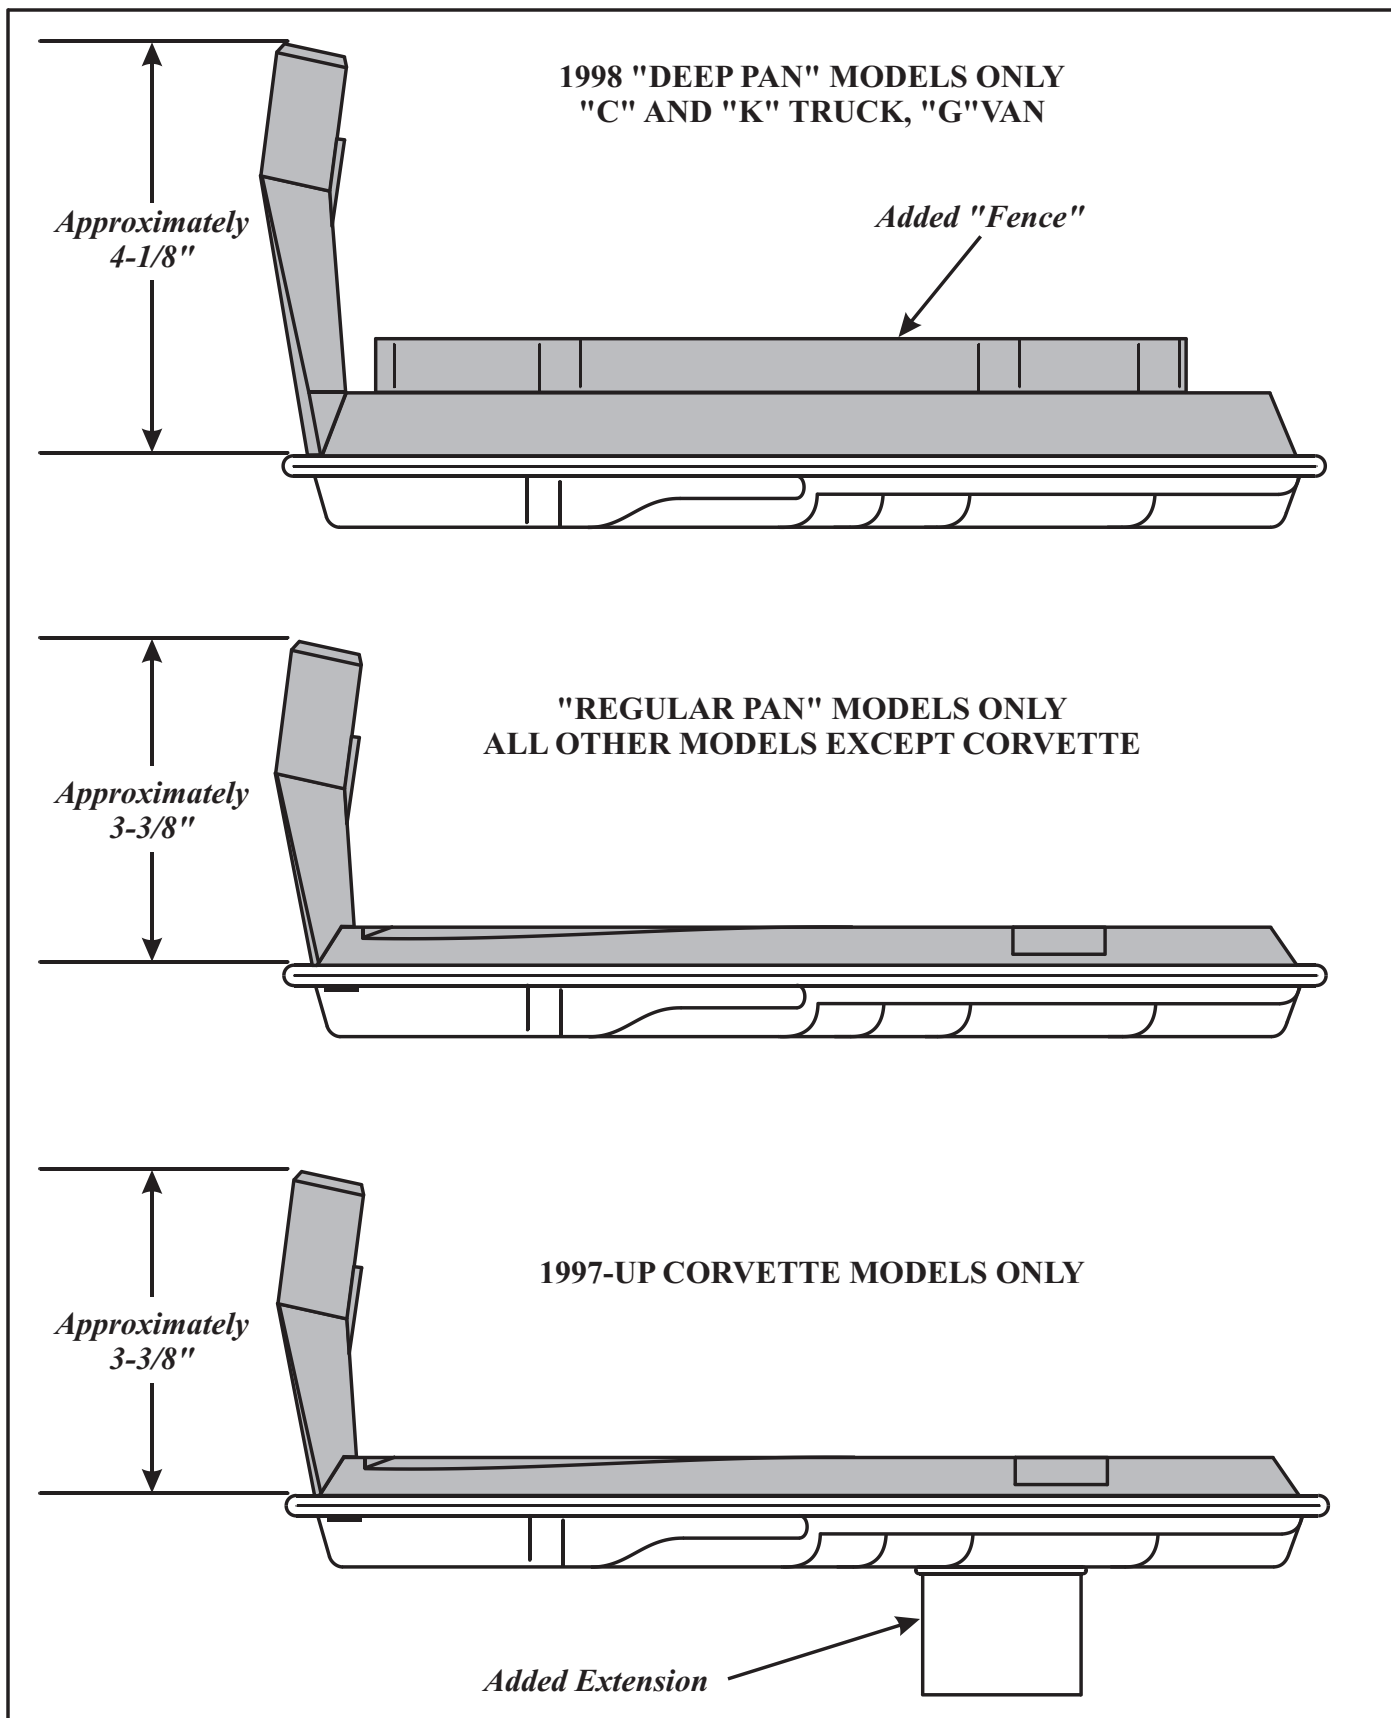
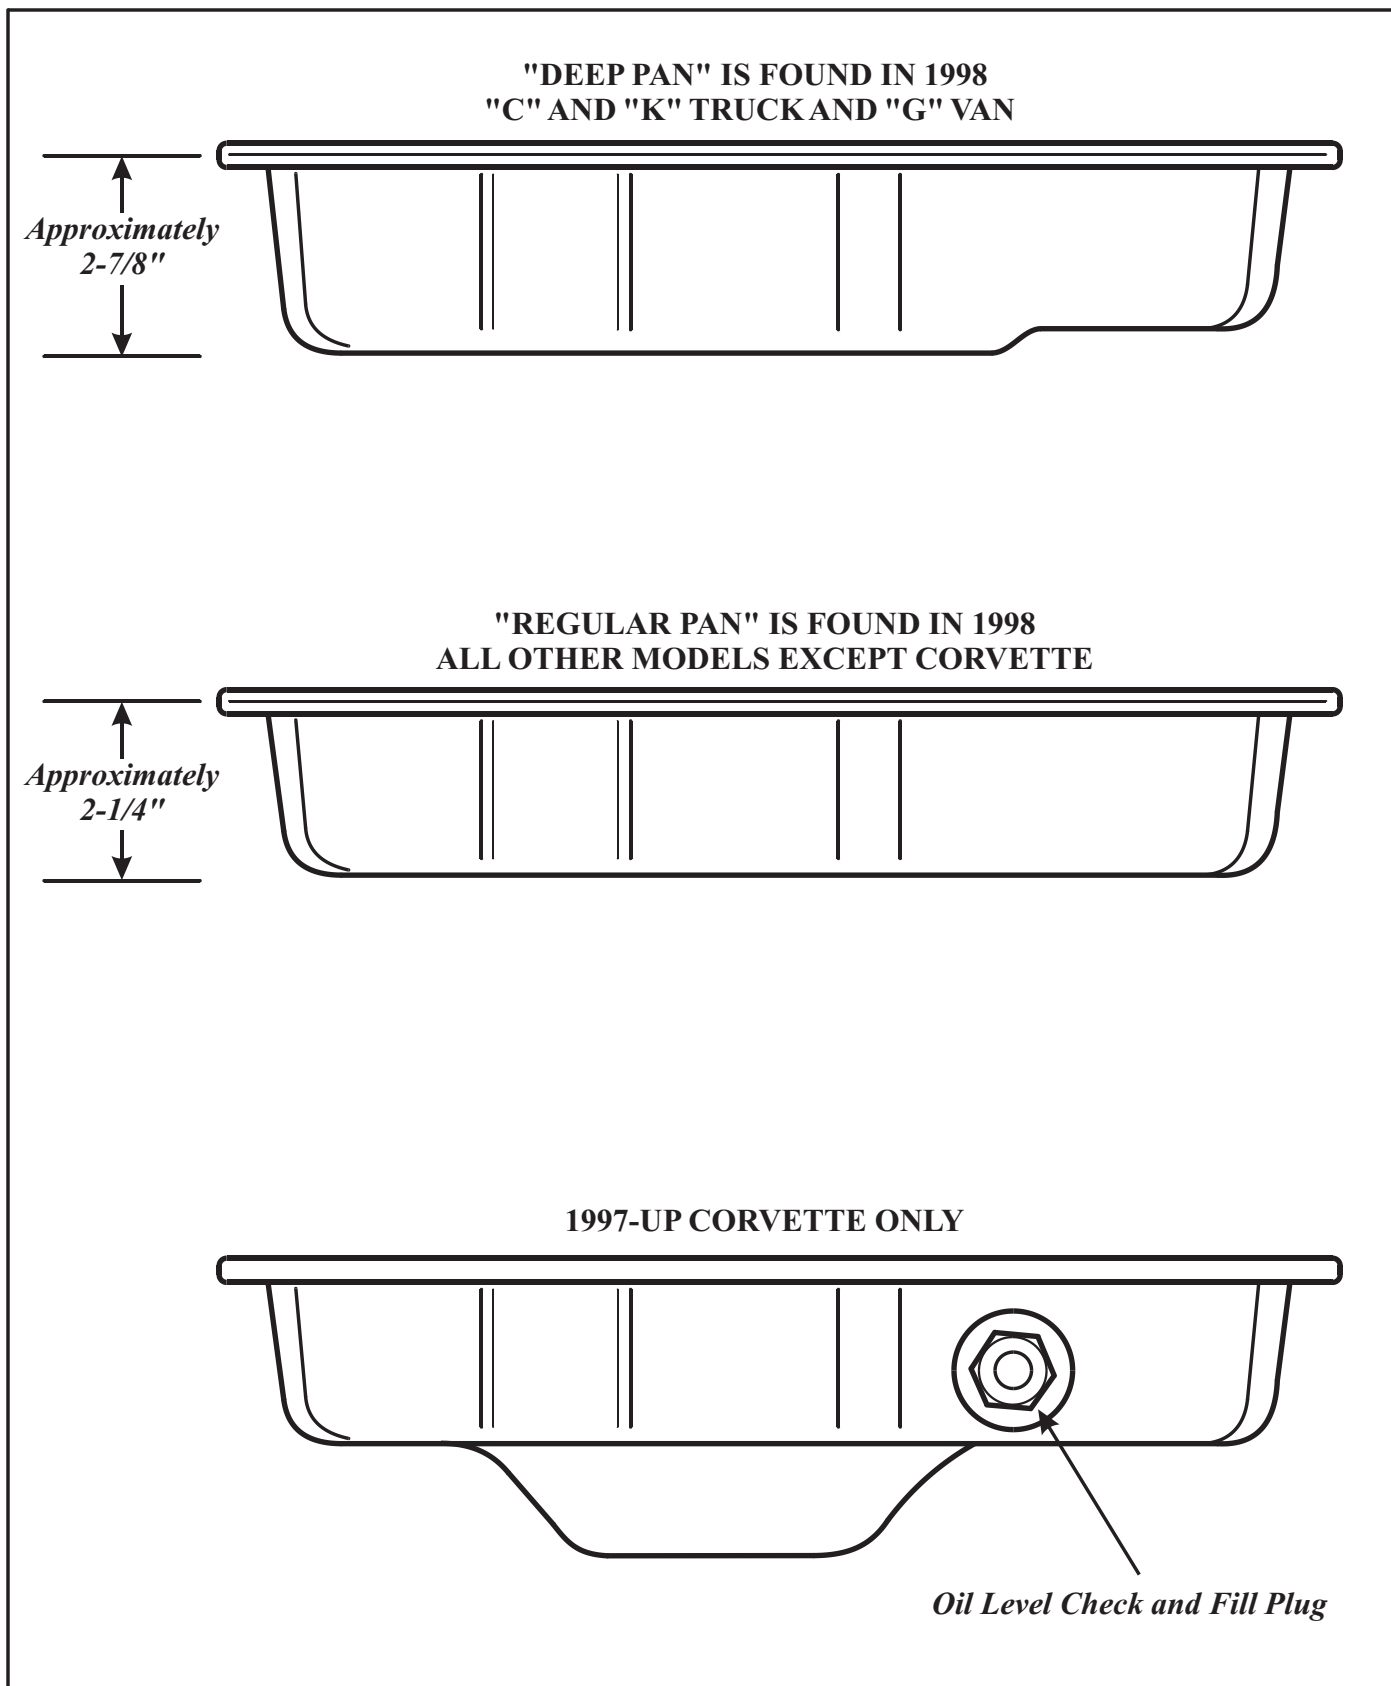
Bottom pan filters must be used with the correct design level bottom pans and must be used on the models that they were intended for, as shown in Figures 1, 2, and 3.

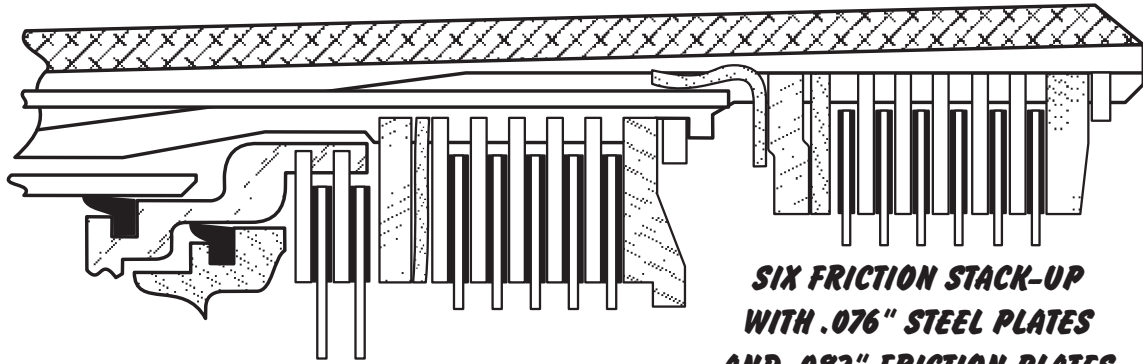
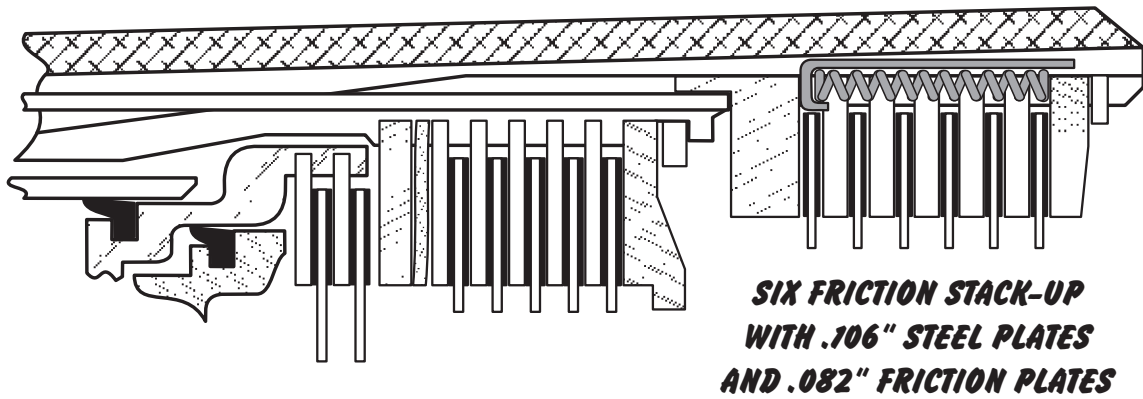
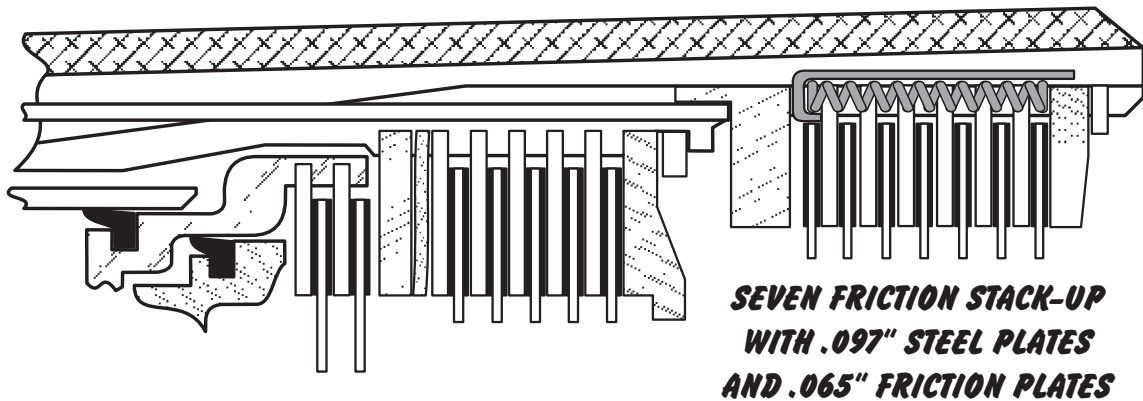
Figure 1

CHANGE: Beginning at the start of production for model year 2001, General Motors introduced a new transmission designated THM 4L65-E (M32) with many engineering changes. Currently this unit is found in all 2001 Cadillac Escalade and any vehicle with 6.0L engine or larger, that was previously equipped with the THM 4L60-E transmission. One of the changes includes adding a seventh lined plate to the 3-4 clutch pack, as shown in Figure 1, with no dimensional changes to the input housing. There is a "Kitted" Service Package available from OEM under part number 24220129, as shown in Figure 2.

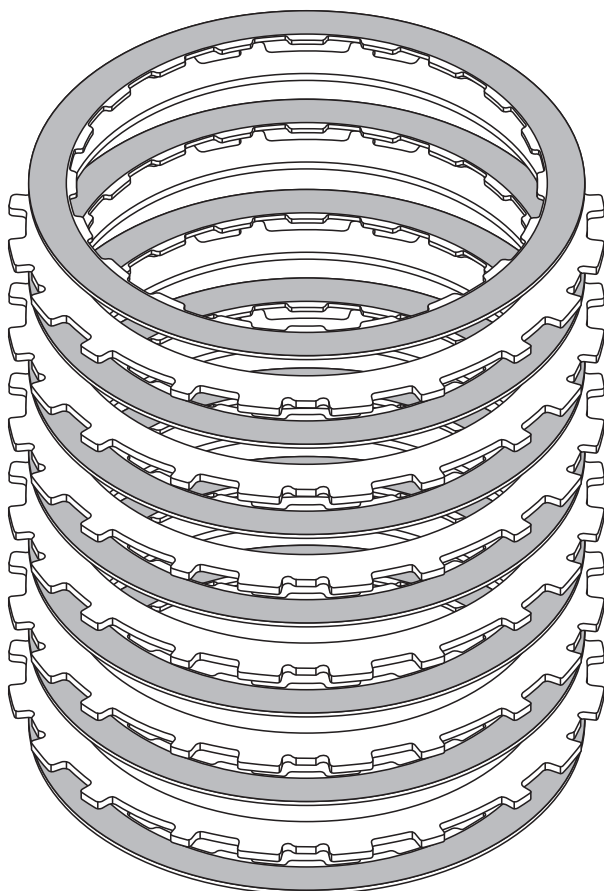
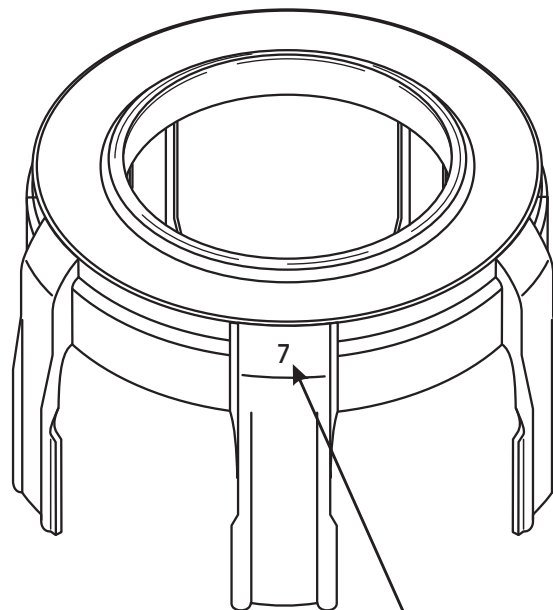
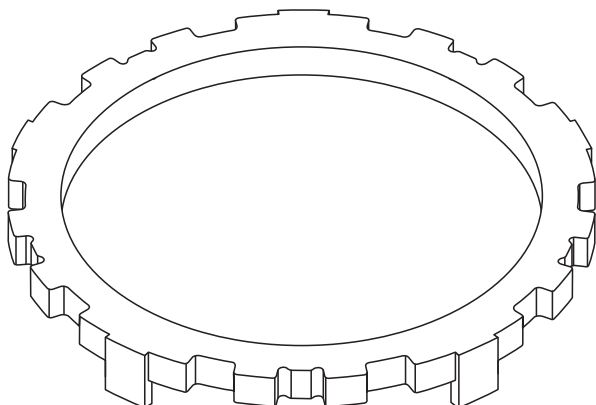
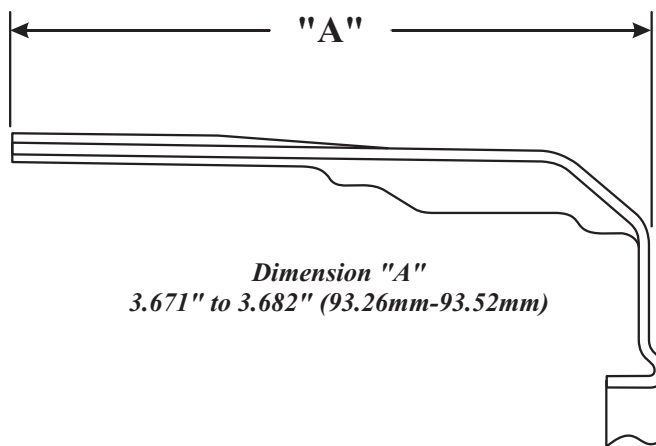
Figure 2

CONTENTS OF SERVICE PACKAGE
PART NUMBER 24220129

- 7 .065" Thick High Energy Friction Plates
- 6 .097" Thick Steel Plates
- 1 .218" Thick 3-4 Apply Plate
- 1 3-4 Apply Ring (Same As Previous, Stamped "7")
- 5 3-4 Load Release Springs (Same As Previous)

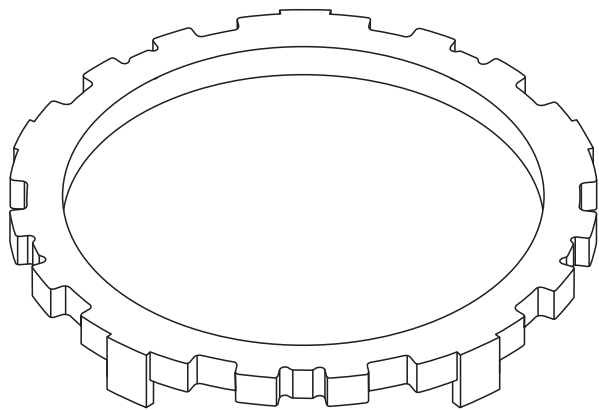
Figure 3

Thickness For Six Friction Plates = .224"
Thickness For Seven Friction Plates = .218"

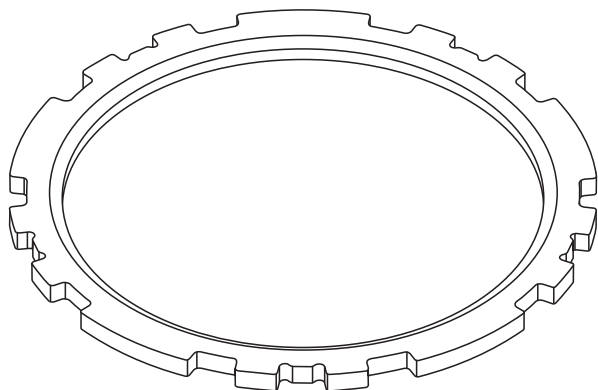
Figure 4

24217450 = .144" Thick (New)
24217453 = .165" Thick (New)
24212460 = .194" Thick (Same As Previous)
24217516 = .219" Thick (New)
24217517 = .241" Thick (New)

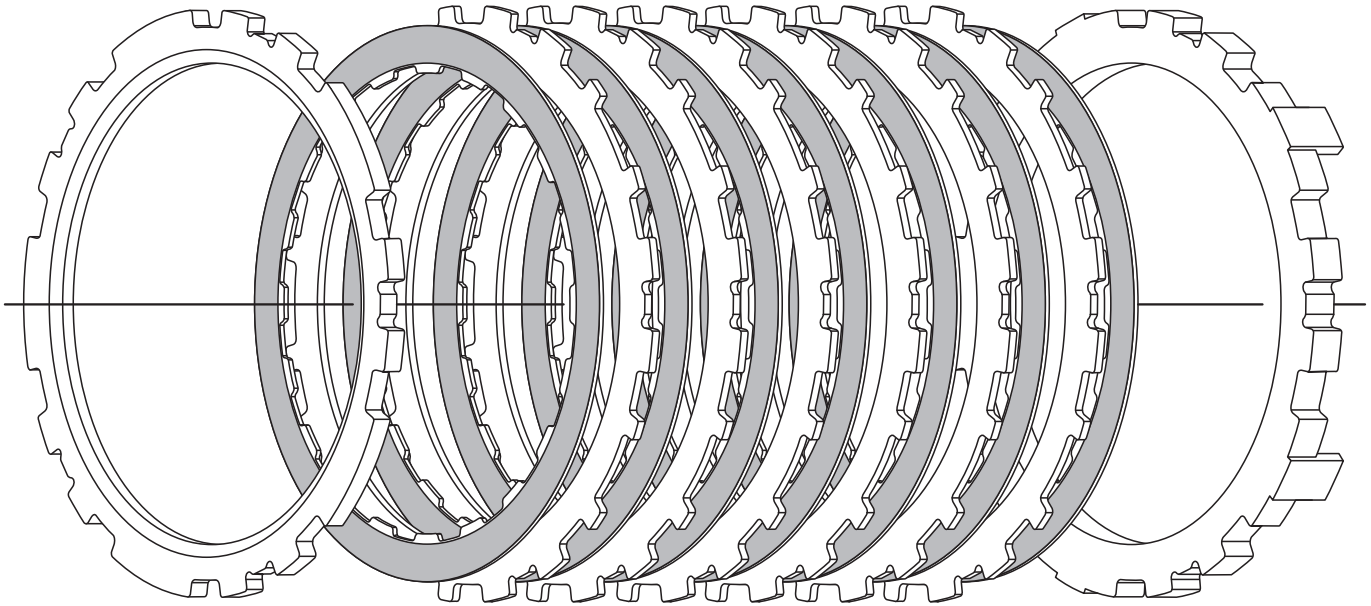
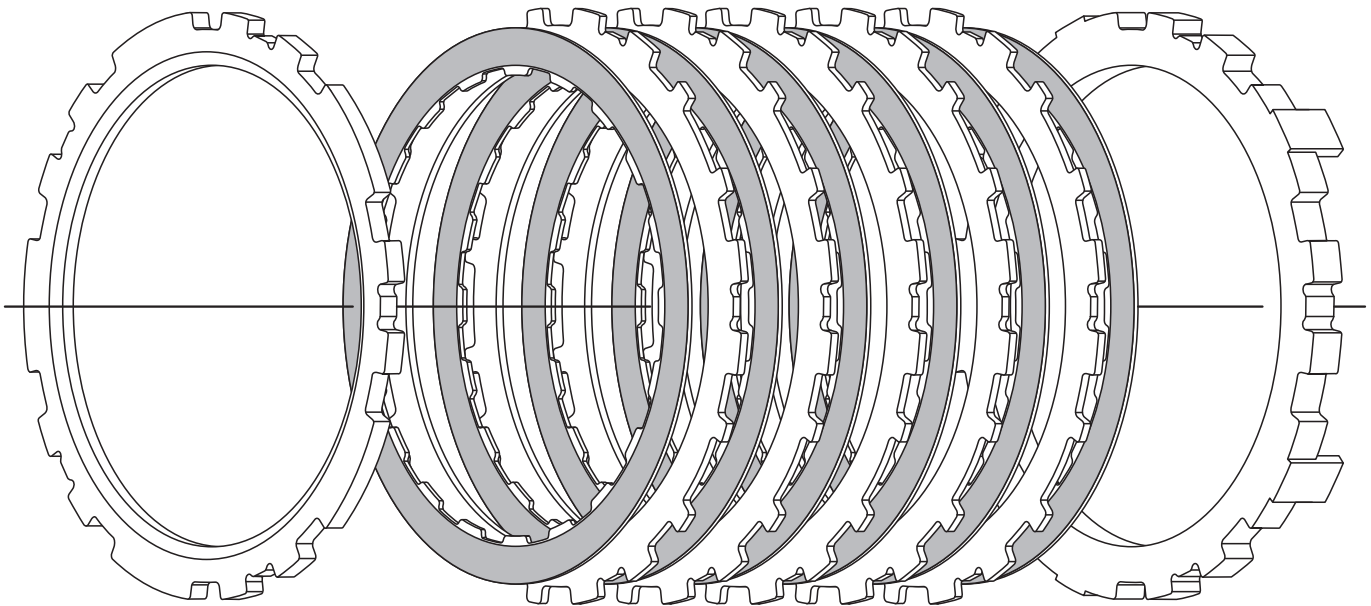
Figure 5

*Friction Plates = .065" Thick, 7 Required
Steel Plates = .097" Thick, 6 Required*

*Friction Plates = .082" Thick, 6 Required
Steel Plates = .106" Thick, 5 Required*

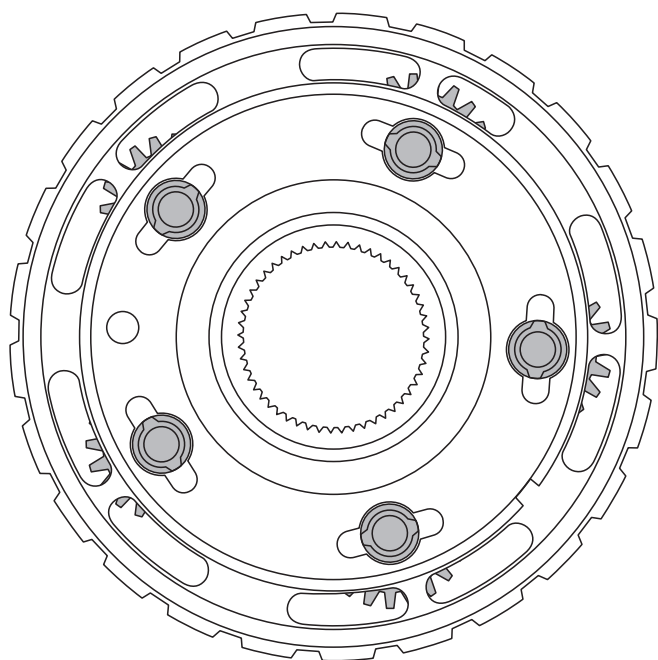
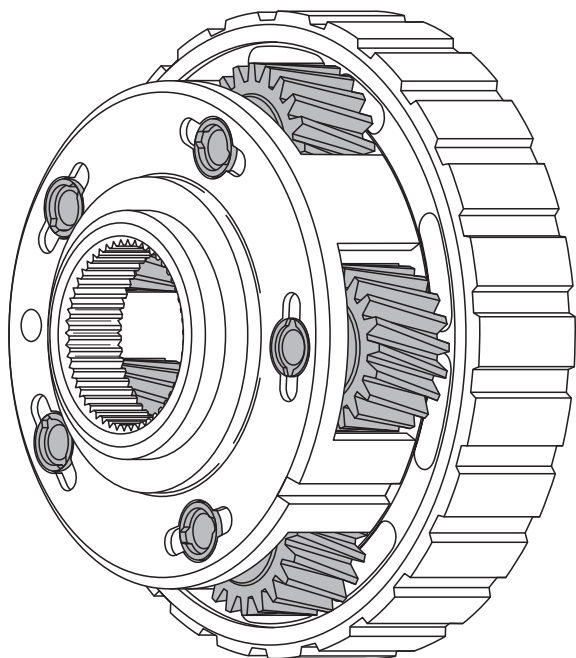
Figure 1

ATSG has recieved several calls on these units with the reaction (rear) ring gear broken. Since the part number changed but the dimensions did not, it would be logical to assume that the manufacturing process changed in some manner. Our recommended procedure, at this time, is to replace it with a reaction ring gear from a THM 4L60-E transmission and available under OEM part number 8667055.

**THM 4L65-E
5 PINION REAR CARRIER**

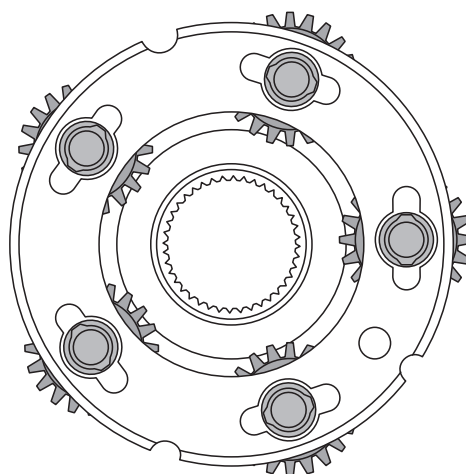
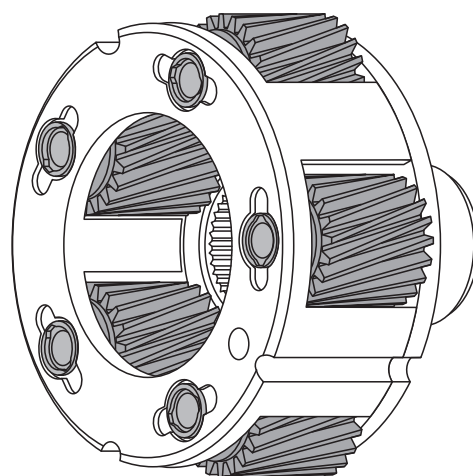
Figure 2

**THM 4L65-E
5 PINION FRONT CARRIER**

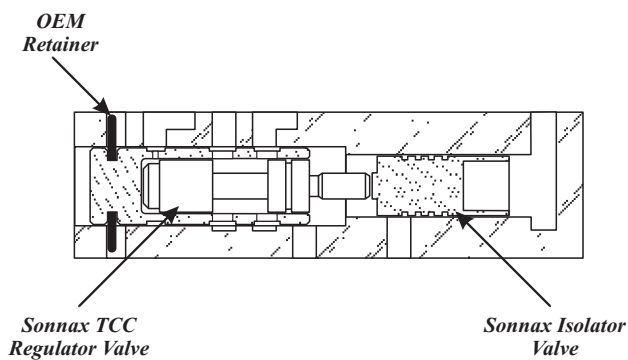
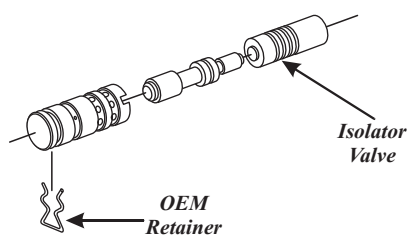
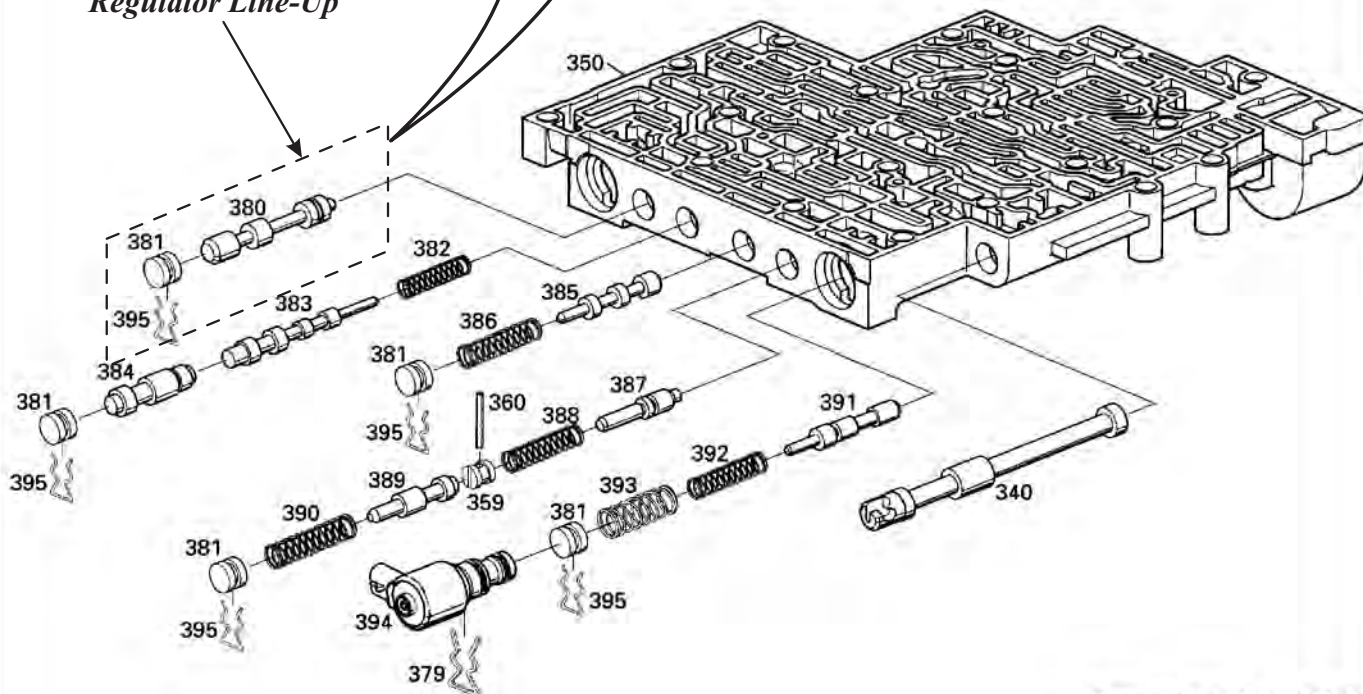
CAUSE: The cause is usually Torque Converter Clutch slippage, created by a badly worn valve body casting in the Converter Clutch Regulator Valve bore.

CORRECTION: Sonnax manufactures two different kits to repair the current valve body castings, both of which require a reamer, also available from Sonnax. One of the kits, Sonnax part number 77754-03K, fits 1993 thru 1997 model transmissions, but they require different assembly processes. Refer to Figure 1 for the 1994-1994 models and Figure 2 for the 1995-1997 models, for the proper assembly. The other kit, Sonnax part number 77754-04K, fits only the 1998 and later ECCC models, as it is a different calibration. Refer to Figure 3 for proper assembly of the 1998 and later models. The reamer required is the same for either kit and is available under Sonnax part number 77754-R2.

**Sonnax kit for 93-94 NON-PWM Models:
Install Isolator Valve as shown below
and use OEM retaining clip.**
