# **4L60E/65E/70E- 4L80E/85E DIAGNOSTIC CODE BOOK**

## **INTRODUCTION**

The GM 4L60E/65E/70E-4L80E/85E Diagnostic Code Book is designed to provide the technician with a step by step diagnostic approach to each and every transmission code available from 1991 to the 2007 model year. This manual can be used in collusion with any type of scanner utilized in retrieving these codes from the computer. As an aid to the technician, component location is recognized throughout the manual.

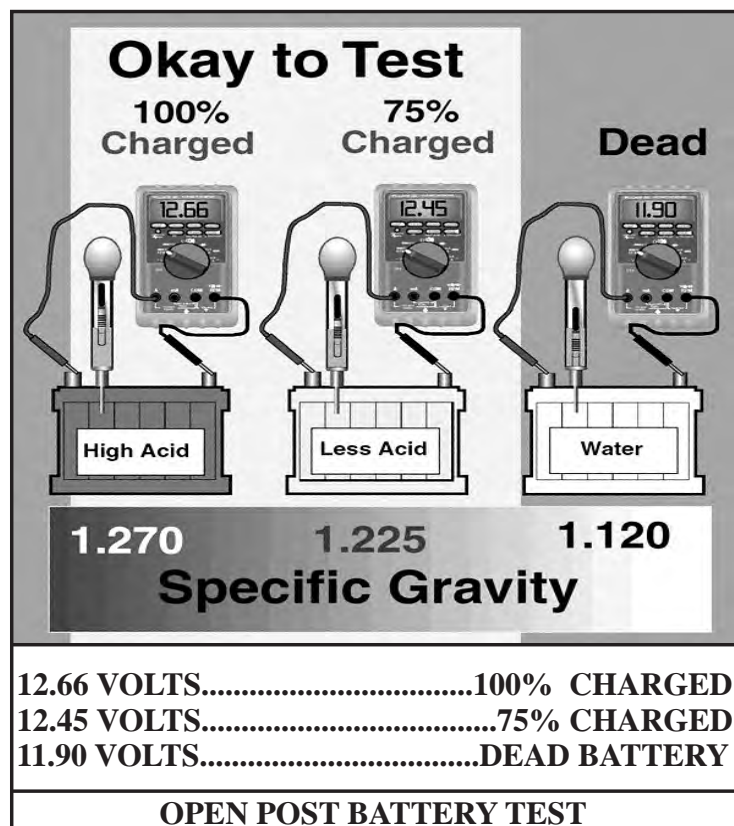
When diagnosing an electrically generated problem, the diagnostic procedure should always begin with verifying the vehicles power supply and ground systems. A battery in a poor state of charge can cause an electronically controlled transmission to not perform as it should. Begin by checking the battery state of charge as shown in Figure 1 below.

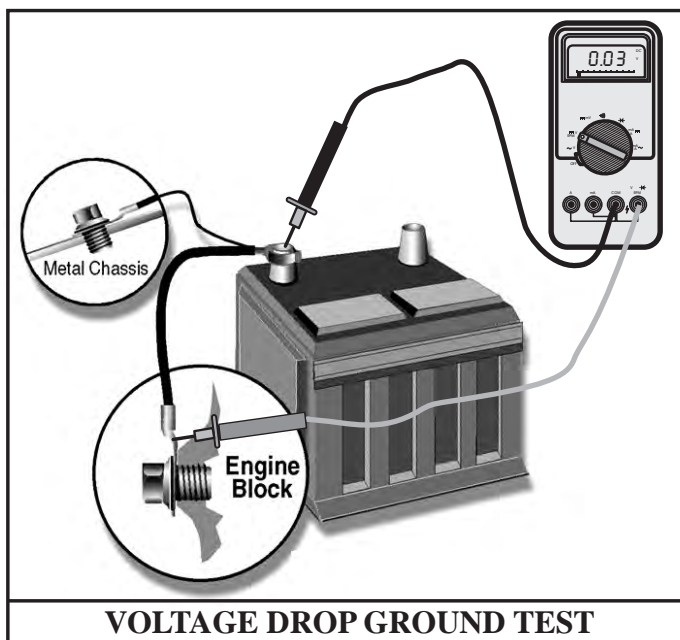
Figure 2

Next, with the engine running, place the negative meter lead to the negative battery POST, and the positive meter lead to the ground wire in question, 0.3 volts or 300 millivolts or less should be seen as illustrated in Figure 2. Any voltage reading higher than this requires attention.

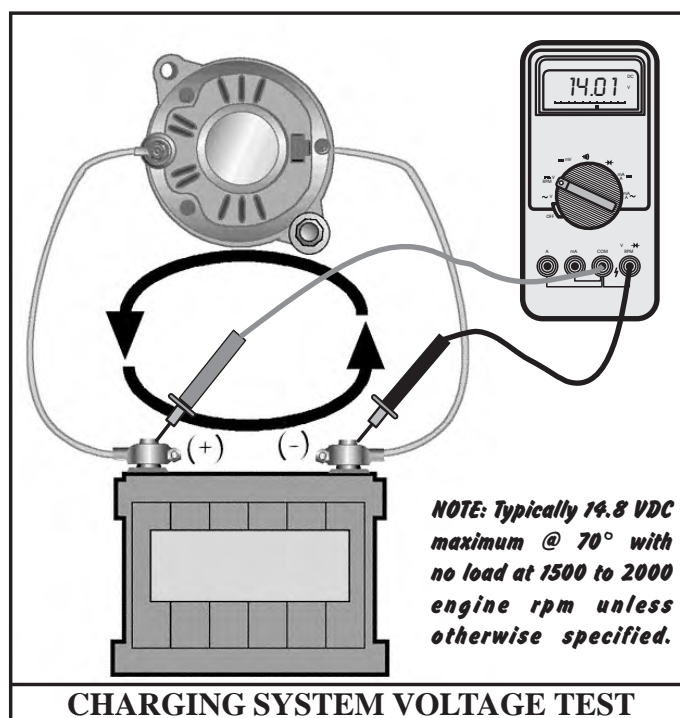
Figure 3

Next, charging system voltage should be verified to manufacturers specs to insure proper alternator output is present as shown in Figure 3. It is also recommended that intermittent voltage spikes do not exist, which can cause erratic and unusual electrical problems which could effect normal transmission operation *especially when pressure control solenoid codes are stored.*

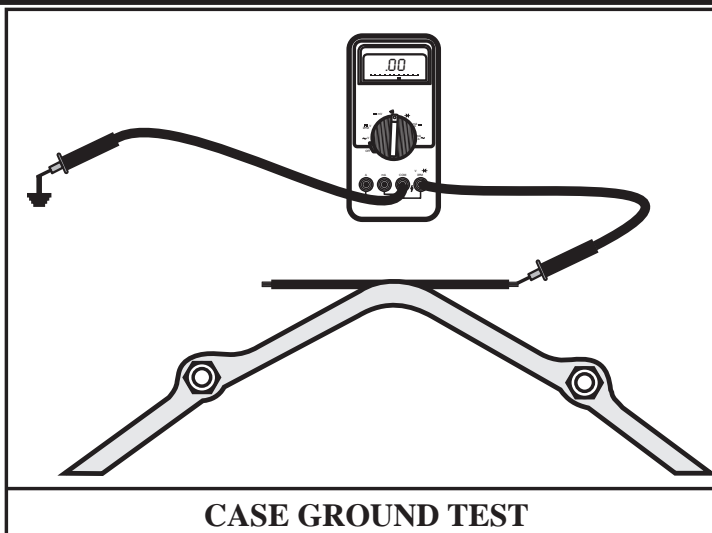
Figure 4

Transmission operation can be impaired as well as internal damage of bushings, washers and other hard parts such as pump rotors, gears or planet carriers. Preferably with the engine running, place the negative meter lead to a good **KNOWN** ground, and the positive lead to the transmission case, as seen in Figure 4. The maximum allowable voltage should not exceed 0.3 VDC or 300 millivolts. If the voltage seen is excessive, one or more ground straps may be necessary.

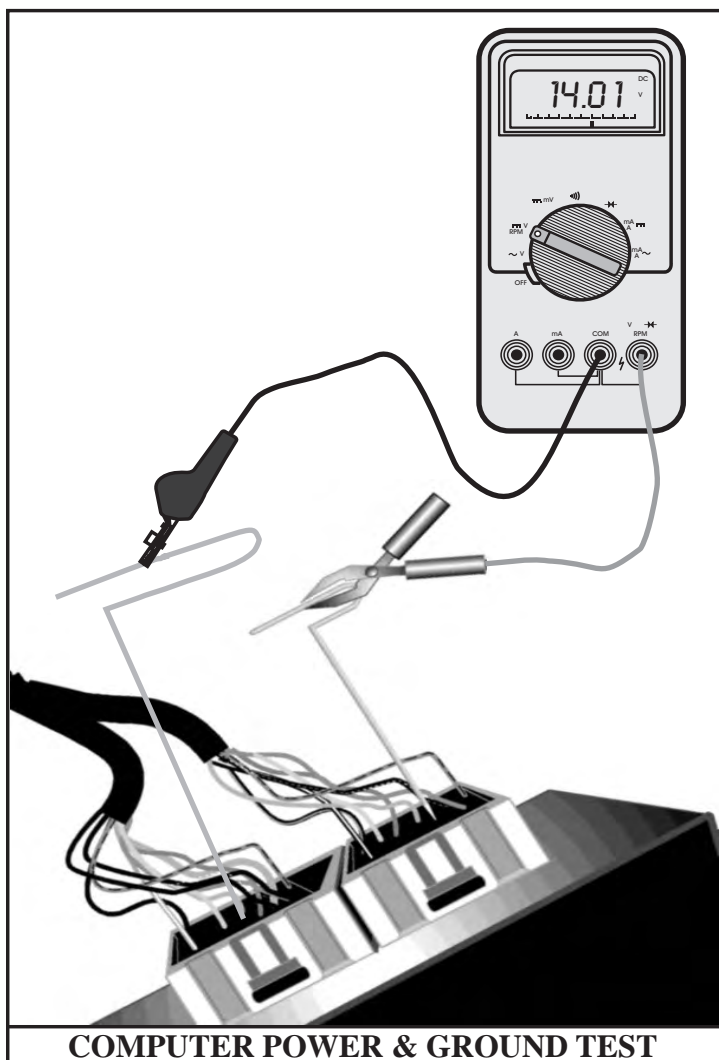
Figure 5

Next, check power and ground at the computer by back probing the computer connector. Battery or charging system voltage should be approximately the same as the readings seen at the battery or alternator. (See Figure 5) The ground readings should be 0.2 or 200 millivolts or less.

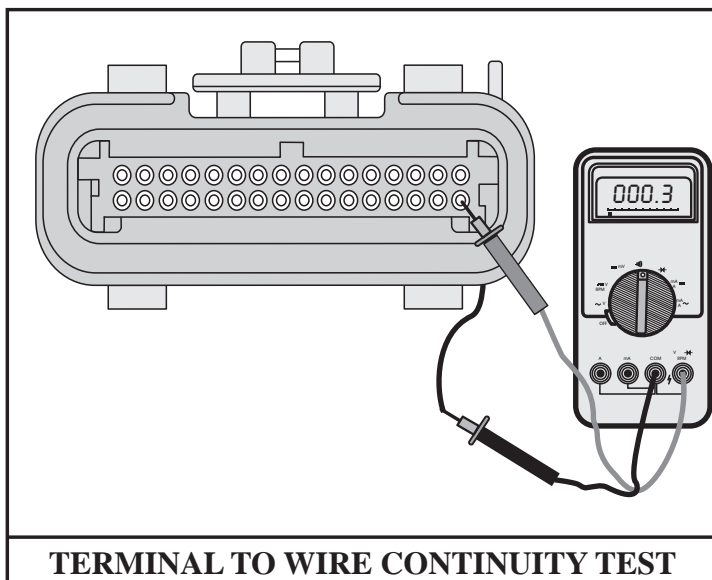
Figure 6

In order to verify the integrity of the wire end connection at the crimp, carefully place one meter lead into the cavity opening and the other meter lead into the wire behind the connector with the DVOM set to OHMS ( ) as seen in Figure 6.

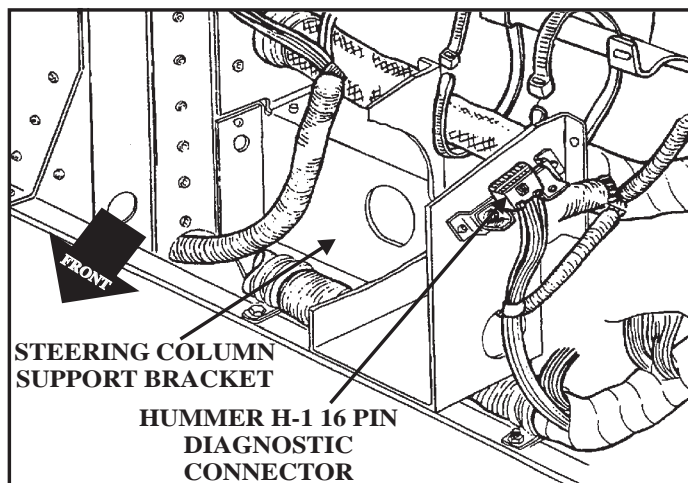
Figure 14

Use the following 10th, 3rd and 8th digits for Hummer VIN ID: "**T**" for 1996, "**K**" for 4WD Pickup and "**S**" for 6.5 Turbo-Diesel Engine. You may be asked to locate the 12 pin connector on some scan tools, disregard this and locate the 16 pin OBD-II connector located on the left side of the steering column support bracket as seen in Figure 14.

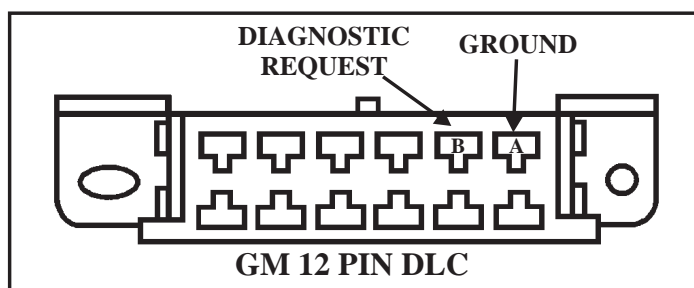
Figure 16

The standard 12 pin GM Data Link Connector (DLC) used in most NON-OBD-II vehicles is shown in Figure 16.

These computer systems produce two digit codes which could be retrieved without a scan tool by jumping the "A" and "B" terminals. The "Check Engine" or Service Engine" Lamp would flash long and short blinks indicating the two digit trouble codes stored.

With the scan tool connected to this type of DLC, a separate power supply is required to power up the scan tool such as the vehicles cigarette lighter.

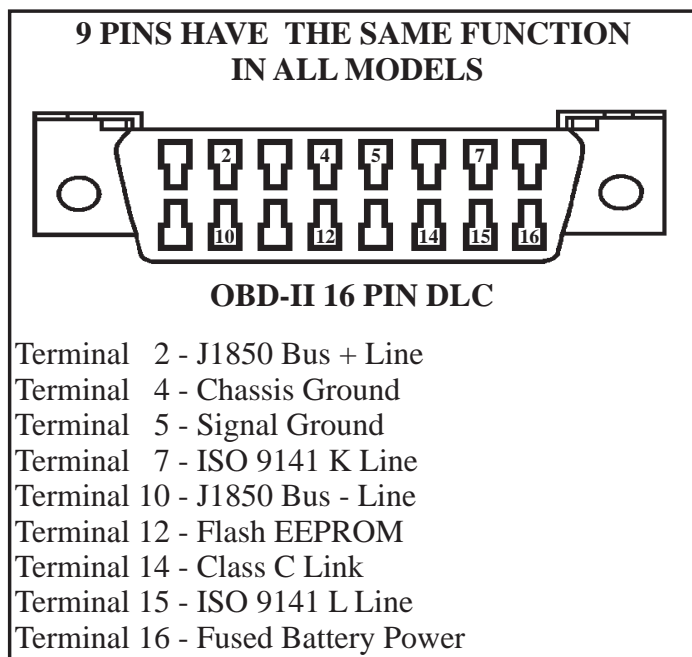
Figure 17

The standard OBD-II diagnostic connector is a 16 pin connector. OBD-II mandates require 9 of these pins to perform the same function no matter who made the vehicle.

This is illustrated in Figure 17, the remaining 7 pins are manufacturer specific. This is the reason “jumping” this type of diagnostic connector is NOT recommended. The use of a scan tool is mandatory for purposes of communication.

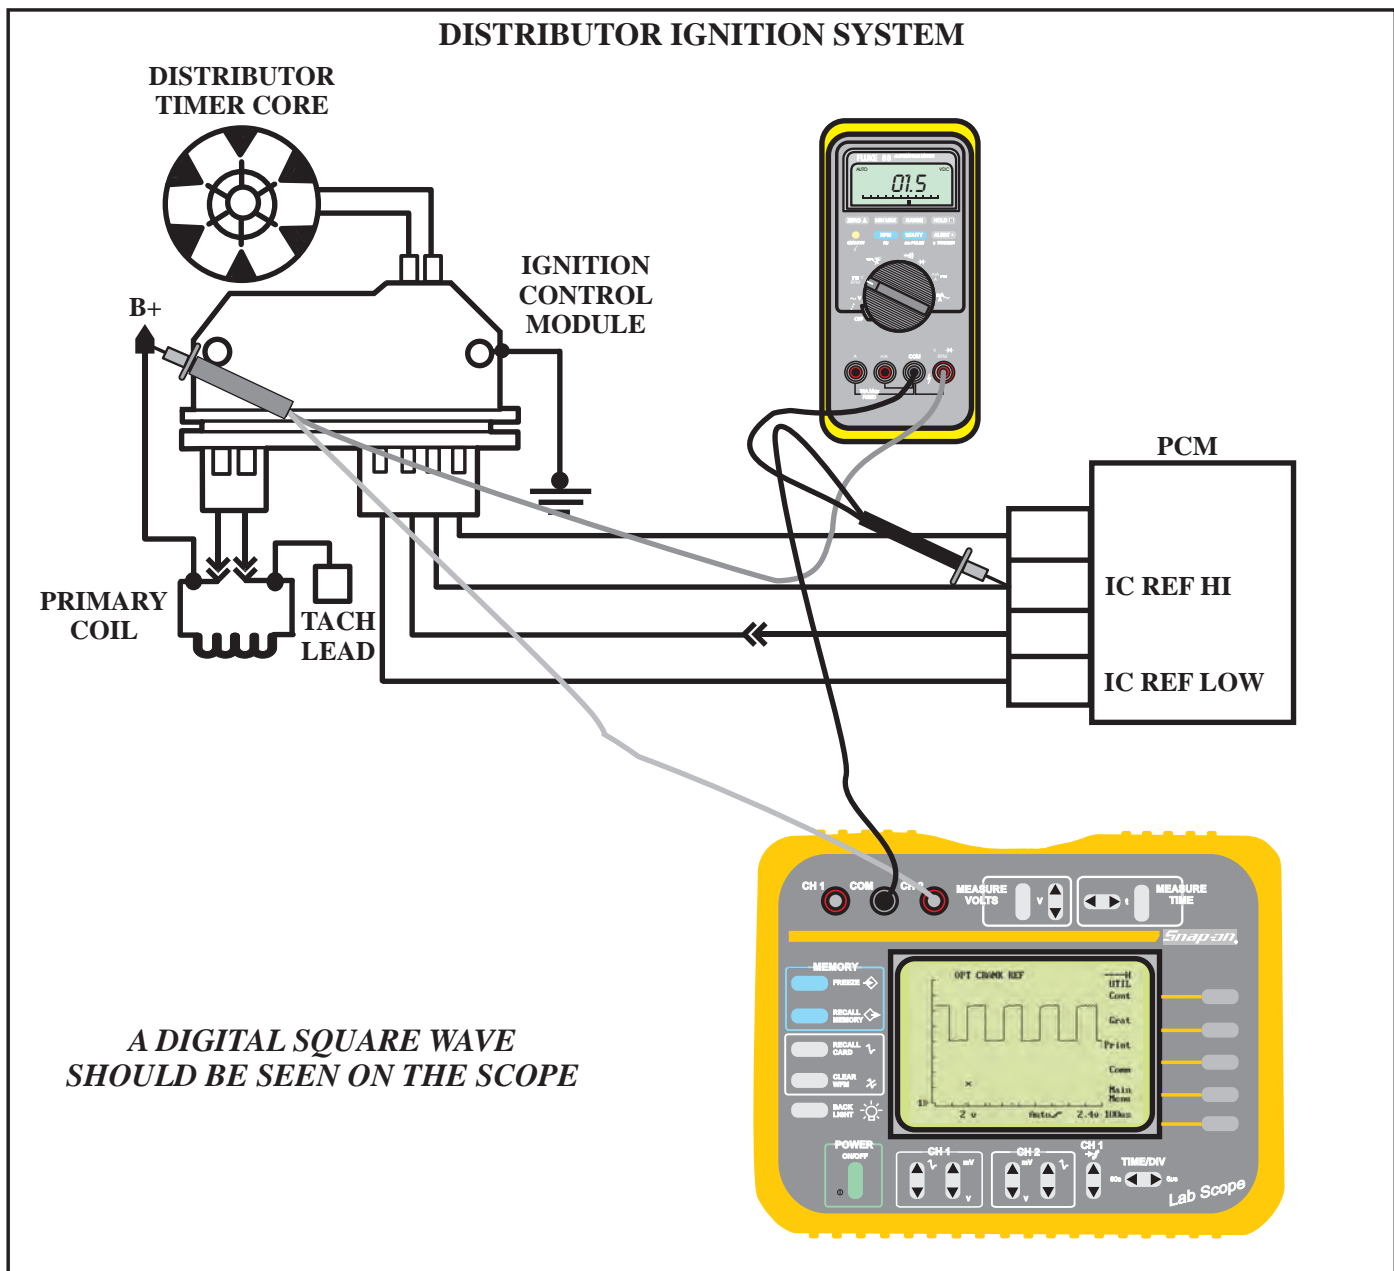
Figure 34

- With a voltmeter connected to the IC Reference High circuit and B+, as shown in Figure 34, a zero to approximately 1.5 volts signal should be seen. This is NOT the best method of checking this signal.
- Since the distributor timer core is responsible for creating this AC voltage signal, it is the Ignition Control Module that converts this signal into a digital square wave for the PCM to use for engine speed calculations.
- The digital square wave can be monitored with an oscilloscope or a graphing voltmeter as also seen in Figure 34.

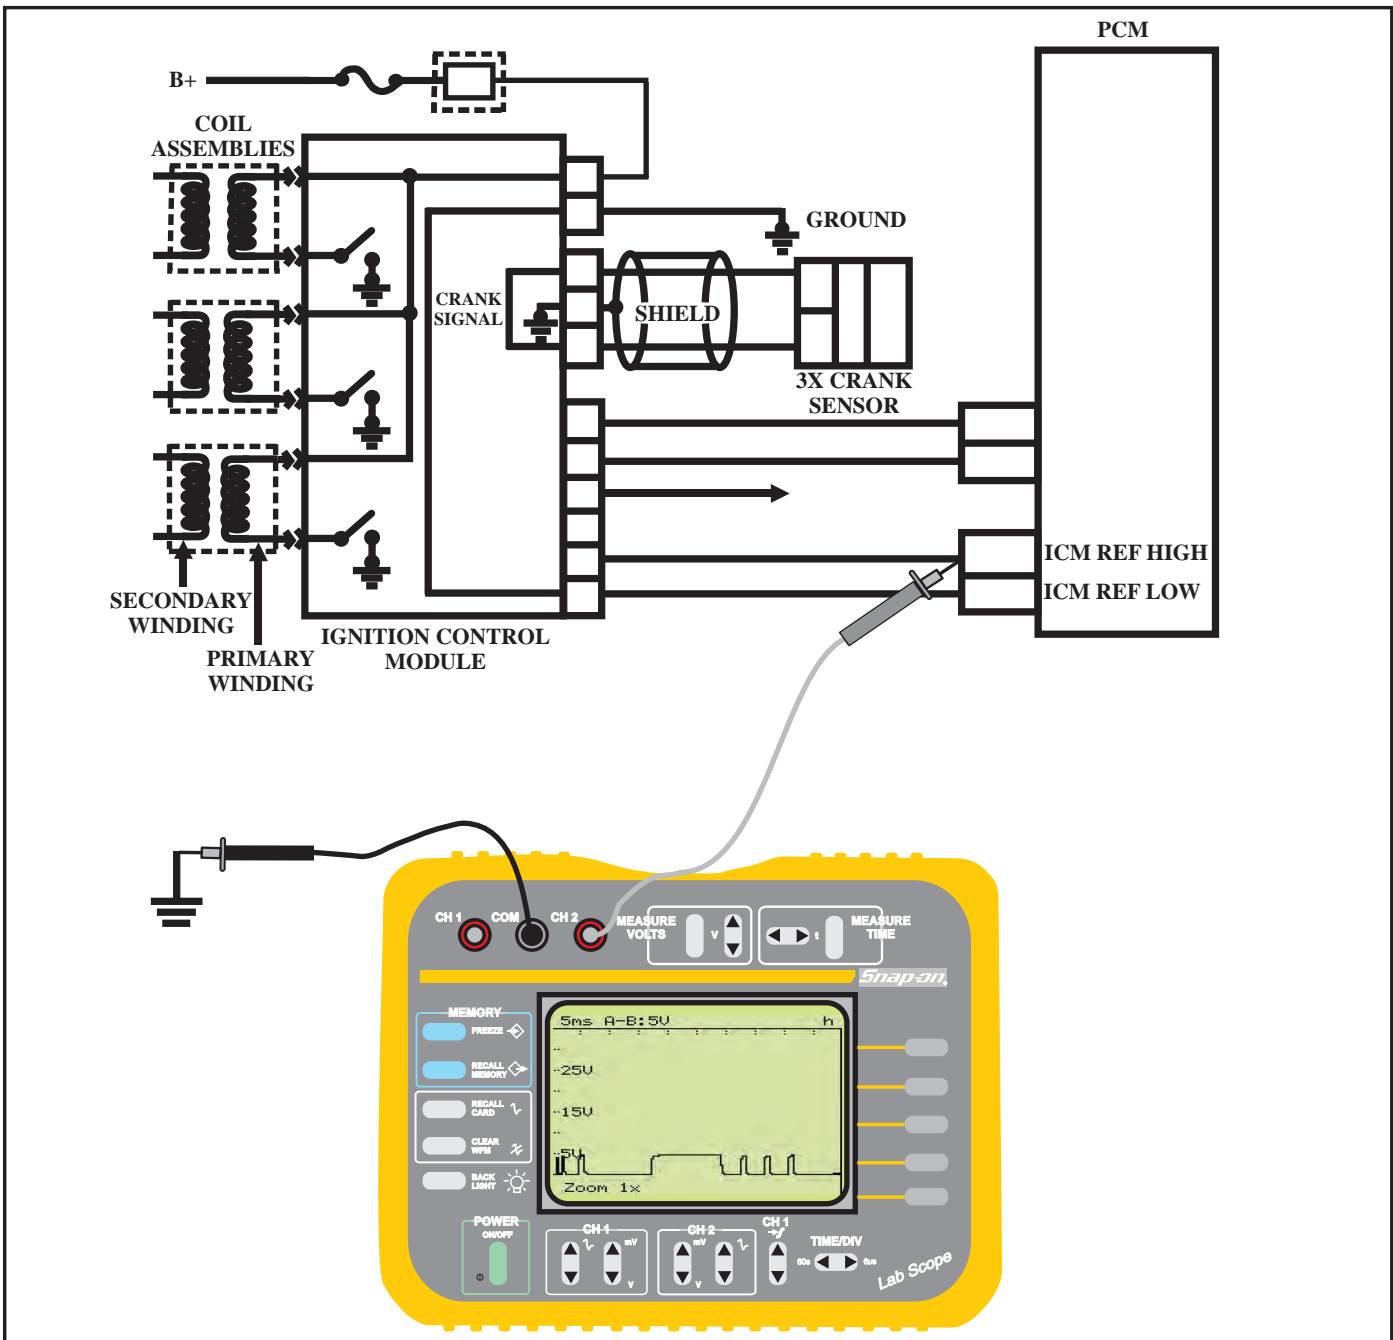
Figure 35

• With an oscilloscope or graphing voltmeter connected to ground and the ICM Reference High terminal at the computer, the waveform in figure 35 should be seen.

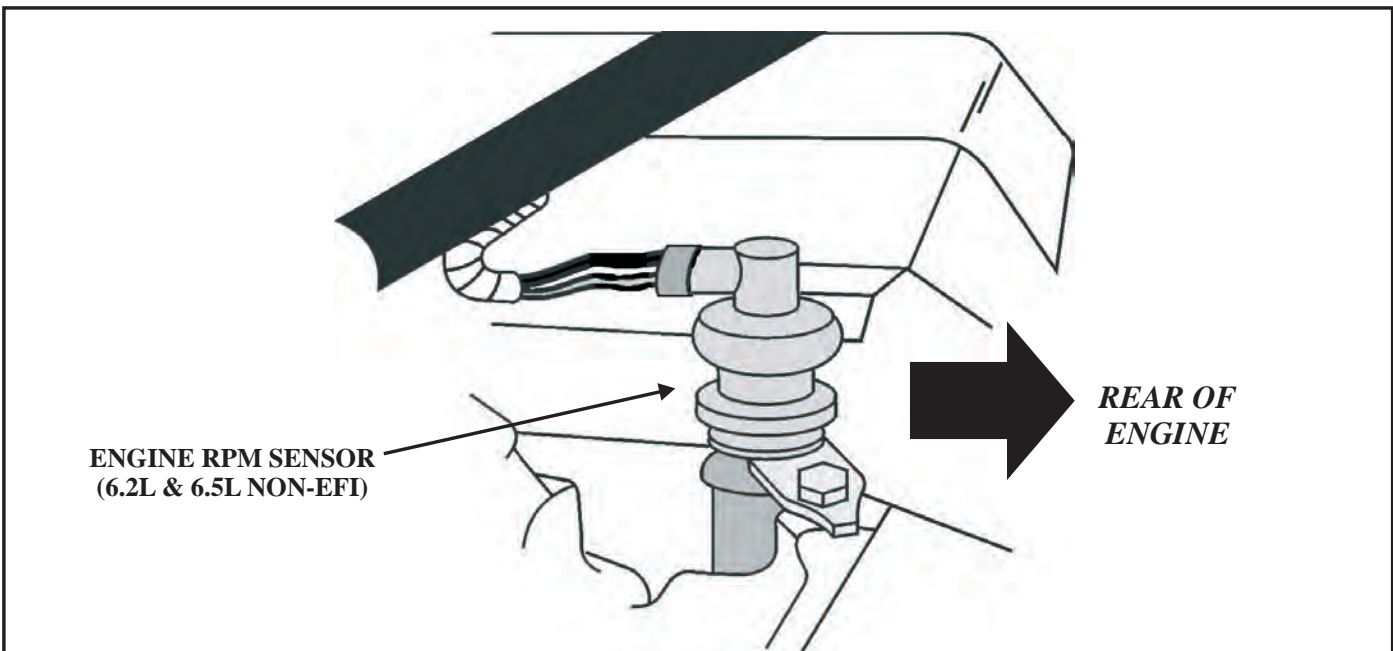
Figure 36

The Engine Speed Sensor on 6.2 and 6.5 Liter Non-EFI engines is mounted at the rear of the engine where a distributor would be located in a gasoline engine, (Refer to Figure 36). The Engine Speed Sensor is a 2 wire, AC voltage generator that sends a raw signal to the TCM where it is buffered internally (Refer to Figure 37). This sensor is used as an input for line pressure control and WOT upshifts. The TCM compares this signal to the Input Speed Sensor signal to calculate TCC slip.

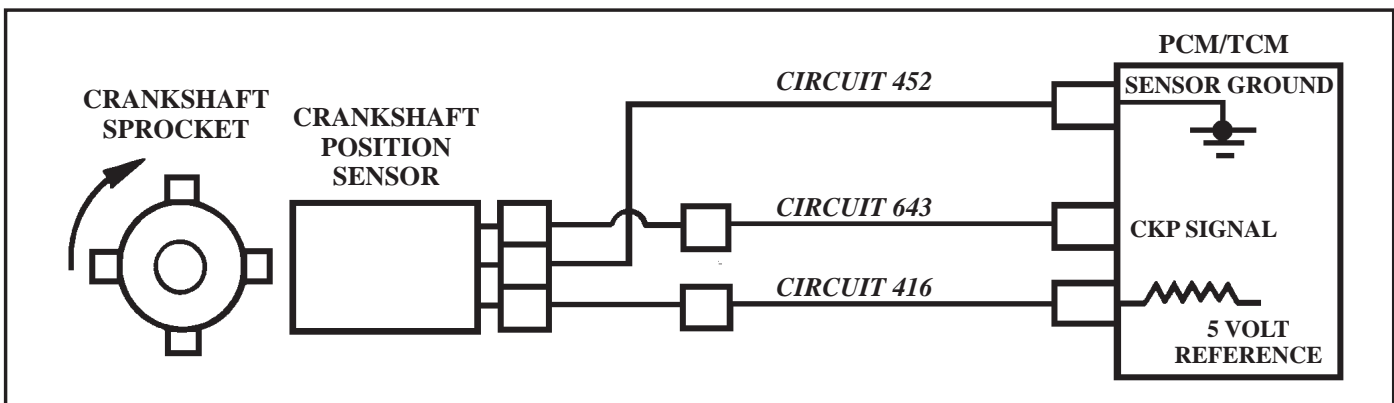
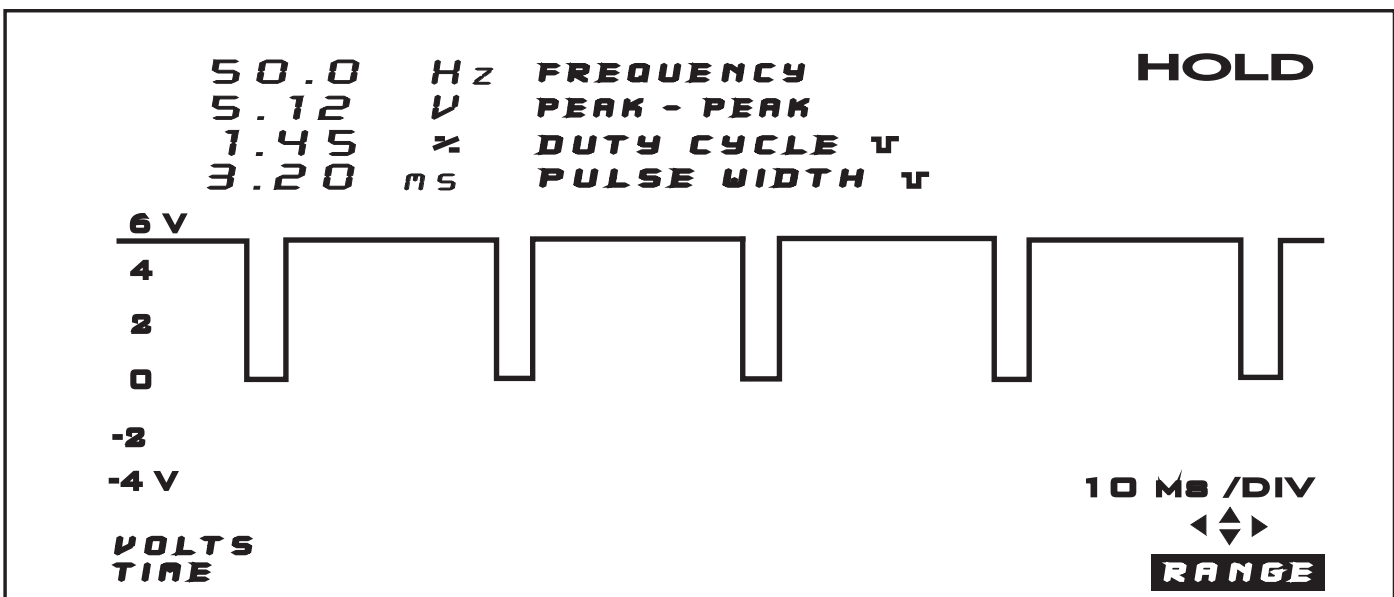
- Beginning in model year 1994 the previous two wire AC voltage generator type engine rpm sensor was replaced by a three wire Hall Effect Crankshaft Position (CKP) Sensor to provide the PCM/TCM with an engine rpm signal.
- This sensor should have a 5 volt reference voltage supply as well as a good ground circuit. The remaining circuit 643 is the engine rpm signal which is a 0 to 5 volt pulse (Refer to Figure 38) as the four teeth, spaced 90° apart, on the crankshaft sprocket spin in front of it when checked with a DVOM.
- When this sensor is checked with a scope, it will be a digital square wave that will be displayed, (Refer to Figure 39). The Crank Sensor can be found in the front timing case cover in line with the crankshaft sprocket.

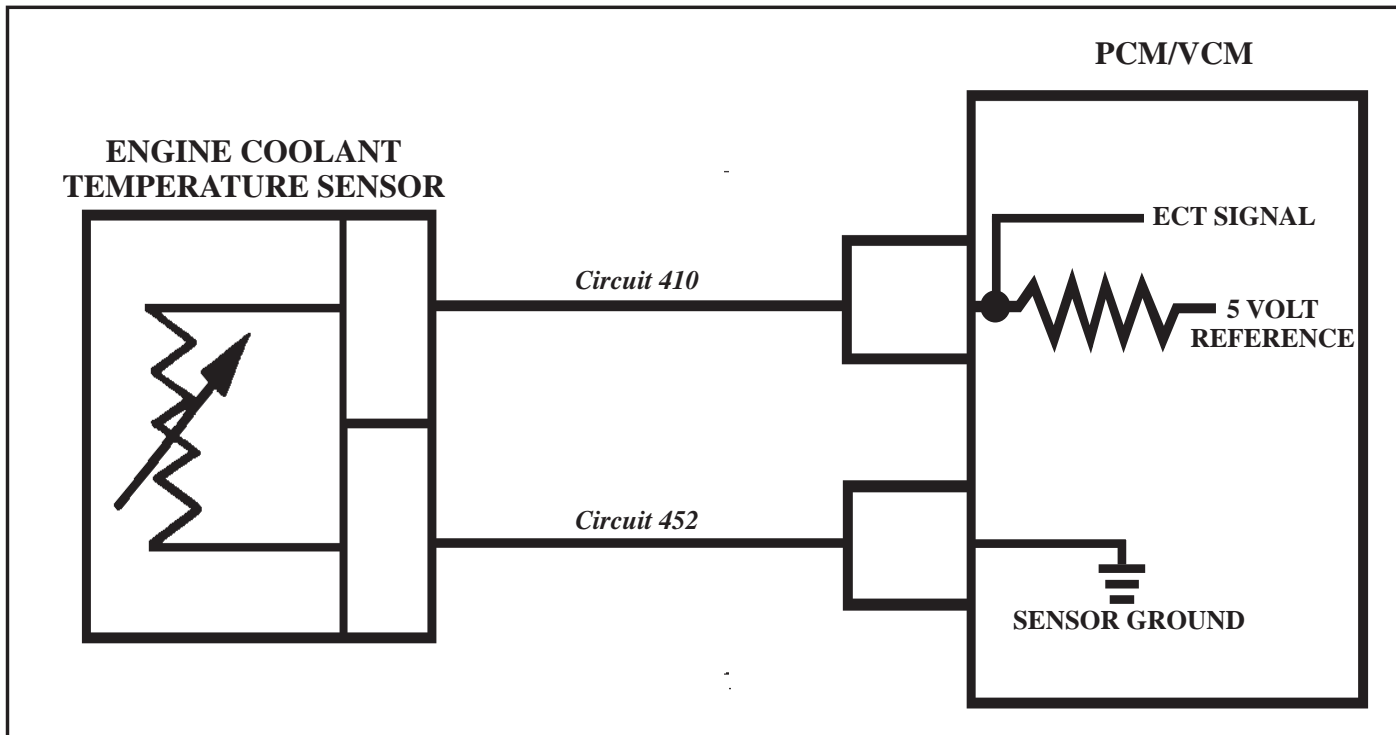
Figure 40

- Check the ECT Sensor Ground Circuit 452, as shown in Figure 40. It should not have more than 0.2 volts with the engine running.
- Check the signal wire, Circuit 410, for 5 volts (Refer to Figure 40) when disconnected from the sensor and the ignition "ON".
- Disconnect and check the ECT sensor for the correct resistance when compared to the actual engine temperature using the chart in Figure 41.
- Connect the ECT Sensor and turn ignition "ON" and check voltage on the signal wire, Circuit 410, using the chart in Figure 41.

- Engine temperature sensor is faulty or shorted.
- Engine temperature signal wire, Circuit 410, is shorted, (Refer to Figure 40).
- A faulty PCM/VCM.

- Engine Temperature Sensor is Faulty or Open.
- ECT Sensor Signal Wire, Circuit 410, is Open, (Refer to Figure 40).
- ECT Sensor Ground Circuit 452 is Open, (Refer to Figure 40).
- A Faulty PCM/VCM.

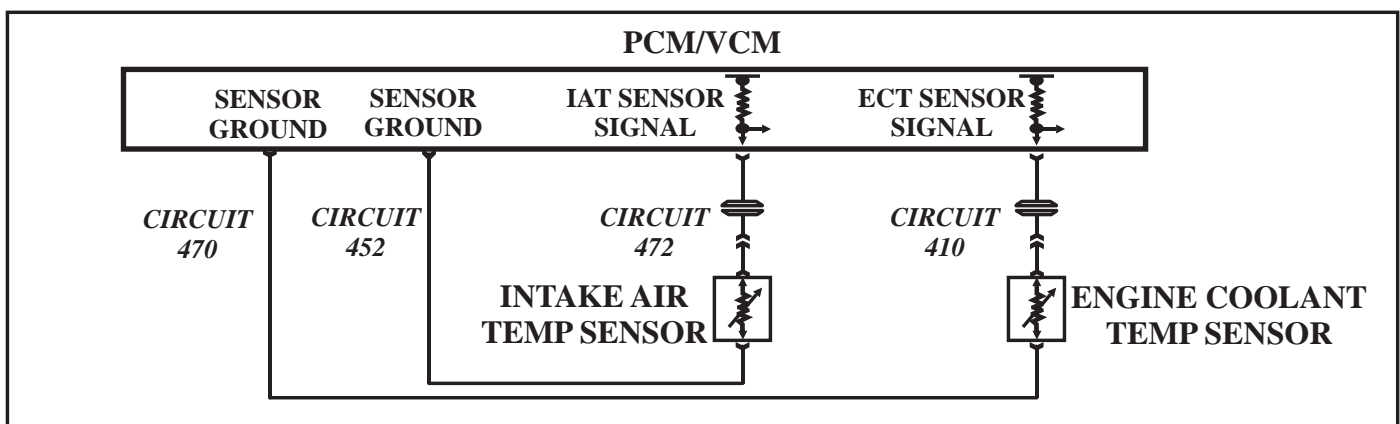
Figure 42

- When looking at the voltage range in the chart above it is noticed that the voltage reaches approximately 1.2 volts and then jumps to 3.7 volts and once again begins to drop as the temperature climbs.
- These ECT Sensors are “Dual Range” sensors and operate in such a manner for a greater degree of accuracy.
- The ECT and IAT Sensors cannot have more than 27°F (15°C) difference after the engine is allowed to cool and is then run for five minutes at normal road speeds, Refer to the IAT Sensor schematic in figure 42 and the temperature chart in Figure 43.

- A skewed High Engine Coolant Temperature Sensor.
- A skewed Low Intake Air Temperature Sensor.
- A Faulty Intake Air Temperature Sensor.
- High Resistance in ECT or IAT Sensor Circuits 472, 410, 452 or 470, (Refer to Figure 42).
- An Engine Block Heater Is or Was In Operation.

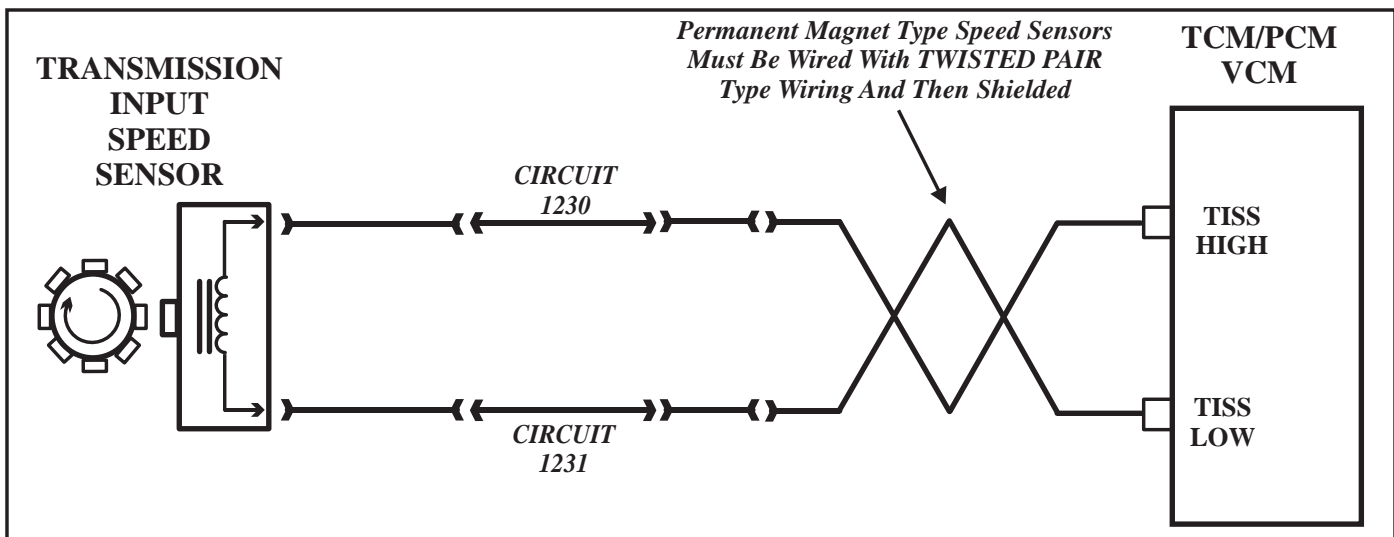
Figure 45

- *The Input Speed Sensor is Faulty, (Refer to Chart in Figure 44).*
- *Input Speed Sensor Circuits 1230 or 1231 are damaged, (Refer to Figure 45).*
- *Connector end damage or water intrusion.*
- *The TCM/PCM/VCM is faulty.*

- *Input Speed Sensor Circuits 1230 or 1231 are damaged, (Refer to Figure 45).*
- *Connector end damage or water intrusion.*
- *RFI/EMI signal interference.*
- *Incorrect sensor air gap, (.045" - .109").*

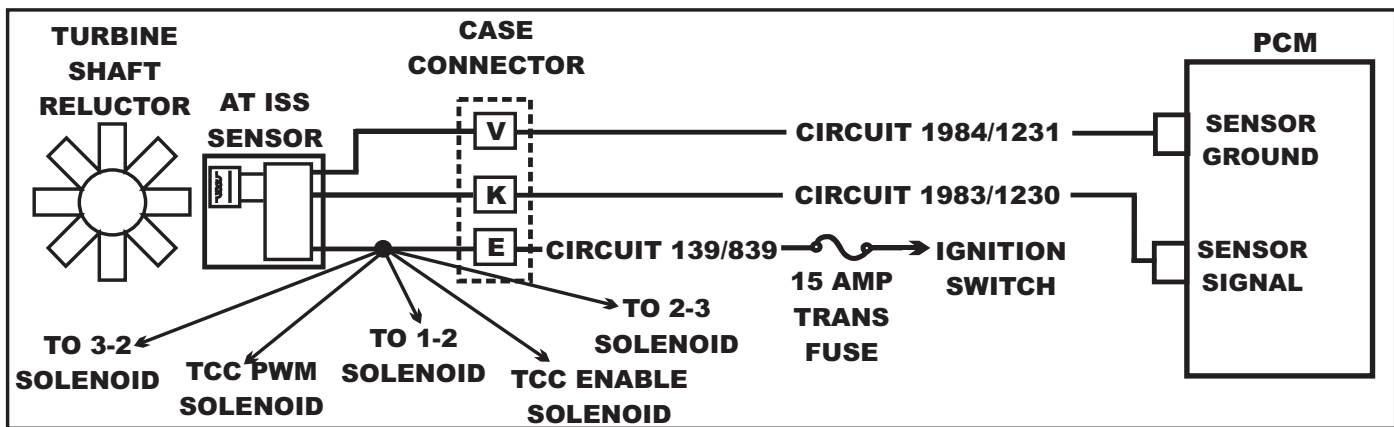
Figure 46

- Check the scan tool data list for an input RPM value.
- If there is no input RPM displayed, or it is erratic, begin by verifying the battery voltage supply to case connector terminal “E on Circuit 139/839 as seen in Figure 46. A definitive procedure to do this is to attach a battery fed jumper lead to terminal “E” and see if the code does not return, especially if solenoid codes are stored, (except line pressure control), and if the code stores during cranking of the engine.

- Check Circuit 1984/1231 for ground integrity using the voltage drop method, this is the AT ISS Sensor ground circuit, Refer to Figure 46.
- Check Circuit 1983/1230 for a clean digital square wave signal or a toggled voltage signal.

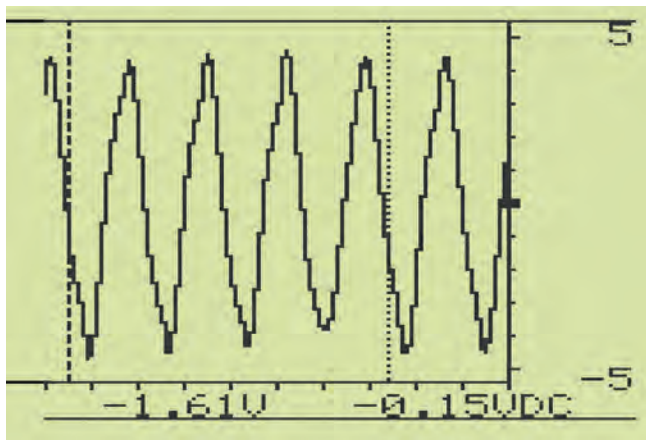
When checking the raw signal from the output speed sensor, this is the waveform that should be seen, this is a good sine wave with no drop out and good strength of signal. If the speed sensor is checked using a DVOM and Hertz, use the sensor value chart in Figure 52 for specs.

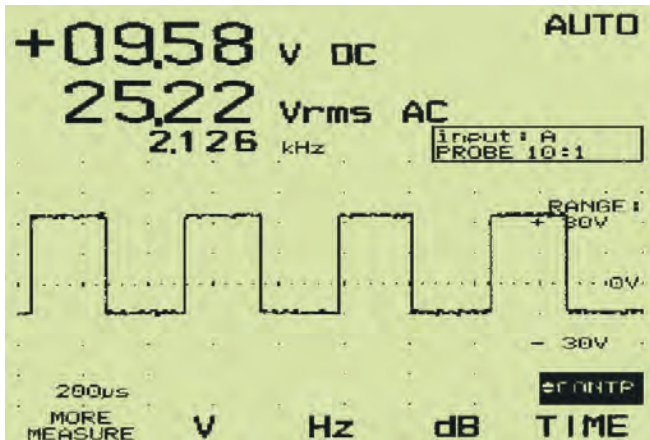
When checking the conditioned signal coming out of the "DRAC" on circuit 437, a digital square wave signal is what should be seen. This is a good signal with very little noise and good amplitude.

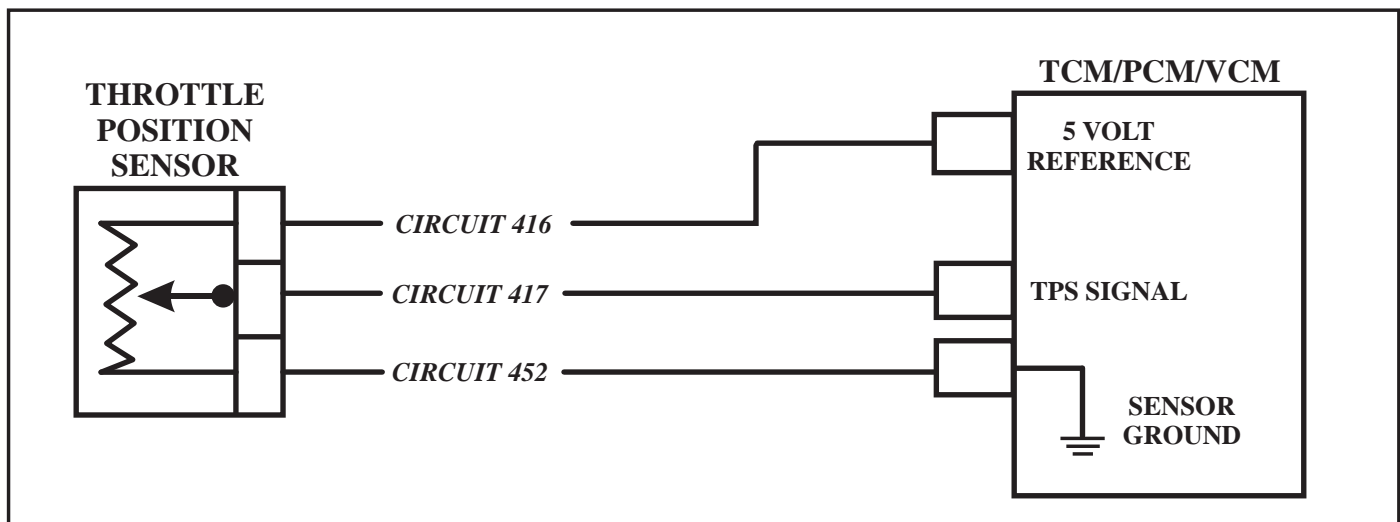
Figure 65

- TPS signal voltage is typically 0.5 volts at idle, and 4.5 volts at wide open throttle. The scan tool will also display a “Throttle Percentage of Opening” parameter which is a computer calculated value based on the comparison of signal return voltage to sensor voltage supply.

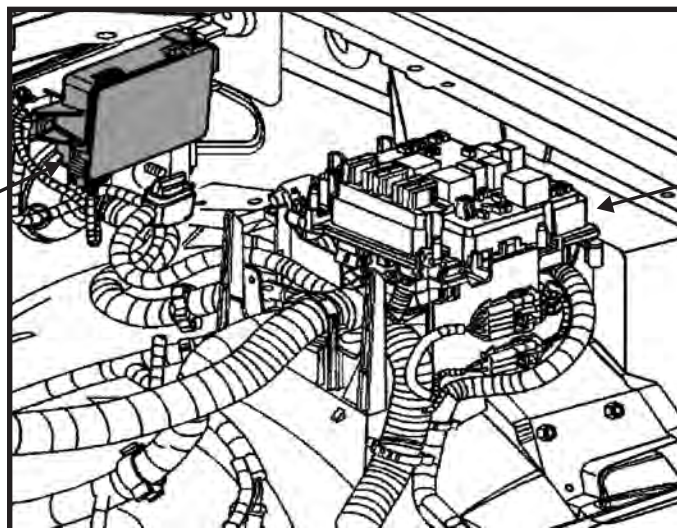
Figure 70

*Typical location of the TAC Module...Driver side, rear corner of engine bay.*

- The **TAC Module** is responsible for controlling throttle positioning, based on input from various sensors as well as data from the PCM over a dedicated serial data line. The TAC and the PCM monitor the commanded (desired) throttle position and compare it to the actual throttle position. This is accomplished by monitoring the APP Sensors and the TP Sensors. These two values must be within a target value of each other, if they are not, the appropriate fault codes will be stored. The TAC Module is usually located in the driver side, rear, of the engine bay, as shown in Figure 70.

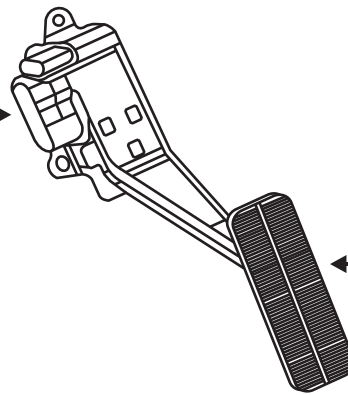
Figure 71

ACCELERATOR  
PEDAL POSITION  
SENSOR

THROTTLE PEDAL  
ASSEMBLY

- The *Accelerator Pedal Position Sensor (APPS)* (Refer to Figure 71) contains 3 individual throttle position sensors up to and including the 2002 model year. 2003 and later models have an APP Sensor with one sensor disabled and two functional, this sensor determines pedal angle and sends its signals to the TAC Module and is an integral part of the throttle pedal.

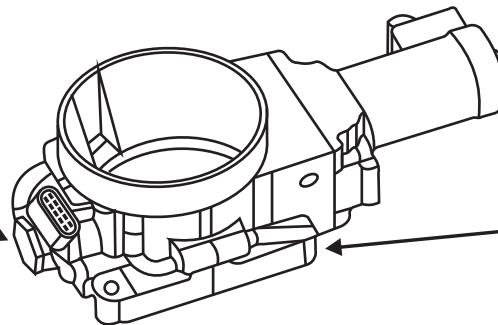
Figure 72

THROTTLE  
POSITION  
SENSOR  
ASSEMBLY

THROTTLE  
ACTUATOR  
MOTOR

THROTTLE  
BODY

- The *Throttle Body* contains the *Throttle Position Sensor Assembly* (See Figure 72) which contains two throttle position sensors and are used to determine throttle plate angle. The throttle body also contains the *Throttle Actuator Motor* (See Figure 72). This electric motor opens and closes the throttle plate. The throttle plate is spring loaded in both directions with the default position being slightly open.

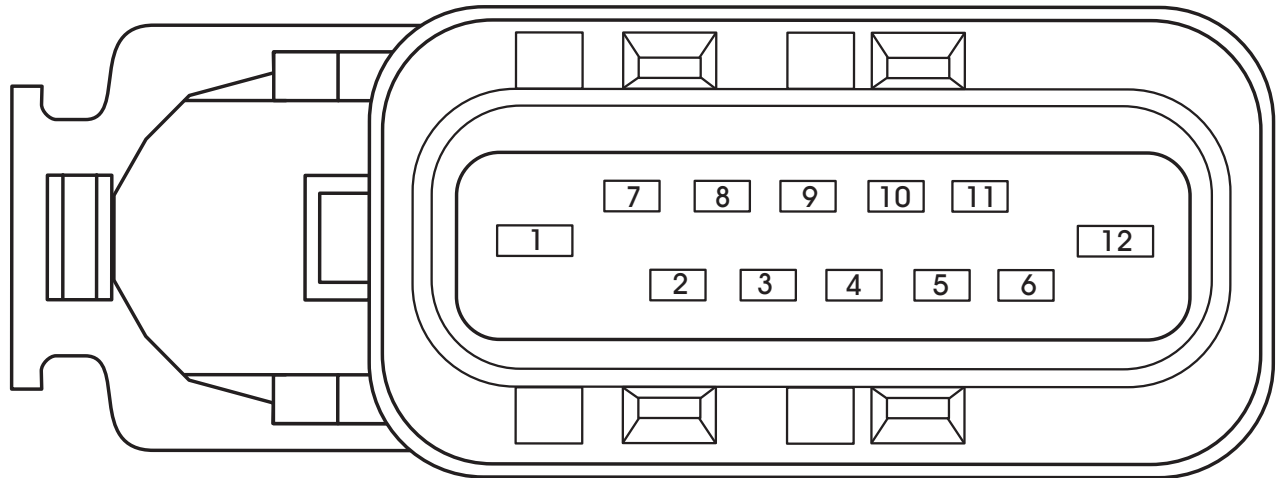
**VEHICLE HARNESS VIEW**

- Disconnect the 4-Way connector if it is the 2003 design switch or earlier, or the single connector if it is the 2004 or later design switch, and check range circuits “A”, “B”, “C” and “P” for approximately 12 volts using Figure 84 for the 2003 and earlier design level switch and Figure 85 for the 2004 and later design level switch.

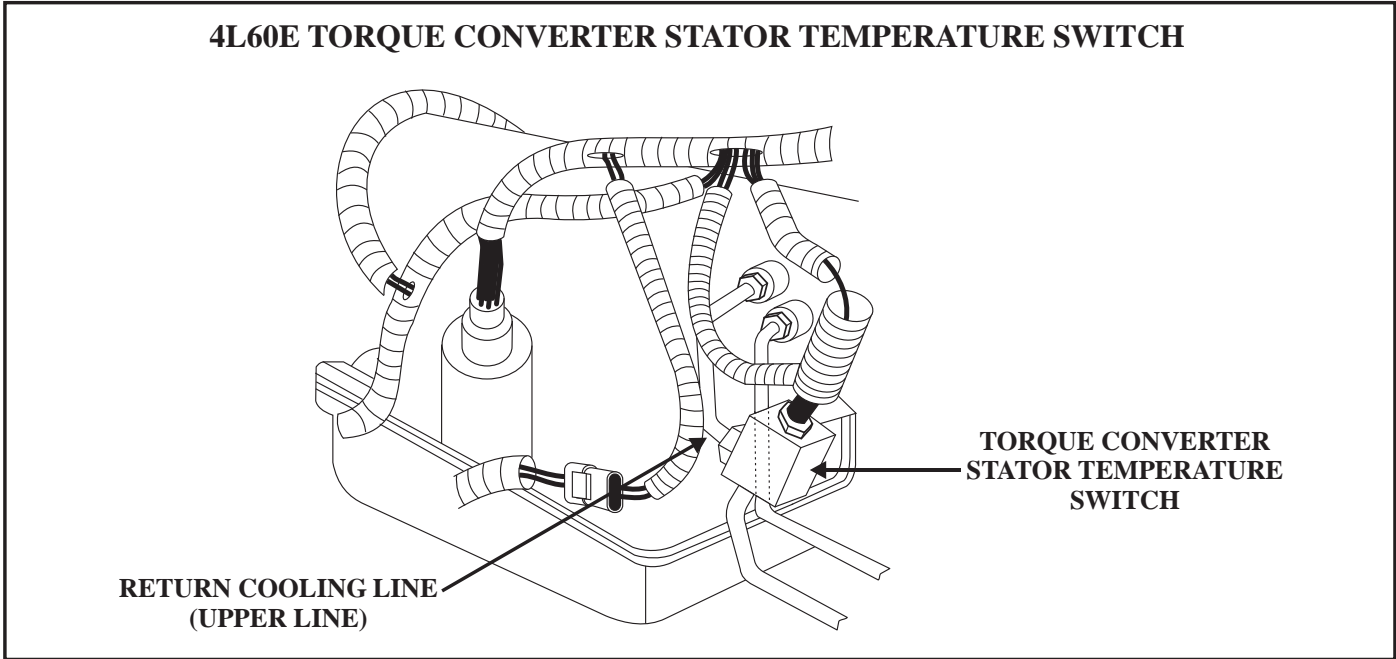
Figure 95

- The TC Stator Temperature Switch is located in the return cooler line as shown in Figure 95. This switch is a single wire, normally open switch which grounds through the cooler line. The switch closes at a temperature of 327°F (164°C), at which time this signal is sent to the PCM. The PCM will now take steps to cool the torque converter by commanding TCC after second gear.

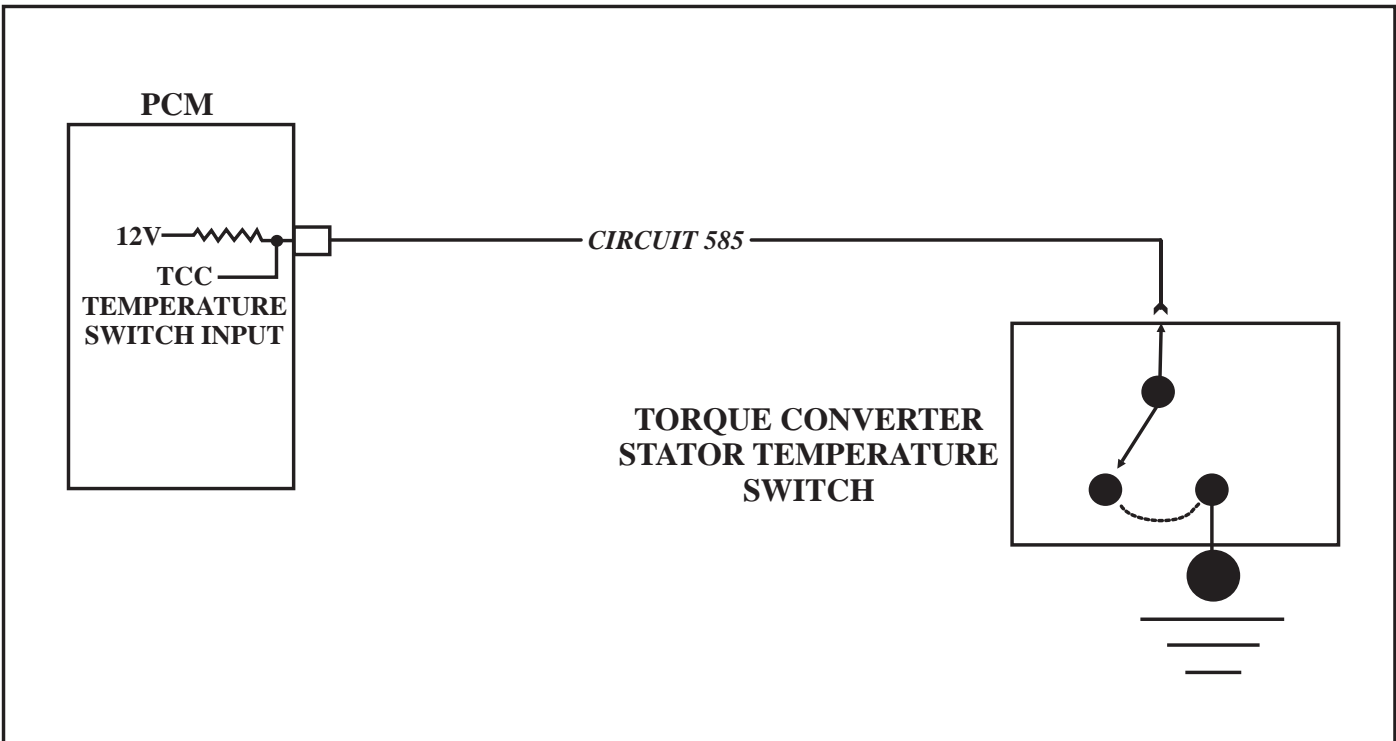
Figure 96

- Circuit 585 (See Figure 96) displays 12 volts when it is NOT indicating "Hot Mode", and less than 1 volt when it is indicating "Hot Mode" during normal operation.

- Code P1873 is stored when the PCM sees the TFT Sensor indicating a temperature of less than 140°F (60°F) but the Stator Temperature Switch is indicating "Hot Mode", (less than 1 volt on circuit 585, Refer to Figure 96).

- Code P1874 is stored when the PCM sees the TFT Sensor indicating a temperature of more than 284°F (140°C), but the Stator Temperature Switch is not indicating "Hot Mode", (battery voltage on circuit 585, Refer to Figure 96).

- Circuit 585 is shorted to B+, (Refer to Figure 96).
- The Torque Converter Stator Temperature Switch is stuck open.
- The Torque Converter Stator Temperature Switch to cooler line ground is poor.
- The PCM is faulty.

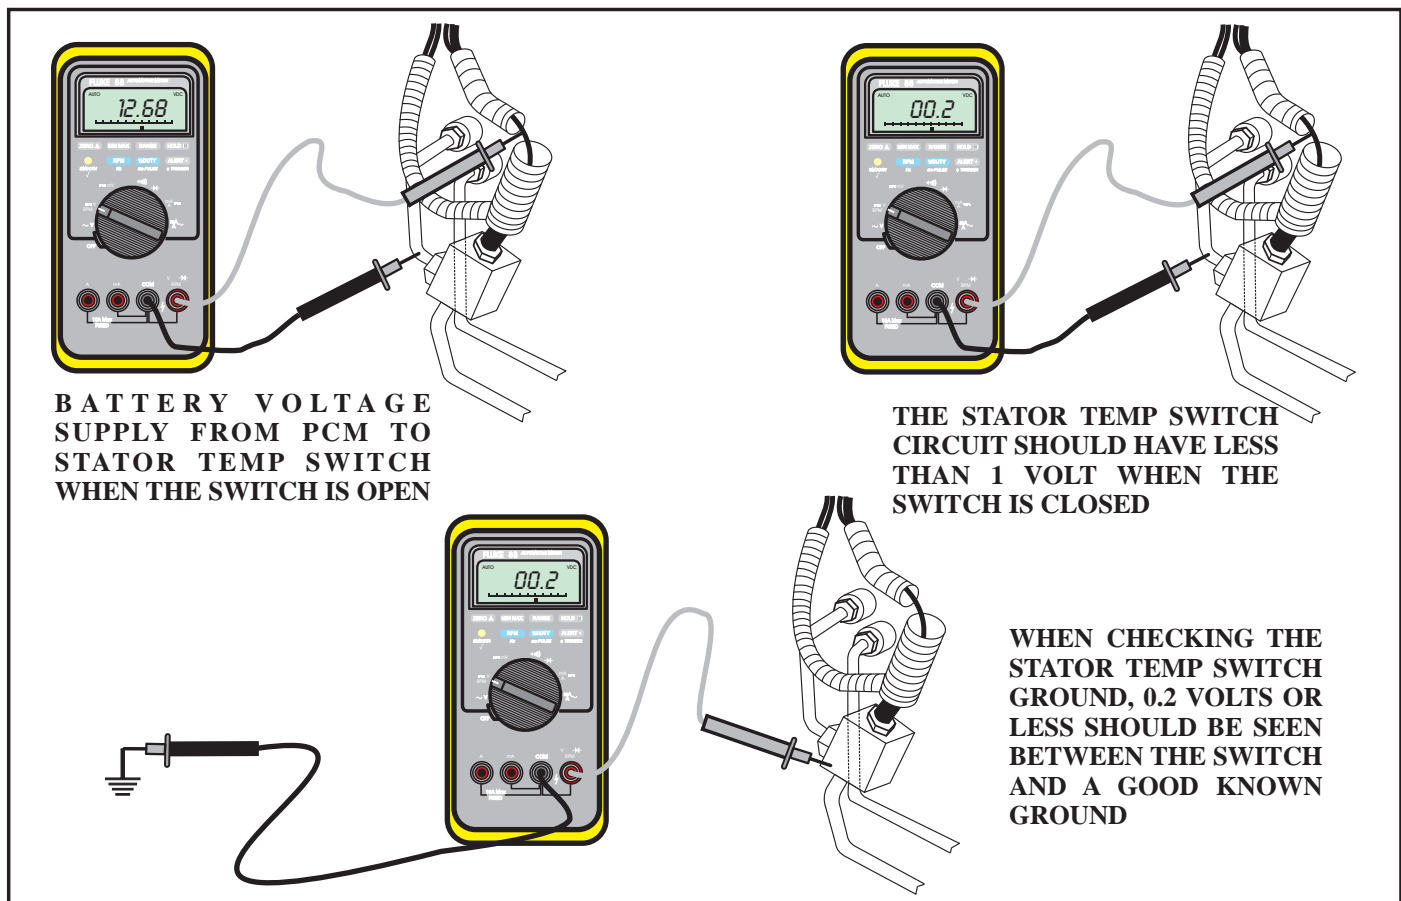
Figure 97

- If Circuit 585 has less than one volt when disconnected, then the wire is grounded. Cut the wire approximately three inches from the PCM and check the voltage on it coming from the PCM. If it has battery voltage, the wire is grounded. If it has less than one volt, the PCM is grounding it at all times, replace or repair the PCM, (Refer to Figure 97).

- If the switch is not stuck open and it is well grounded, then the Circuit 585 wire is shorted to power or it is shorted to power inside the PCM, (Refer to Figure 97).
