# **4L60E/65E/70E- 4L80E/85E DIAGNOSTIC CODE BOOK**

## **INTRODUCTION**

The GM 4L60E/65E/70E-4L80E/85E Diagnostic Code Book is designed to provide the technician with a step by step diagnostic approach to each and every transmission code available from 1991 to the 2007 model year. This manual can be used in collusion with any type of scanner utilized in retrieving these codes from the computer. As an aid to the technician, component location is recognized throughout the manual.

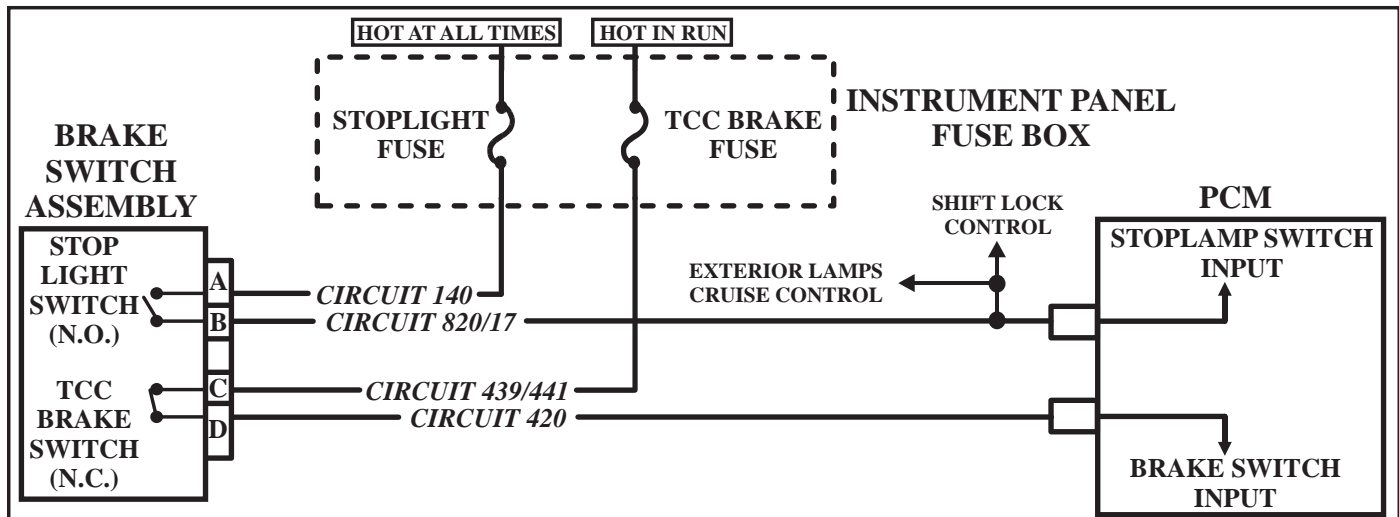
- If circuit 420 is checked under the above condition, there should be zero volts present, Fig. 98.
- When the brake is released, the scan tool should indicate that the TCC Brake Switch is CLOSED, which allows converter clutch operation.

- If circuit 420 is checked under the above condition, there should be battery voltage present.
- Check the Brake Switch parameter on the scan tool, (You will probably have to switch to engine data). With the brake released, it should display OPEN. There should be no voltage on Circuit 820 or 17, (Refer to Figure 98).

- With the brake applied, the scan tool should display CLOSED which supplies battery voltage on circuit 820 or 17 and illuminates the stop lamps and releases shift lock, (Refer to Figure 98).

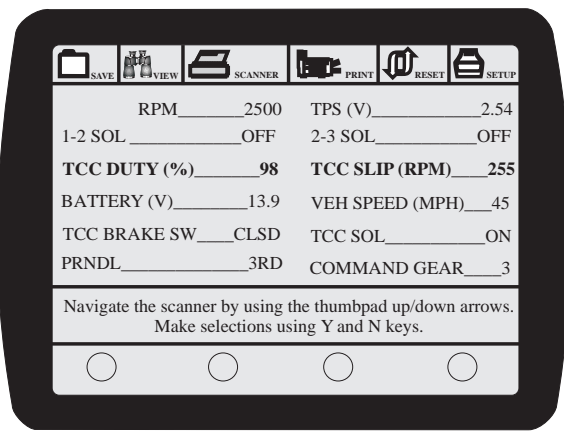
- The data list in Figure 99 is that of a 4L60E with a conventional PWM TCC system. The transmission is in 3rd with the shift lever in the D3 position and the PWM TCC solenoid at maximum duty cycle and the TCC Enable Solenoid is on, yet the TCC slip is 255 rpm.
- This data indicates that we have the proper signals for TCC application, but the converter clutch is *mechanically* slipping which will generate code P0741 or 39 with the 4L80E transmission. In Figure 100 the TCC system is operating properly, slip is near zero rpm.

- Use your scan tool to monitor TCC Duty Cycle and TCC Slip on transmissions using PWM TCC systems. During initial apply of the converter clutch, duty cycle should be at 98% and slip should be less than 10, (Refer to Figures 99 and 100).
- 1998 and Later 4L60E transmissions in all but high performance applications will have the EC<sup>3</sup> system. Duty cycle will vary after the 1-2 shift and TCC Slip will also vary but should not exceed a sustained slip of 130 rpm, for longer than 20 seconds (Refer to Figures 101, 102 and 103).
- If excessive slip is seen, use the available valve repair kits and/or component parts replacement as required.
- If the TCC orifice is broken, it can be removed and replaced with an orifice cup plug with a .028” (.7112mm) hole drilled through the cup plug.

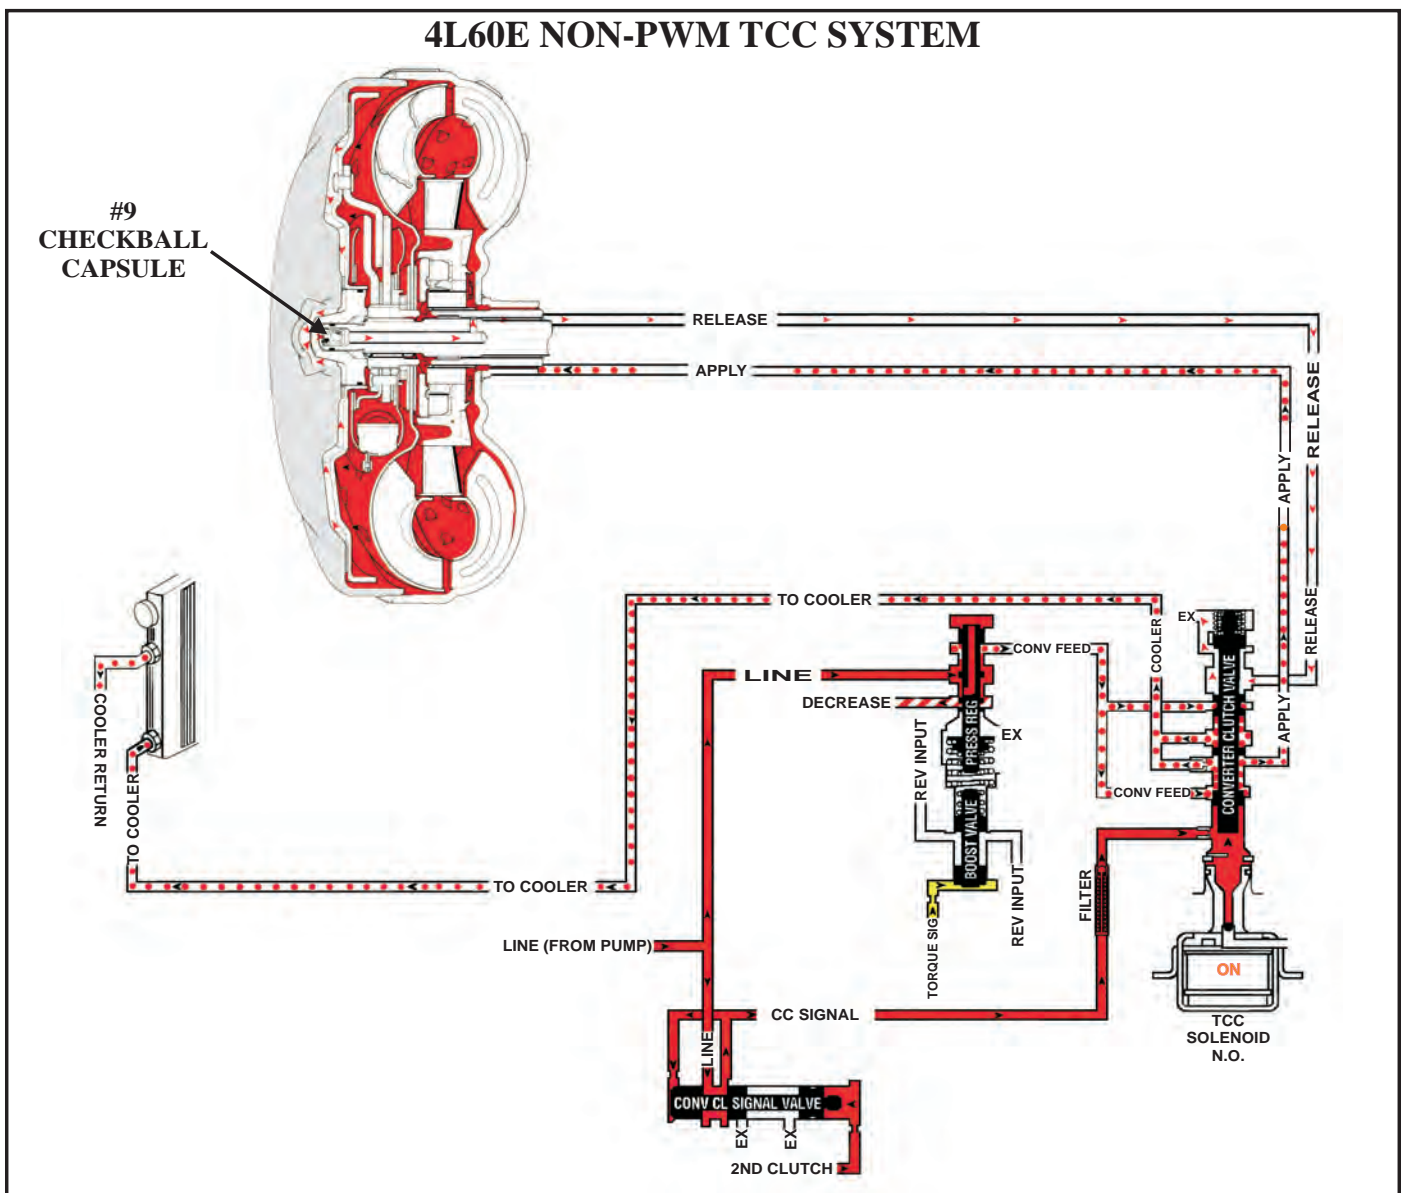
- The 4L60E NON-PWM TCC system in the hydraulic schematic in Figure 104 shown below shows the flow of the TCC apply and release circuits.
- Check for proper operation of the TCC Enable Solenoid as well as the Converter Clutch Apply Valve located under the TCC solenoid, in the pump cover and the Converter Clutch Signal Valve located in the valve body. These valves are prone to wear.
- Make certain the #9 checkball is not stuck.
- Make certain the cooling system has proper cooler flow.

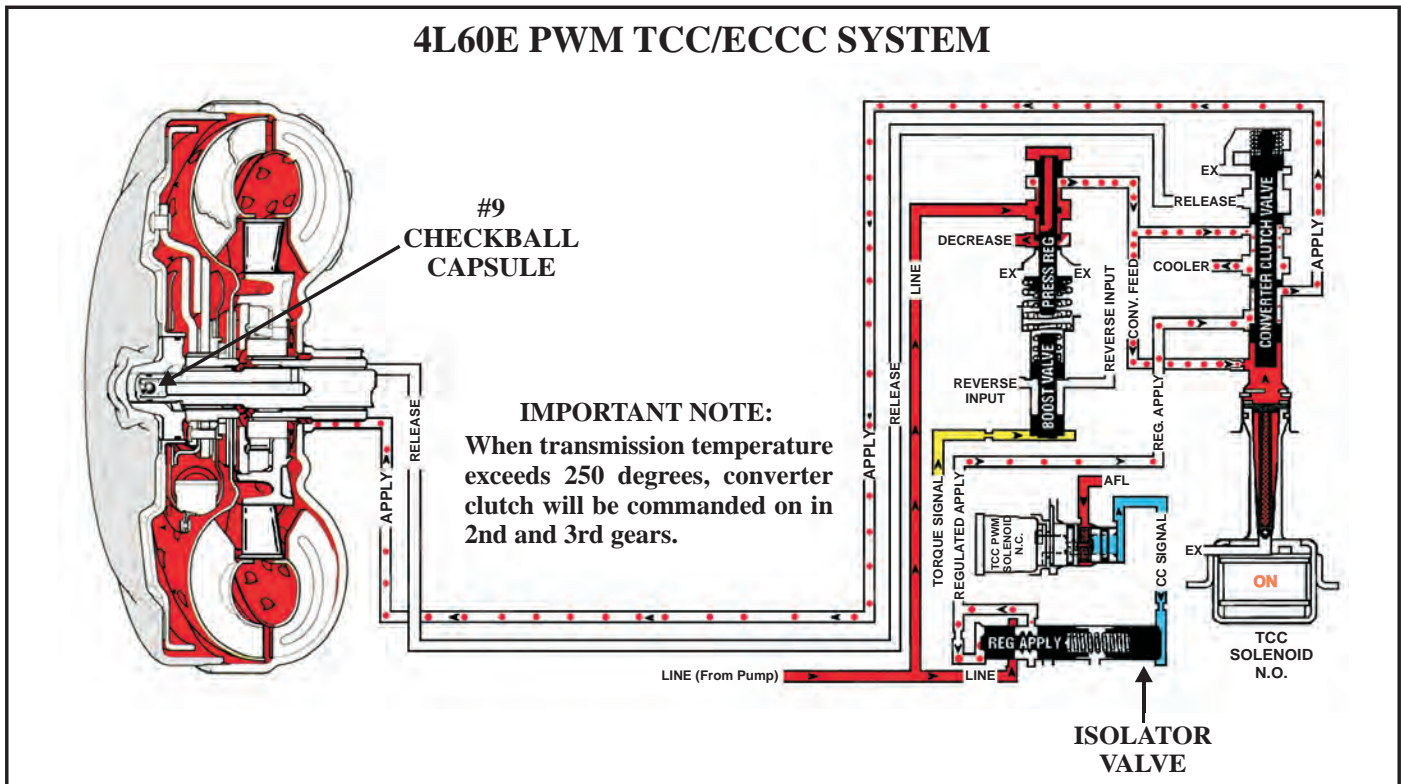
- The 4L60E PWM TCC/ECCC system in the hydraulic schematic in Figure 105 shown below shows the flow of the TCC apply and release circuits.
- Make certain the TCC solenoid is mechanically open when it is off. Make sure the TCC PWM solenoid is not stuck in the full apply position, ( solenoid exhausts at the base of the stem).
- Check converter clutch apply and regulator isolator valves.
- Make certain the #9 checkball is not stuck.

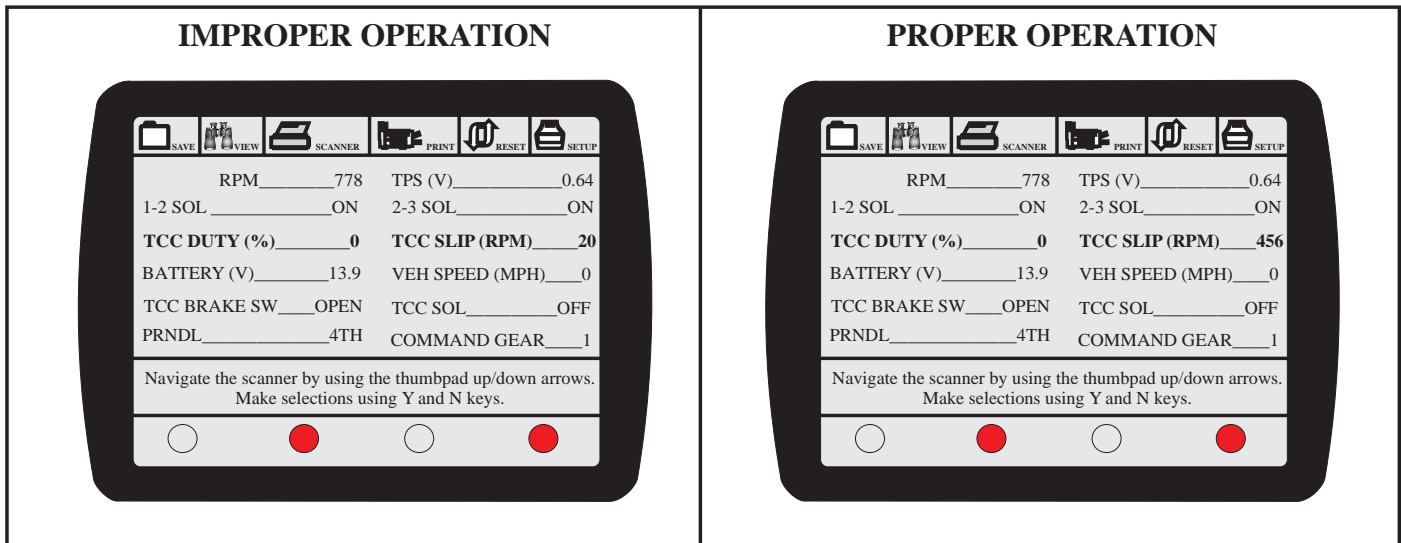
• If TCC was electrically “Stuck On”, the scan tool data list would indicate maximum duty cycle the moment the ignition was turned on. If TCC duty cycle is zero but slip is low when the transmission shifts to 2nd gear, there are no electrical concerns, only mechanical/hydraulic.
- The scan tool movie in Figure 107 is of a vehicle equipped with a 4L60E and indicates that TCC has been commanded “OFF” but TCC Slip is showing 20 RPM. TCC is hydraulically applied without a signal.
- TCC signal oil is bypassing the solenoid due to a mechanically faulty TCC PWM Solenoid or regulated apply oil is bypassing a worn TCC Regulator Valve and has stroked the TCC Apply Valve.

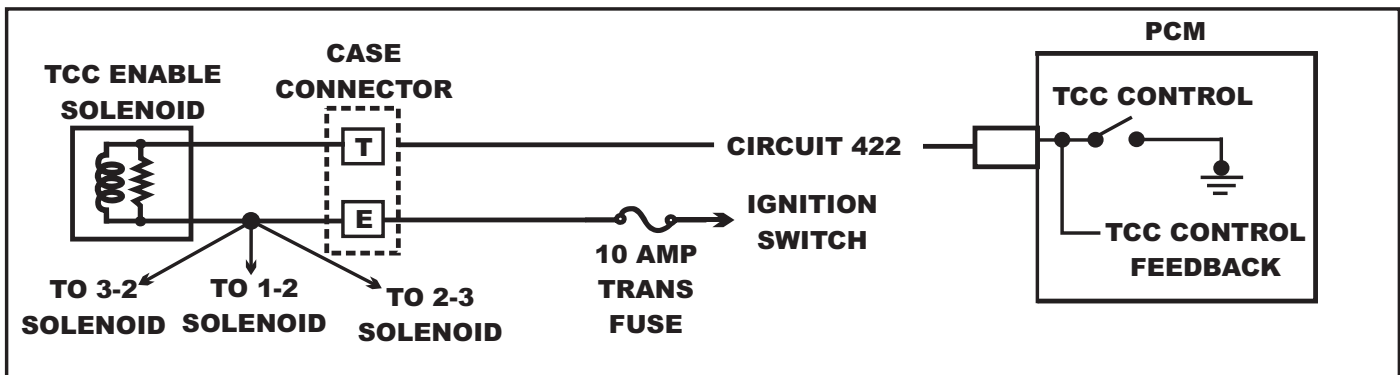
Figure 108

- The TCC Enable Solenoid is faulty.
- A short to power or ground on Circuit 422, (Refer to Figure 108).
- An open in Circuit 422, (Refer to Figure 108).
- A Blown Fuse, causing power loss to case connector terminal “E”,(Other solenoid codes should be stored).
- A faulty ignition switch, Causing intermittent power loss to case connector terminal “E”, See Figure 109 for terminal “E” location. (Other solenoid codes should be stored, use relay harness to bypass ignition switch as shown in Code 81,82, P0753 & P0758 diagnostics.
- Damaged terminal ends, Refer to Code 81,82, P0753 & P0758 diagnostics on how to check terminal cavities, See Figure 109 for terminal”T” location.
- A faulty computer.

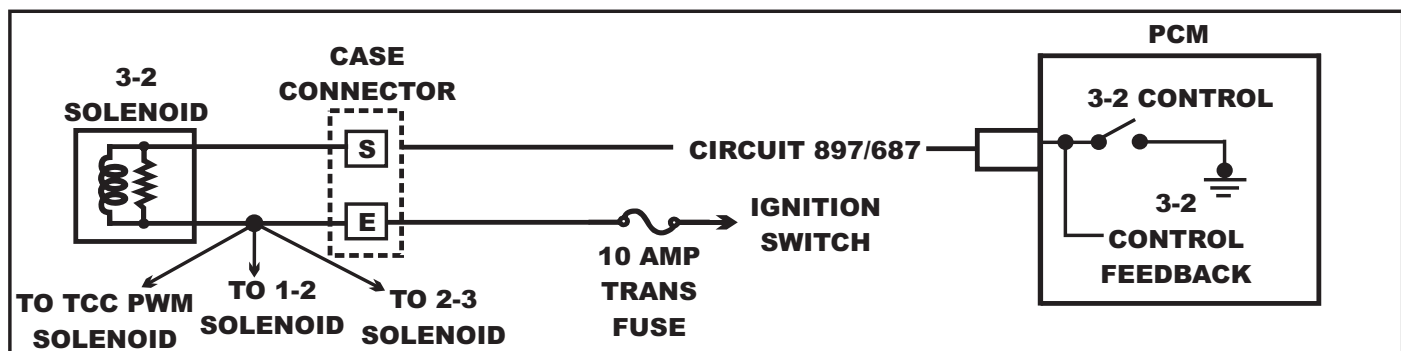
Figure 116

- Replace 3-2 solenoid.
- Make certain the correct 3-2 solenoid is used for the application, PWM 1993-1995(10-15 Ohms), ON/OFF 1996 and later, (20-30 Ohms), Refer to Figure 117.
- Replace wire harness, aftermarket parts are available.
- Repair wiring as necessary by referring to the diagram in Figure 116.
- Check terminal end cavities with a #59 wire gauge drill bit. Refer to Figure 118 for terminal location. Transmission wiring on “G” Vans is routed between the floor of the van and a sheet metal plate, wiring can deteriorate in this area, check for bulk head connector damage as well.
- Repair short and replace fuse.
- Replace ignition switch or use relay wire harness as shown in Figure 125.
- Replace computer, new or rebuilt computers must be programmed or vehicle will not start.

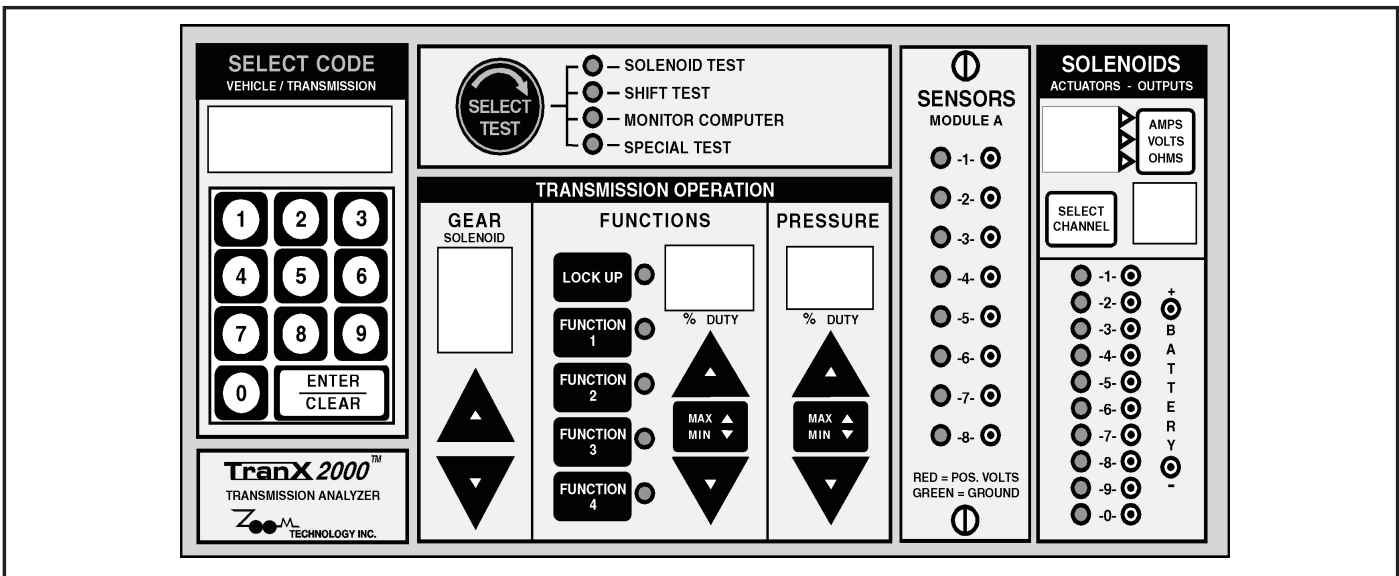
- There will be times when the diagnostic process calls for manual control of a solenoid. If the scan tool is incapable of bi-directional control then a transmission tester would do the job, preferably one that will display what the PCM is telling the solenoid to do as well as operating it independently of the computer as seen in Figure 120 below.

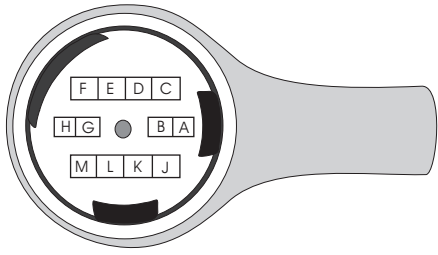
**4L80E EARLY CASE CONNECTOR**

- NOTE:** Be sure to Identify the wire at terminal “K” in the early case connector plug, cut this wire and tape it back into the vehicle wire harness, IT IS NOT USED in the updated case connector.

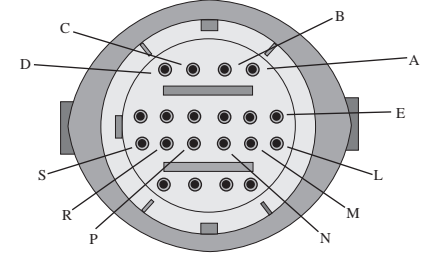
**4L80E LATE & 4L60E CASE CONNECTOR**

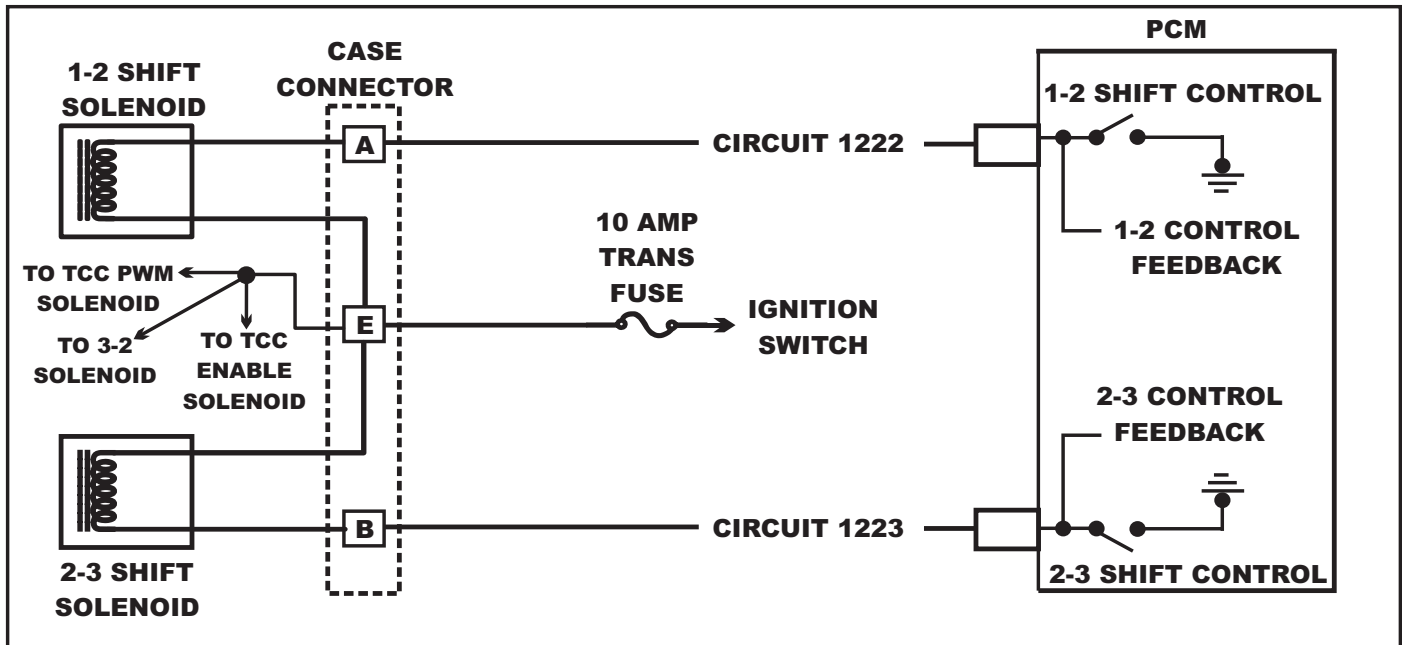
- When checking circuits for damage, use the wire diagram in Figure 122 to identify these circuits. In most applications the 1-2 Shift Solenoid external wire color will be Light Green and the 2-3 Shift Solenoid external wire color will be Yellow/Black. The solenoid power supply wire at Terminal "E" will be Pink except 1991 to 1993 4L80E which will be Pink/Black and is located at case connector terminal "C", Refer to Figure 122 for case connector terminal location.

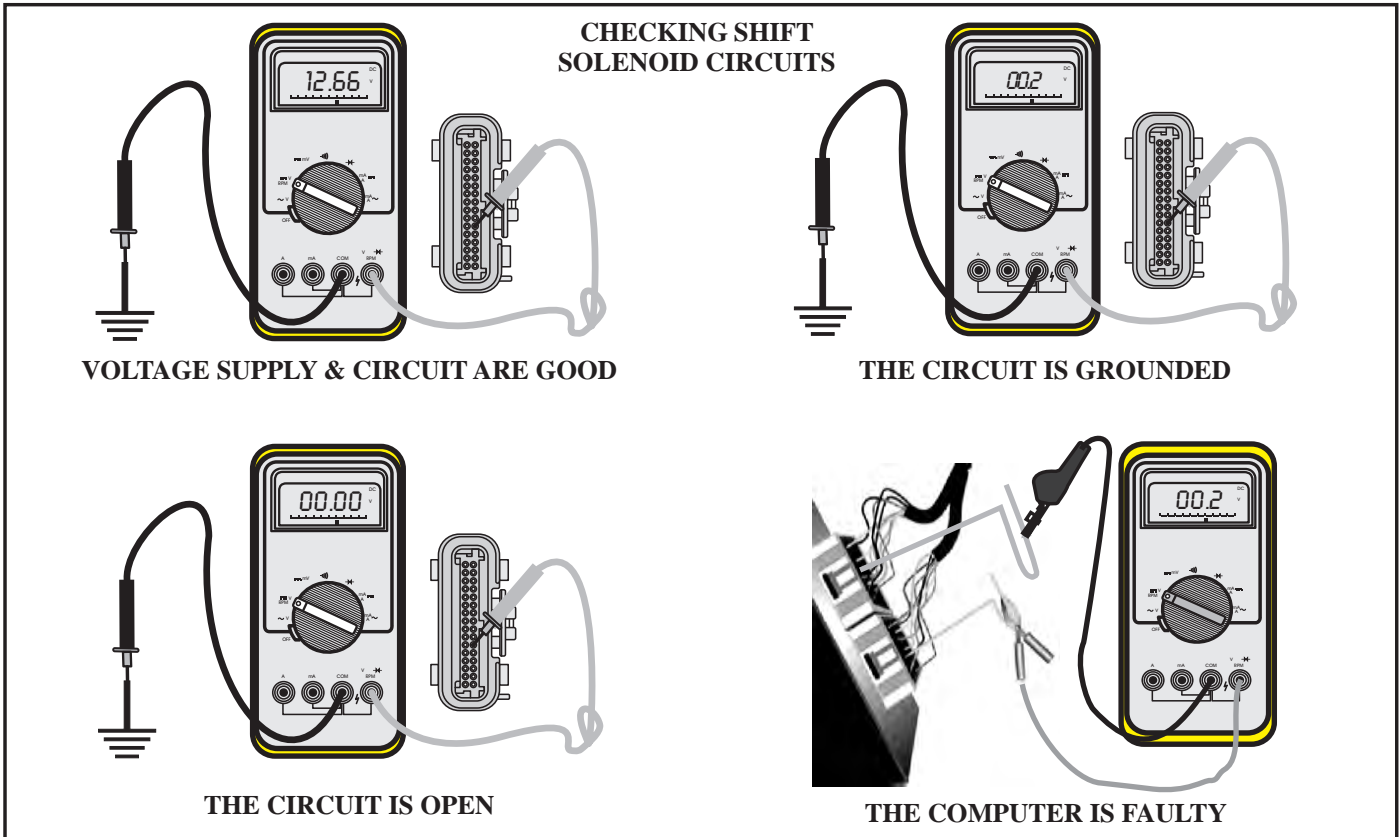
Figure 124

- Referring to Figure 124, unplug the PCM connector containing circuit 1222 or 1223, and with the ignition on, probe the terminal ends for the 1-2 or 2-3 shift solenoid with a voltmeter with the negative meter lead to ground. If the voltage supply at terminal "E" is good and the solenoids and circuit wires 1222 and 1223 are also good, battery voltage will be present at the VCM/PCM connector terminal ends.

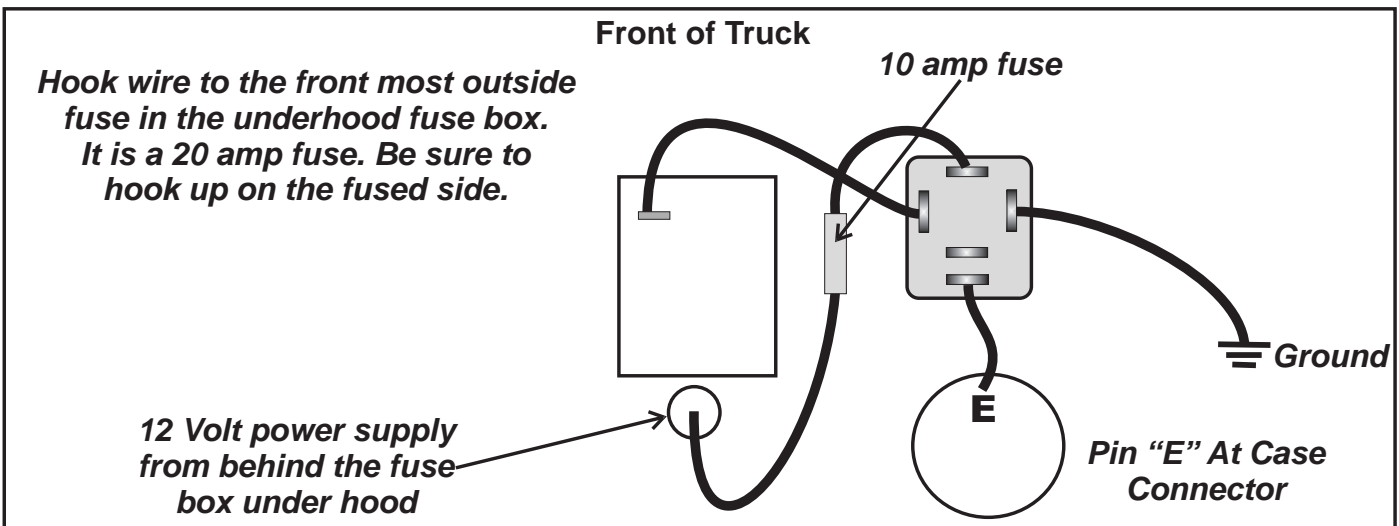
• When solenoid codes are stored due to a voltage drop at case connector terminal “E” caused by a faulty ignition switch, either replace the ignition switch or make the harness using a standard relay as seen in Figure 125 below to bypass the ignition switch and eliminate the codes. These codes are usually stored after engine startup. It is a good idea to put a function explanation tag on the harness.

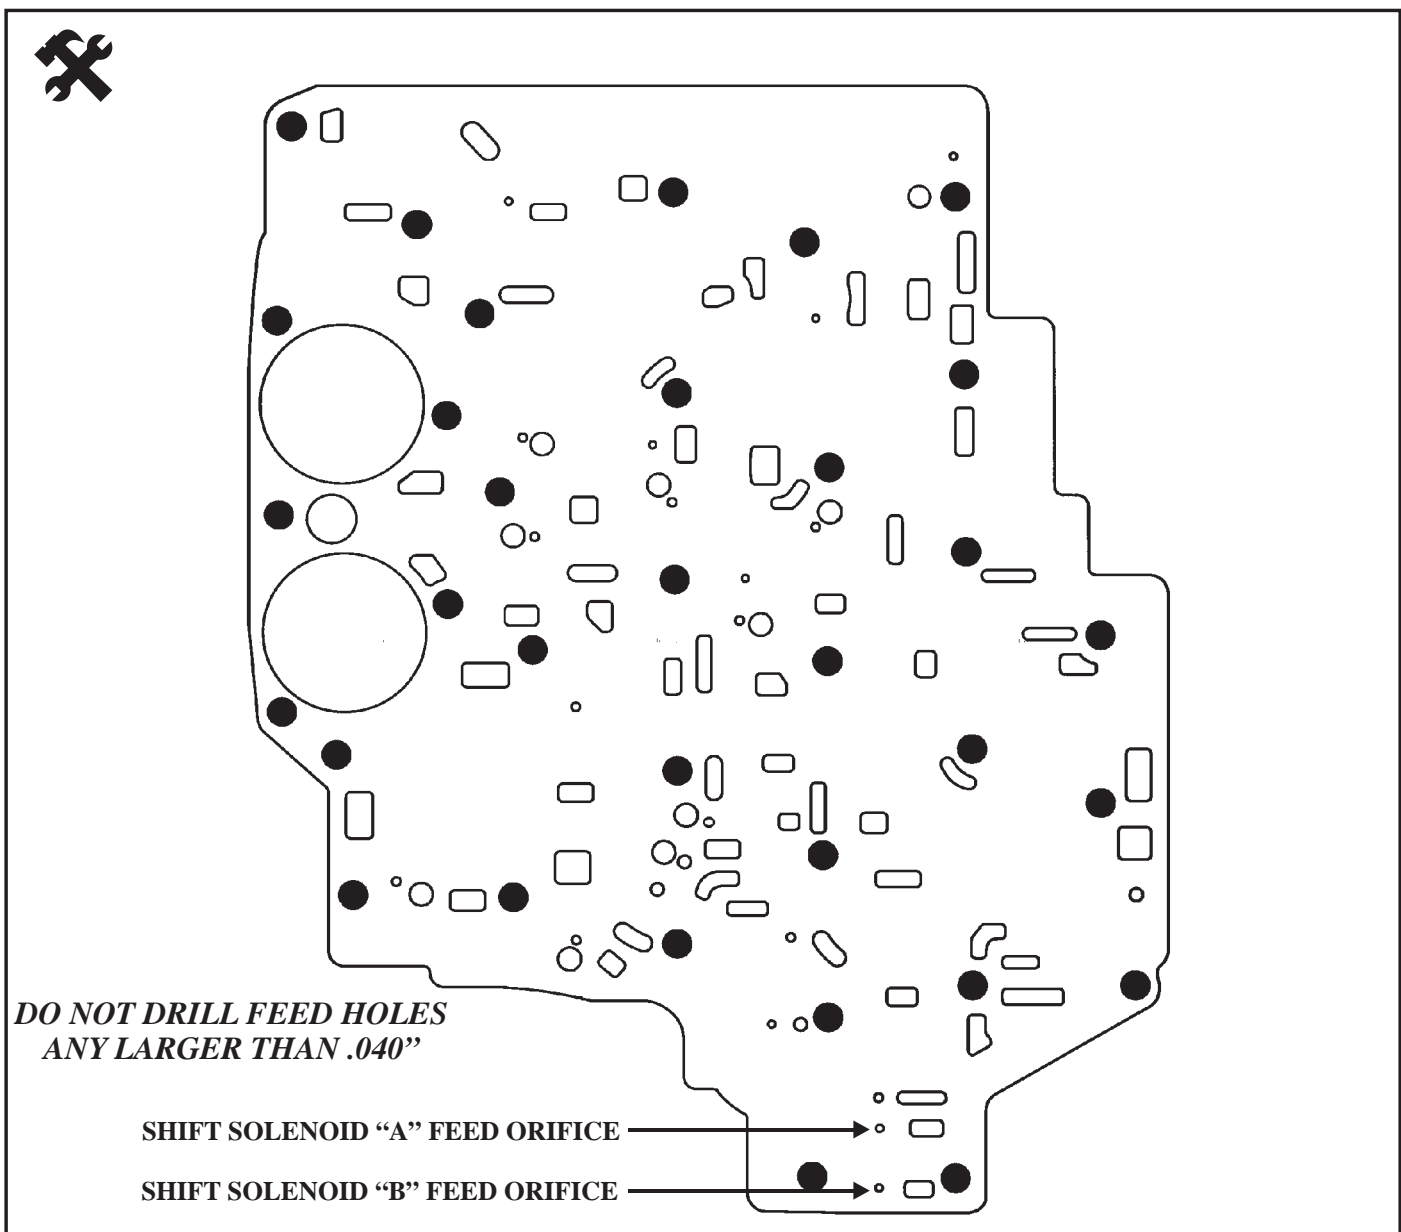
Figure 132

- Electronic aftermarket equipment installed in the vehicle can cause EMI/RFI interference with speed sensor circuits causing ONLY gear ratio error codes to be set. Care should be taken on the placement of this equipment as well as how it is wired.
- As the vehicle ages, the window for setting code 87 or incorrect ratio codes becomes overly sensitive. This can easily be compensated for by enlarging the shift solenoid feed holes to .035" to .040". The shift solenoid feed holes are shown in Figure 132.

**NOTE: Do not drill the solenoid feed holes any larger than .040" as this will flood the solenoid circuits and cause shift problems or wrong gear starts!**

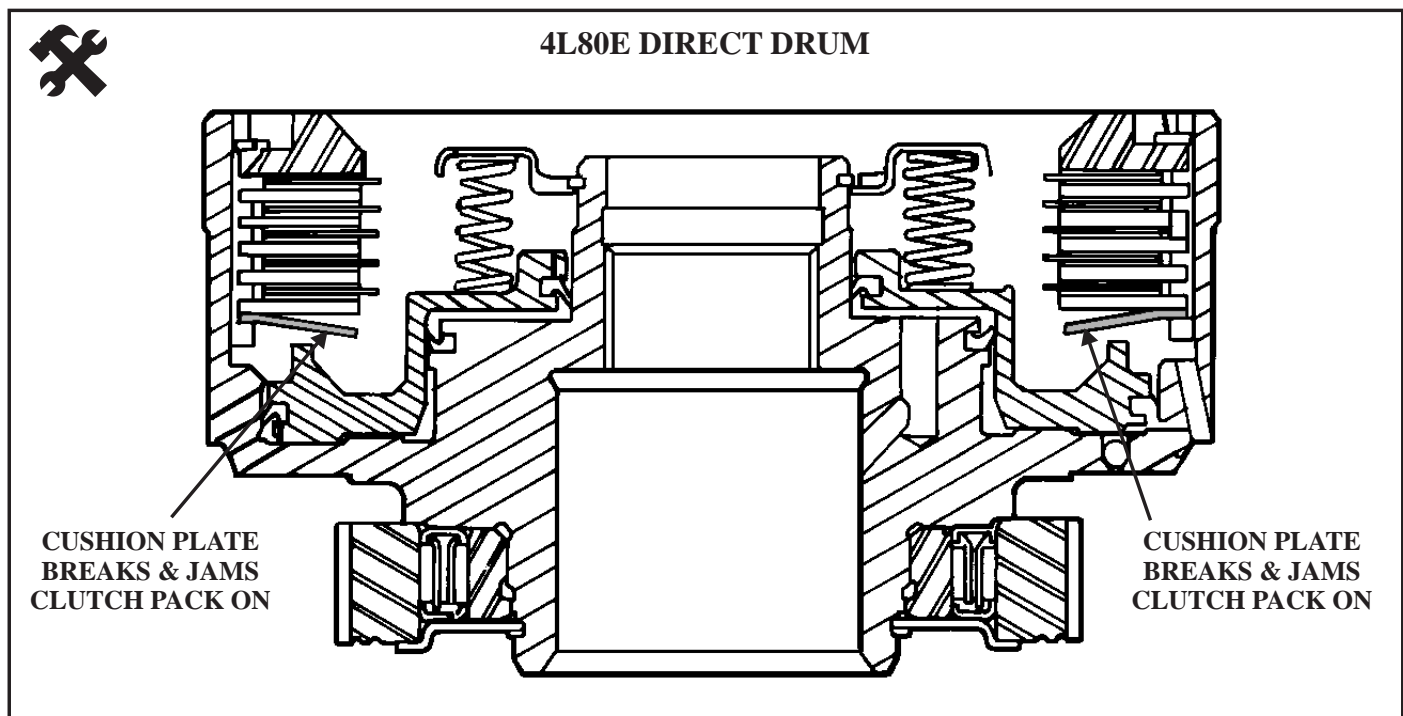
Figure 133

- The dished plate in the direct clutch pack can break and jam the clutch on, use the updated cushion plate, or the plates are welded together, Refer to Figure 133. This will cause code 86 or incorrect gear ratio codes to set.
- Welded planetaries are usually the result of poor cooler flow or too much end play causing misalignment of lube feed holes. Bushing wear can also be the cause. This will cause code 86 or incorrect gear ratio codes to set.
- 1994 to 1996 OBD-I vehicles can set code 87 due to a defective EPROM. Replace the EPROM according to the vehicles VIN number as described in factory bulletin **67-71-53B**.
- A restricted fuel delivery system can cause gear ratio error codes due to the shift solenoid command signaling for higher gears, but the transmission does not respond due to poor engine performance.

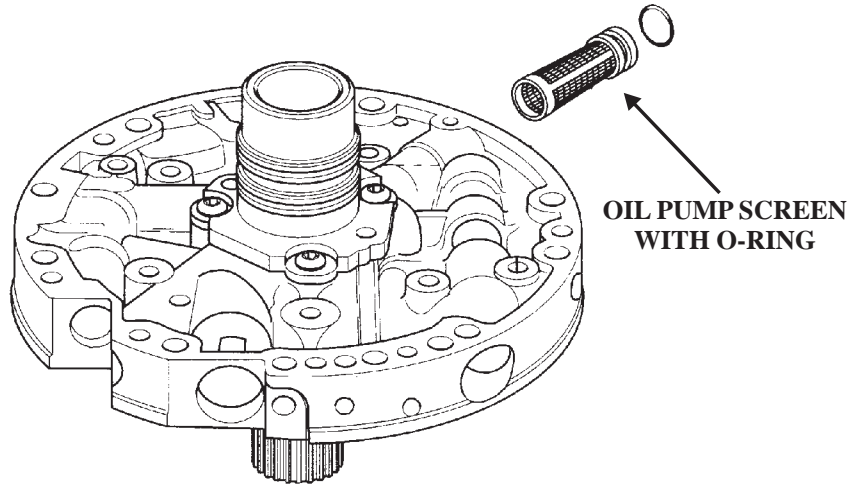
Figure 135

**4L60E/4L65E/4L70E PUMP COVER**

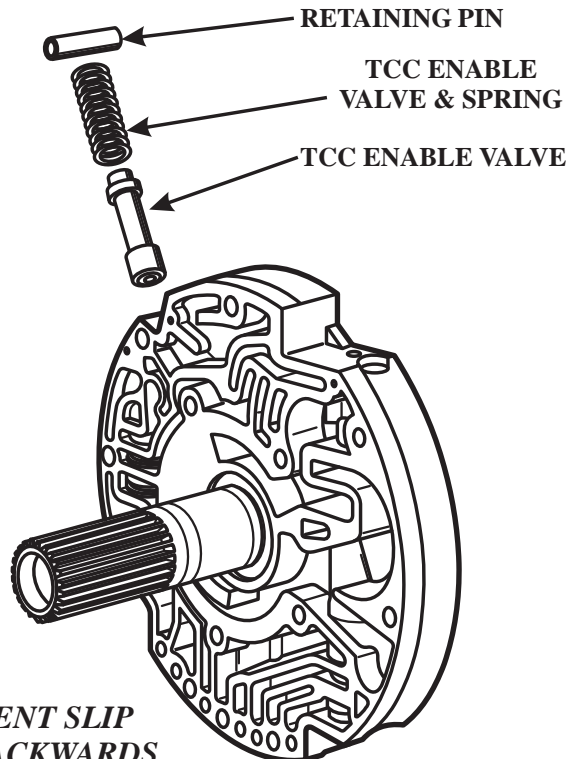
Figure 136

**4L80E/4L85E PUMP COVER**

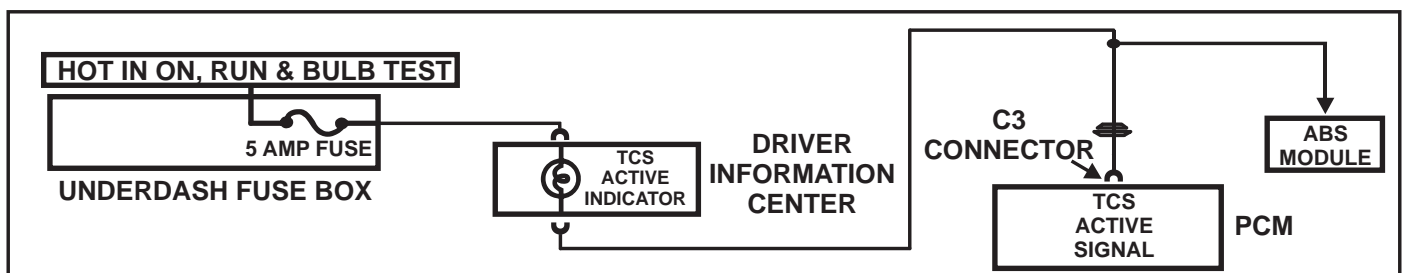
- Disconnect the C3 connector from the PCM, (Refer to Figure 147). With a DVOM, probe the traction control circuit and ground. If the circuit has battery voltage on it, replace the PCM. If the circuit has less than 1 volt or zero volts, repair the wire or connector terminal.

- The PCM receives a signal from the traction control system (ABS Module) indicating that a traction control event is occurring. This signal is either battery voltage, indicating traction control is not active, or less than 1 volt, indicating traction control is active, (Refer to Figure 147).
- This signal can be duplicated by grounding the TCS Active circuit or by supplying battery voltage to indicate to the PCM a traction control signal that is active or not.

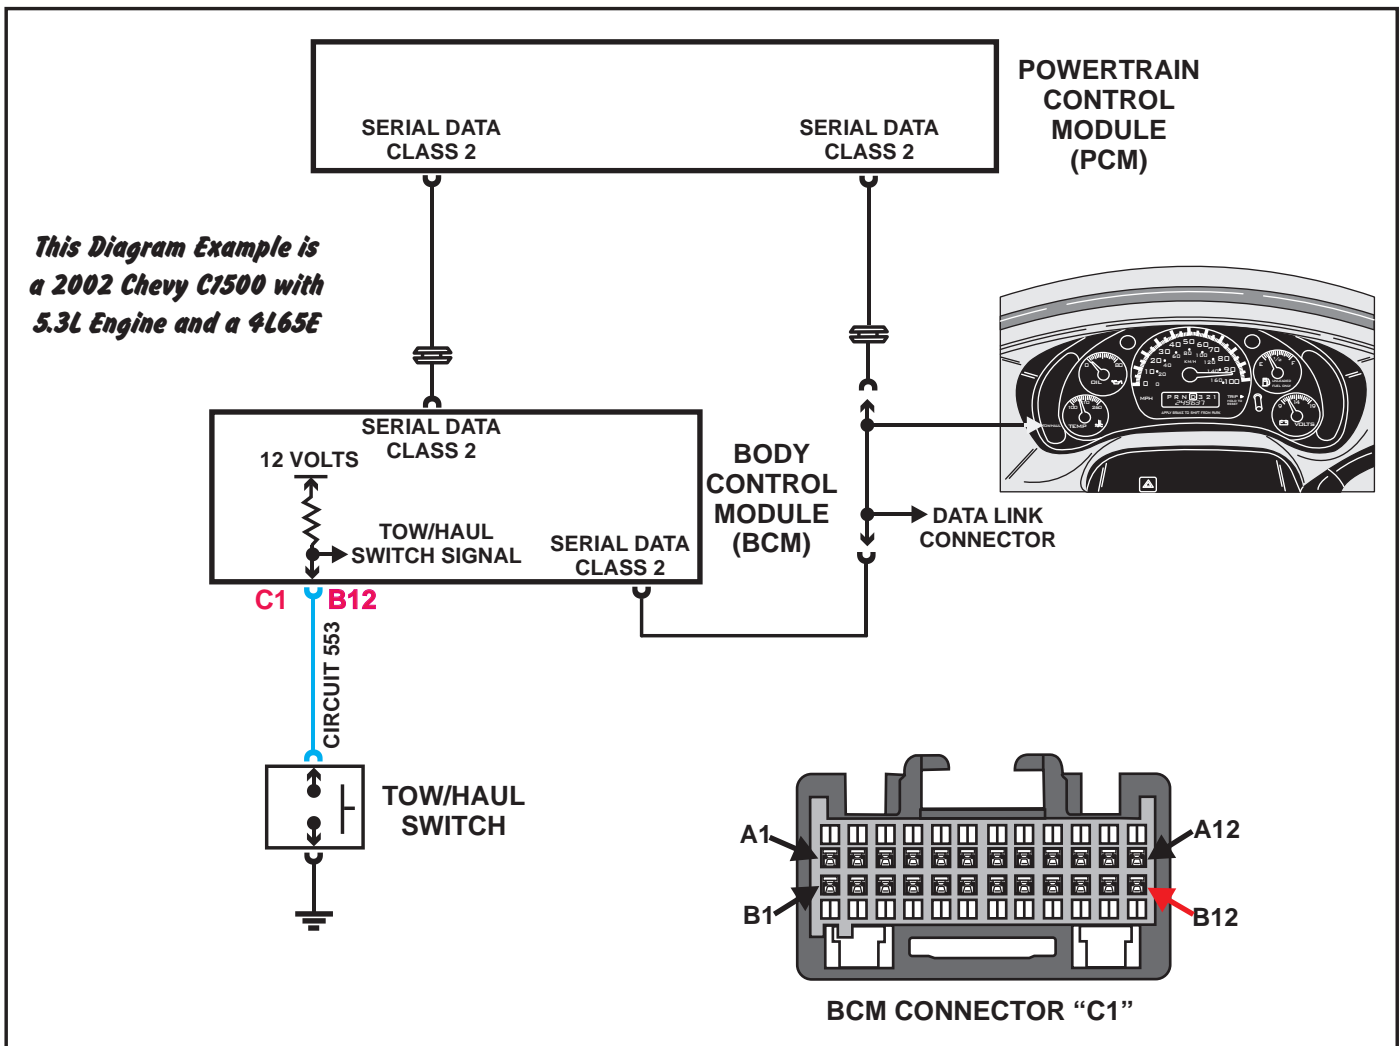
Figure 148

- Some scan tools will not show a state of change on the Tow/Haul parameter when the switch is cycled, this is a scan tool issue in most cases. In such instances use a DVOM to check operation on circuit 553, (Refer to Figure 148).

- If the Tow/Haul Switch requires replacement, the entire shift lever containing the switch is how it is available.
- If the Body Control Module (BCM) requires replacement, **it must be programmed or it will not function properly.**
- The Tow/Haul signal can be duplicated by taking a jumper lead and momentarily striking the Lt.Blue (Circuit 553) wire at the BCM, like a match to a metal surface, this will duplicate the signal the BCM is looking for.
- In most cases, the Lt. Blue wire is circuit 553 and is located in BCM connector C1 at the B12 location, (Refer to Figure 148).

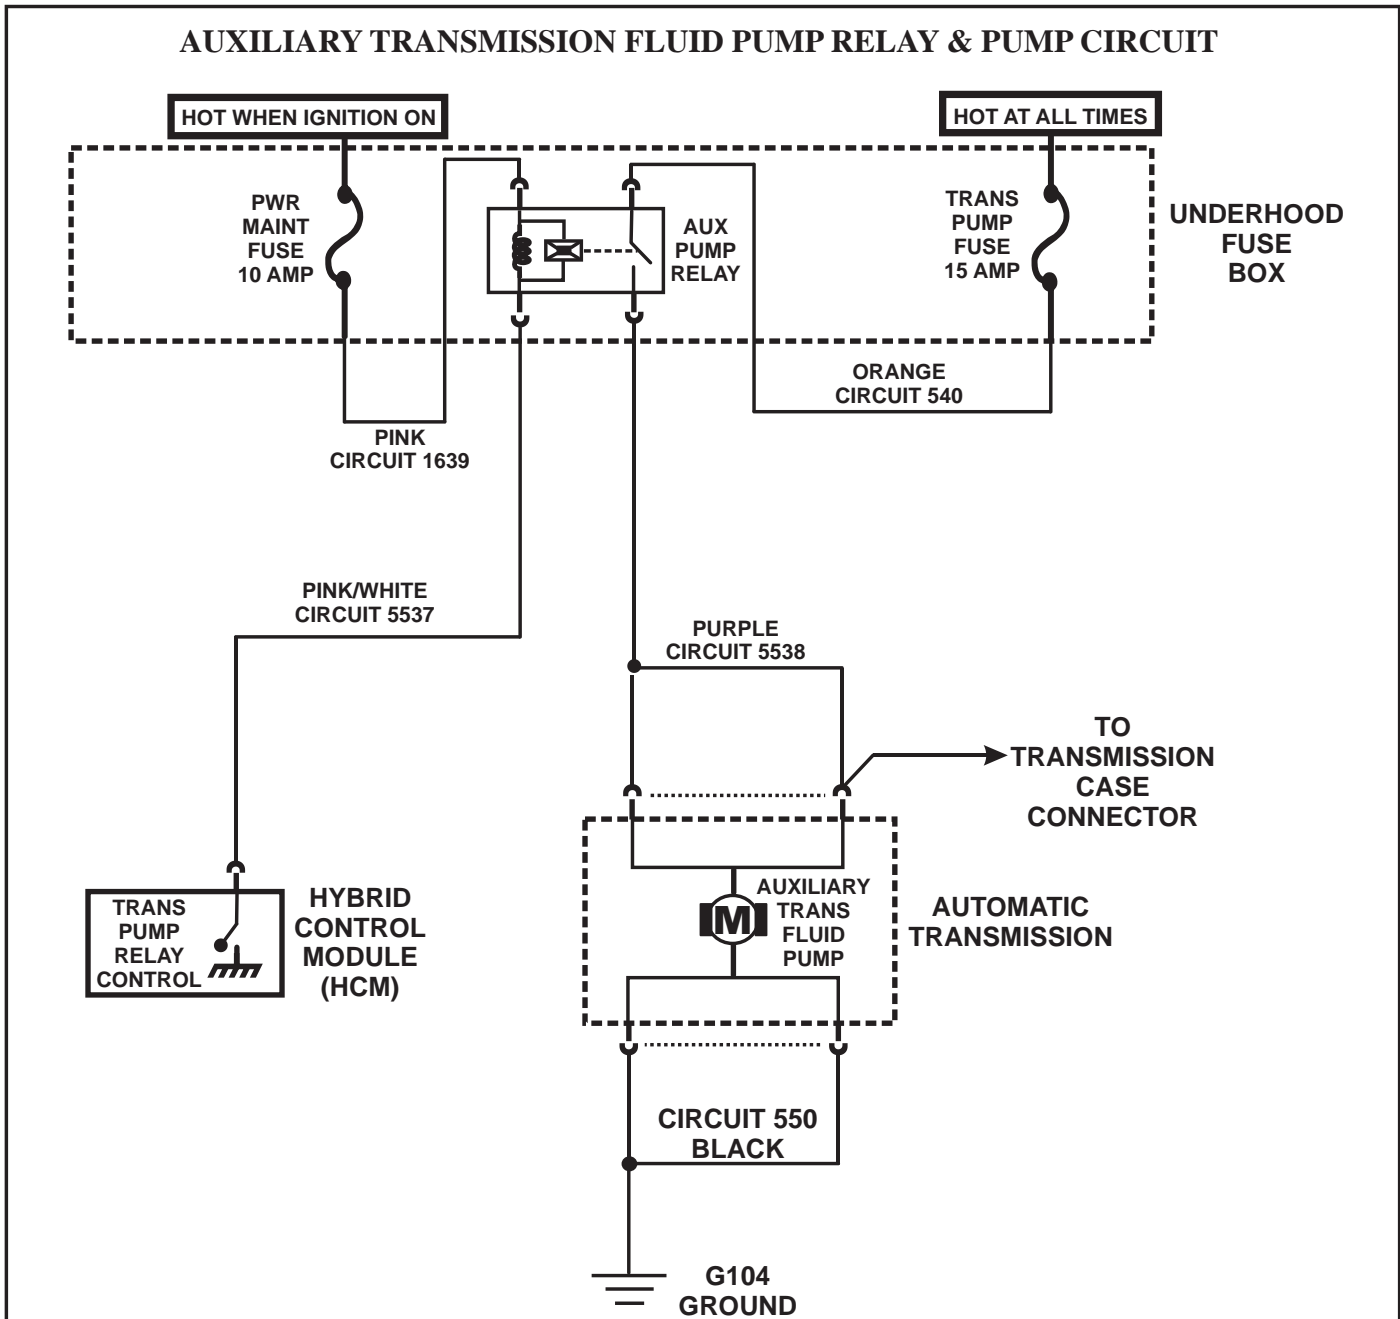
- Command the relay on with a capable scan tool, check the wire going to the Auxiliary Pump, for voltage, Refer to Figure 149 and Figure 151 for case connector identification.

- Make certain the “PWR MAINT” and “TRANS PUMP” fuses have voltage on both legs. They are located in the underhood fuse box, Refer to Figure 149 and Figure 151 for case connector terminal identification.

- Make certain the Pink wire at the relay is hot with the ignition ON and the Orange wire at the relay is hot with the ignition OFF, Refer to Figure 149 and Figure 151 for case connector identification.

- Check the Pink/White (Circuit 5537) wire at the relay to see that it is grounded. If it is grounded, the circuit will have less than 1 volt. If the circuit has battery voltage, make certain the wire and connections are good. If they are good, replace the Hybrid Control Module (HCM), Refer to Figure 149 and Figure 151 for case connector terminal identification.

- Check the G104 ground for 0.3 volts or less voltage drop, the ground point is at the top left bellhousing bolt, Refer to Figure 149 and Figure 151 for case connector terminal identification.

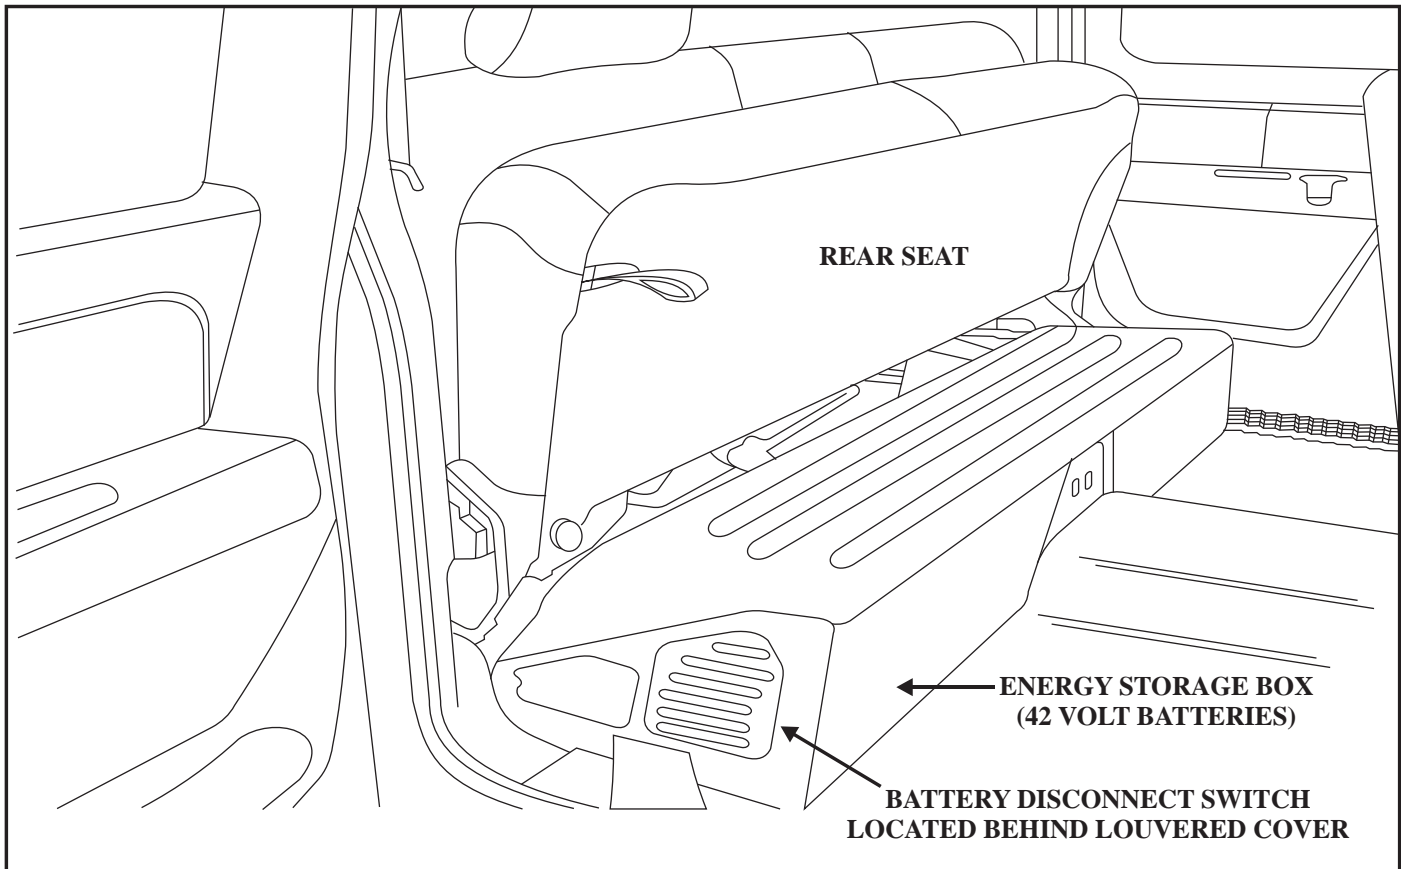
Figure 150

- Before starting any repairs that will put you in contact with any of the high voltage circuits, disable the high voltage system by turning the battery disconnect switch off, Refer to Figure 150) which is located at the passenger side of the battery pack under the rear seat, on the end, with a louvered cover over it. Disconnect the 3 phase connector from the Starter/Generator Control Module (SGCM) located in the engine bay, (Orange 3 cable connector).
