# **4L60E/65E/70E- 4L80E/85E DIAGNOSTIC CODE BOOK**

## **INTRODUCTION**

The GM 4L60E/65E/70E-4L80E/85E Diagnostic Code Book is designed to provide the technician with a step by step diagnostic approach to each and every transmission code available from 1991 to the 2007 model year. This manual can be used in collusion with any type of scanner utilized in retrieving these codes from the computer. As an aid to the technician, component location is recognized throughout the manual.

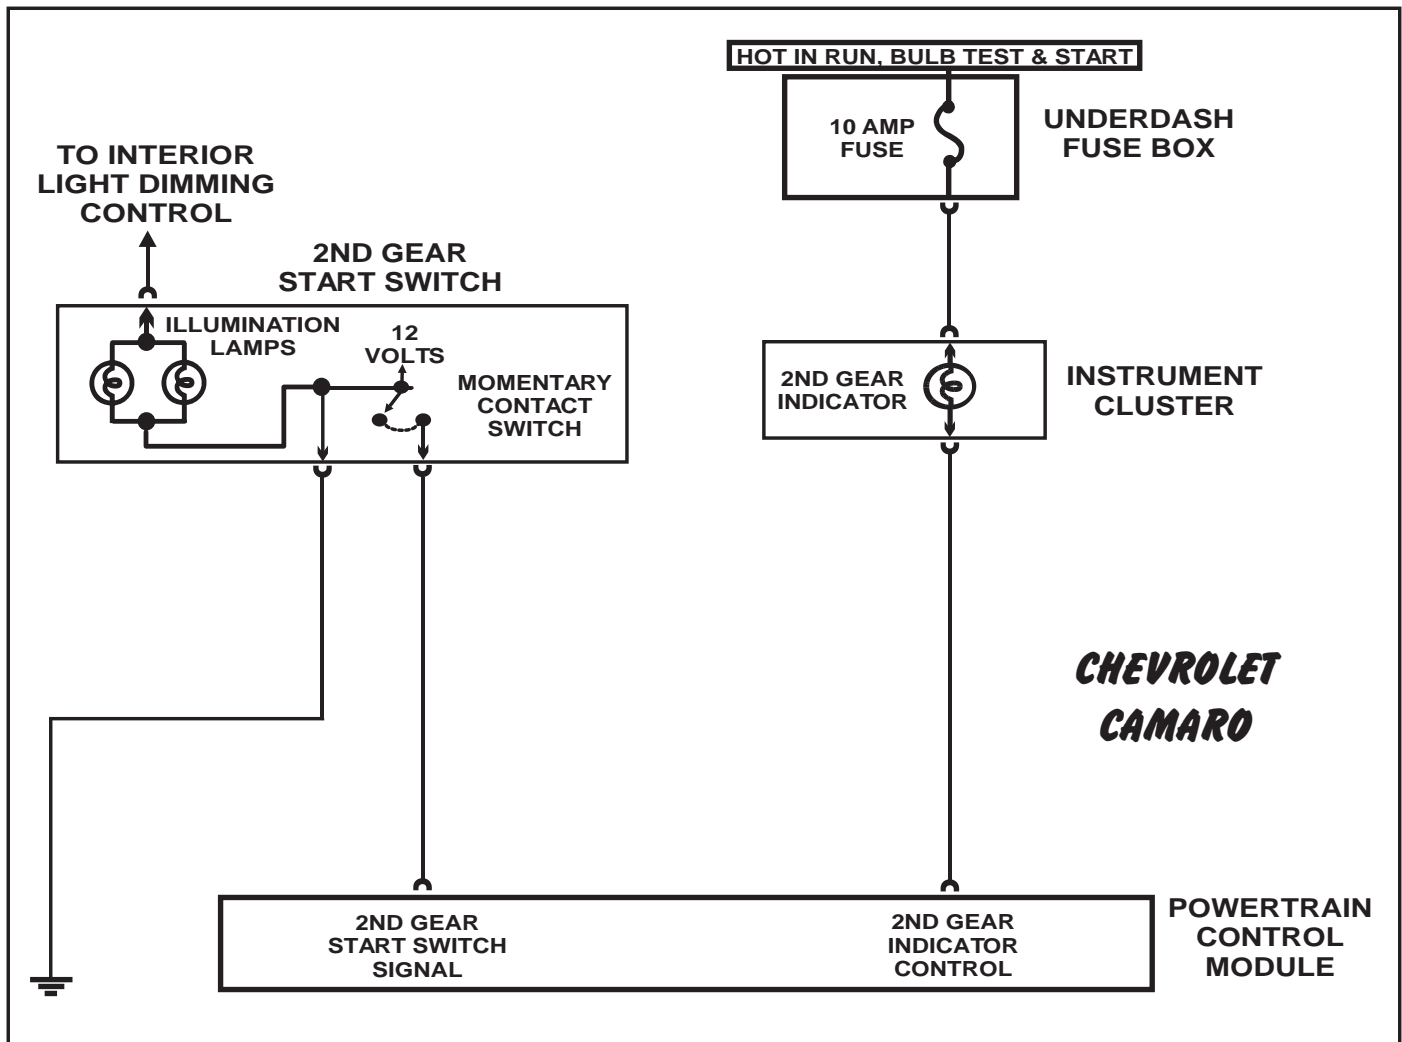
Figure 152

- The circuit that supplies battery voltage to the switch may be open or shorted to ground, (Refer to Figures 152 and 153).
- The Second Gear Start Switch is a Normally Open Momentary Contact Switch. When the switch is pressed and released, (like a doorbell) the 12 volt supply on the signal wire circuit is momentarily toggled to ground and then back to 12 volts when the switch is released. When this pulse is sensed by the PCM, the PCM will respond by illuminating the LED lamp and now make a 2nd gear start and the transmission will shift 2-3-4.  
When the switch is pressed and released again, the PCM interprets this signal pulse as a return to normal operation at which time first gear will be commanded and a normal shift pattern will occur. Upon release of the switch, it should always return to a grounded circuit, (less than 1 volt).

- Check the ground circuit with the ignition "ON", the DVOM should display 0.3 volts or less, if the ground circuit is carrying more voltage than 0.3, it can be cut and reattached to a known good ground, (Refer to Figures 152 and 153).

- This signal can be imitated by attaching a jumper lead to the 2nd gear switch circuit and momentarily providing 12 volts to the 2nd gear switch signal wire which goes to the PCM, (Refer to Figures 152 and 153).

- It is the PCM that supplies the 12 volts on the 2nd Gear Switch Signal Circuit, isolate the wire and check at the PCM for voltage, if none is present, replace the PCM. (Refer to Figures 152 and 153). If there are 12 volts at the PCM, but not on the switch end of the wire with the switch disconnected, repair the signal wire.
- If the PCM responds to the above test and the scan tool displays a state of change, replace the 2nd Gear Start Switch. If the PCM and scan tool do not respond, replace the PCM.
- The second gear indicator lamp should illuminate during a bulb check when the ignition is first turned on or when the switch is turned on. The indicator lamp located in the second gear switch is an LED Lamp and is replaced with the switch assembly, while the lamp located in the instrument cluster is an incandescent bulb and can be replaced separately.

- The difference between Figures 152 and 153 is where the Second Gear Start Switch Indicator Lamp is located. Chevy Camaro has the lamp located in the instrument Cluster and the Pontiac Firebird has it located in the 2nd Gear Start Switch.

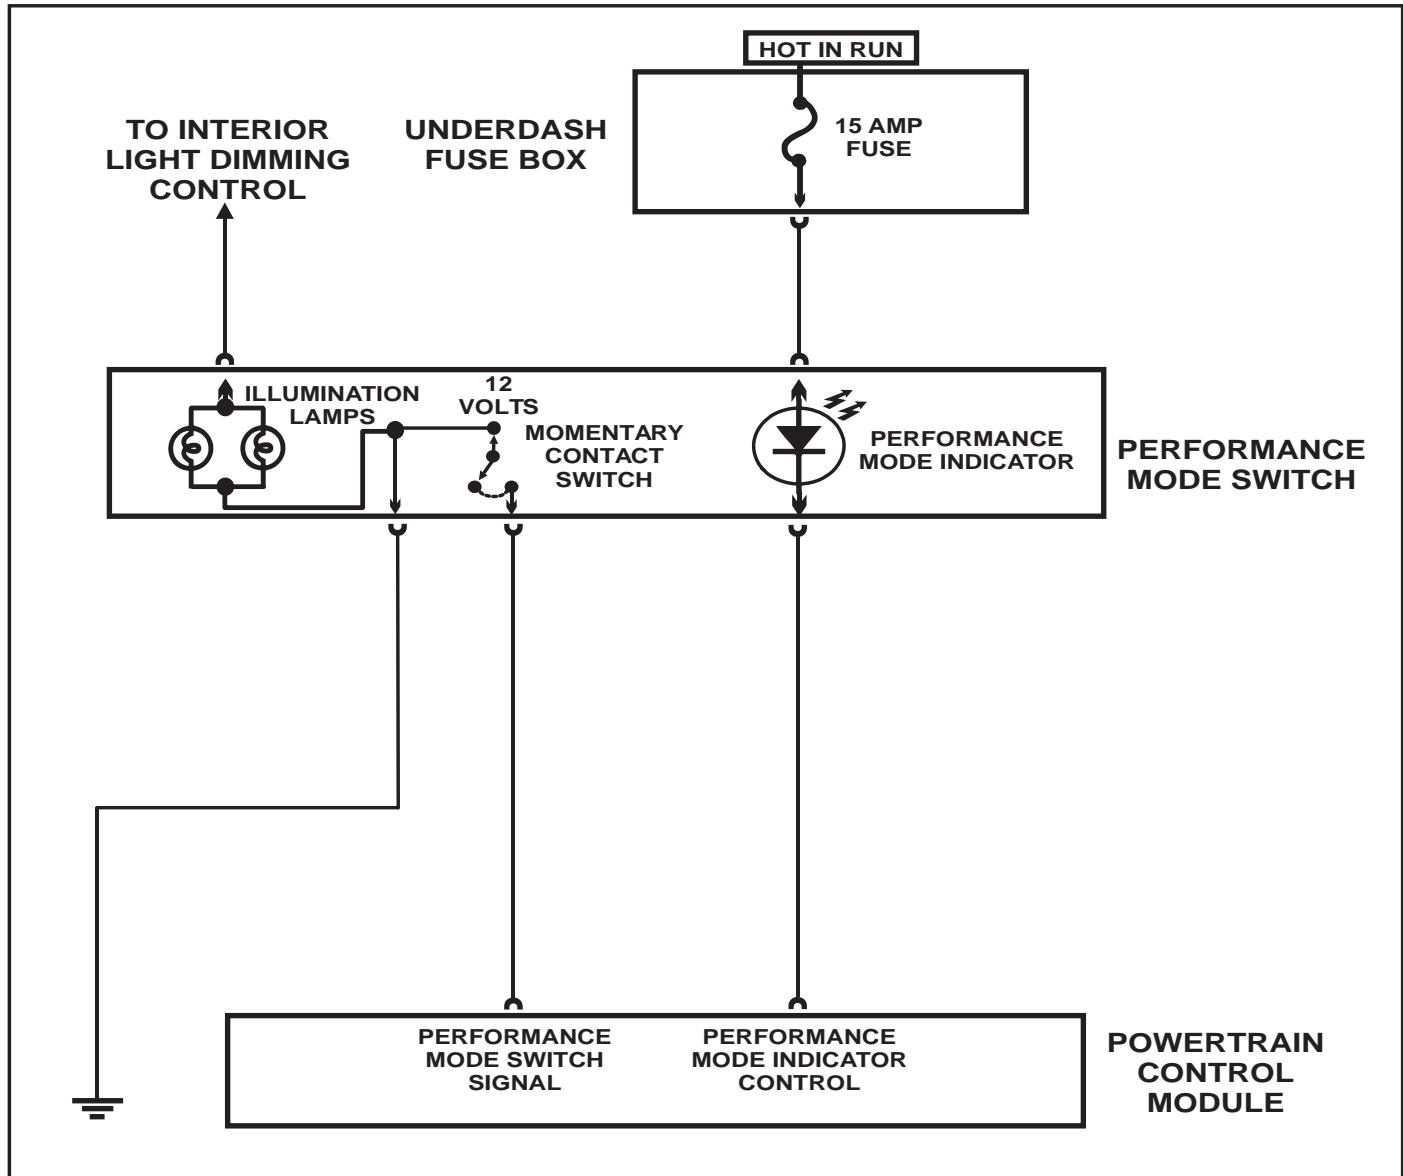
Figure 154

- The circuit that supplies battery voltage to the switch may be open or shorted to ground, (Refer to Figure 154).
- The Performance Mode Switch is a Normally Open momentary contact switch. When the switch is pressed and released once, (like a doorbell), the 12 volts supply on the signal wire circuit is momentarily pulled to ground. When this pulse is sensed by the PCM, the PCM will respond by illuminating the performance LED Lamp and will also switch to performance mode. When the switch is pressed and released again, the PCM will now extinguish the LED Lamp and will also return to normal shift pattern operation, (Refer to Figure 154). When the ignition is turned off, on the next startup mode operation will be in the normal mode.

- Check the ground circuit with a DVOM for 0.3 volts or less, if the ground circuit is carrying more than 0.3 volts, the ground wire can be cut and reattached to a known good ground, (Refer to Figure 154).

- This signal can be imitated with the use of a jumper lead connected to the mode switch ground circuit and then by momentarily touching the jumper lead to the mode switch signal wire, (Refer to Figure 154). If the PCM responds and the scan tool displays a change of state, then replace the switch.

- Disconnect the switch and check the mode switch signal wire for 12 volts from the PCM, if 12 volts is not present, replace the PCM. If it is present, repair the mode switch signal wire, (Refer to Figure 154).

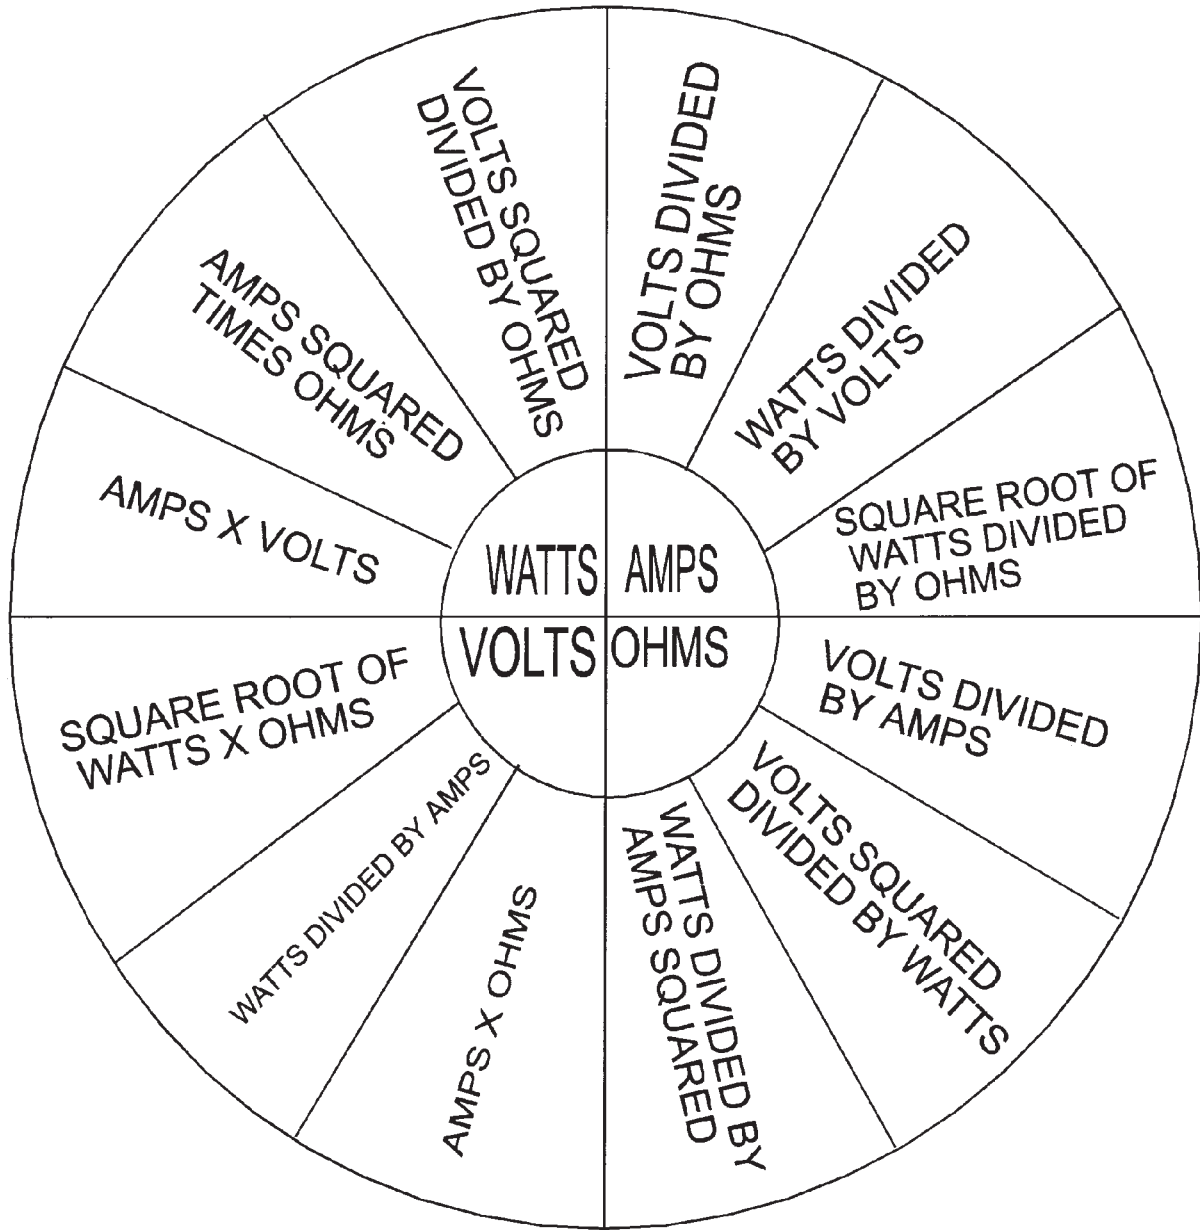
**ELECTRICAL EQUATIONS**

IF THIS STAYS THE SAME	AND THIS GOES UP	THIS WILL	GO
OHMS	VOLTS	AMPS	UP
OHMS	AMPS	VOLTS	UP
AMPS	OHMS	VOLTS	UP
AMPS	VOLTS	OHMS	UP
VOLTS	AMPS	OHMS	DOWN
VOLTS	OHMS	AMPS	DOWN
