# 41TE & 42LE CODE BOOK

## 41TE & 42LE DIAGNOSTIC CODE BOOK INTRODUCTION

The Chrysler 41TE and 42LE Diagnostic Code Book is designed to provide the technician with a step by step diagnostic approach to each and every transaxle code available from 1989 to 1998 model year. This manual can be used in companion with any type of scanner utilized in retrieving these codes from the controller. As an aid to the technician, component location is recognized throughout the manual.

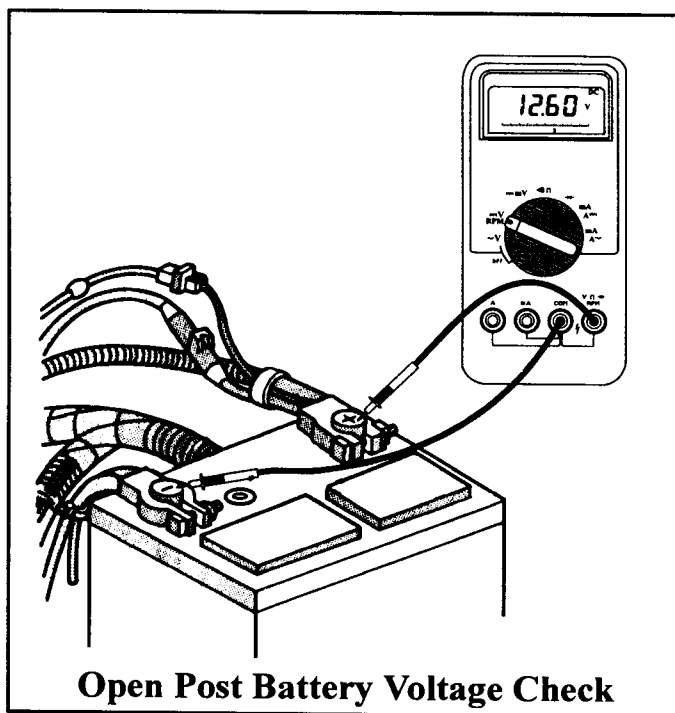
Figure 1

Using a DVOM set to DC volts, measure the open post battery voltage by placing the negative lead to the negative battery post and the positive meter lead to the positive battery post as shown in Figure 1.

A fully charged battery should measure approximately 12.60 volts. However, 12.40 volts is the average seen and is acceptable. If battery voltage is below 12.00 volts, the result may be erratic computer behaviour. Refer to the table in Figure 2 for the typical voltage values in relationship to percentage of charge.

With the volt meter connected to the battery as shown in Figure 1, start the vehicle. Turn on the headlights and blower motor to put a load on the voltage system. Approximately 13.5 to 14.4 volts should be seen (See Figure 3). If 15 volts or higher is seen, this may indicate an overcharging alternator which may result in erratic computer behaviour. This problem needs to be rectified before going to the next step.

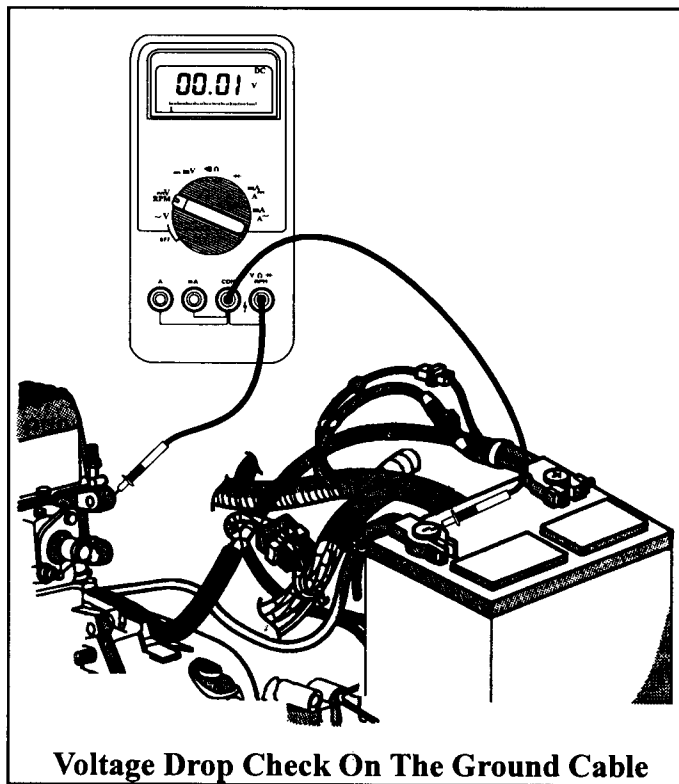
Figure 4

The next step is to perform a voltage drop test across the ground cable. This checks for corrosion or bad connections with the main ground cable itself. To do this, keep the vehicle running and turn on as many accessories as possible, i.e. headlights, AC, radio, etc. With the meter set to DC volts, place the negative lead of the meter to the negative post of the battery. Place the positive lead of the meter to either the body or engine block (See Figure 4). No more than 0.10 volts should be seen. A good ground will usually show 0.00 or 0.01 volts. If 0.20 or more is seen, clean and/or replace the main ground cable to obtain a 0.00 or 0.01 reading.

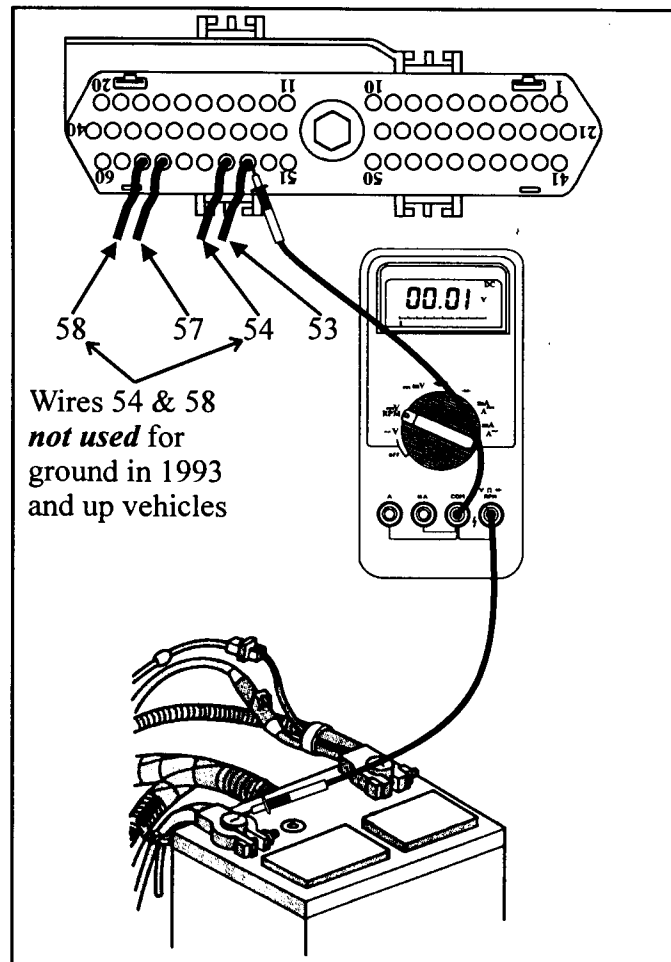
Figure 5

Locate the transaxle controller (See Pages 6 and 7). Once the controller is located, pop the plastic harness cover away from the wires going into the connector (Do not remove the center bolt). Once the cover is removed and the 60 way connector can be viewed from the wire side, locate the ground wires. 1989 to 1992 use wires 53, 54, 57 and 58 for ground (See Figure 5).

Start the vehicle and turn on several accessories. Set the meter to DC volts and place the positive lead of the meter to the negative battery post. Using the negative lead, carefully back probe each ground wire as shown in Figure 5. No more than 0.10 volts can be seen. If more than 0.10 volts is seen, that ground wire is bad.

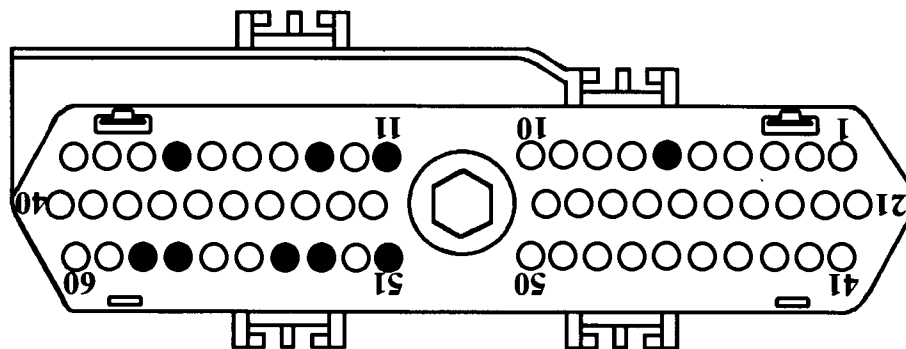
**Special Note: 1993 and later vehicles do not use terminals 54 and 58 for ground wires. Refer to Figure 6 for the controllers main ground wires per vehicle year and application.**

YEAR AND MAKE OF VEHICLE	WIRE # →	6	11	13	17	51	53	54	57	58
1989 - 1992 ALL VEHICLES							✓	✓	✓	✓
1993 DAYTONA		✓					✓		✓	
1993 DYNASTY		✓				✓	✓		✓	
1993 5th AVENUE						✓	✓		✓	
1993 IMPERIAL						✓	✓		✓	
1993 NEW YORKER						✓	✓		✓	
1993 - 1994 SHADOW		✓					✓		✓	
1993 - 1994 SUNDANCE		✓					✓		✓	
1993 - 1994 SPIRIT		✓				✓	✓		✓	
1993 - 1994 ACCLAIM		✓				✓	✓		✓	
1993 - 1994 LEBARON SEDAN		✓				✓	✓		✓	
1993 - 1995 LEBARON CONV/COUPE		✓					✓		✓	
1993 - 1995 CARAVAN (3.0L)		✓					✓		✓	
1993 - 1995 VOYAGER (3.0L)		✓					✓		✓	
1993 - 1995 GRAND CARAVAN (3.3 & 3.8L)							✓		✓	
1993 - 1995 GRAND VOYAGER (3.3 & 3.8L)							✓		✓	
1993 - 1995 TOWN & COUNTRY (3.3 & 3.8L)							✓		✓	
1995 - 1996 AVENGER & SEBRING			✓	✓	✓		✓			
1995 - 1996 CIRRUS & STRATUS						✓	✓		✓	
1995 - 1996 TALON			✓	✓	✓		✓			
1996 CARAVAN & GRAND CARAVAN						✓	✓		✓	
1996 VOYAGER & GRAND VOYAGER						✓	✓		✓	
1996 TOWN & COUNTRY						✓	✓		✓	
1996 SEBRING CONVERTIBLE				✓		✓	✓		✓

1996 BREEZE						✓	✓		✓	
1993 - 1997 ALL LH VEHICLES						✓	✓		✓

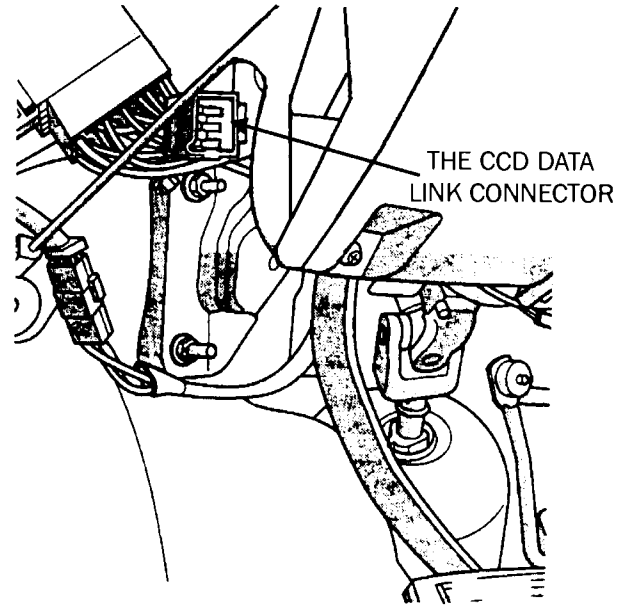
88-92 AA, AC, AY, AG, AJ  
89-95 AS  
93-95 AC, AY

Early 89 vehicles utilized only 4 pins in the light blue CCD data link connector. Midyear the connector went to the full 6 pins and remained light blue in color

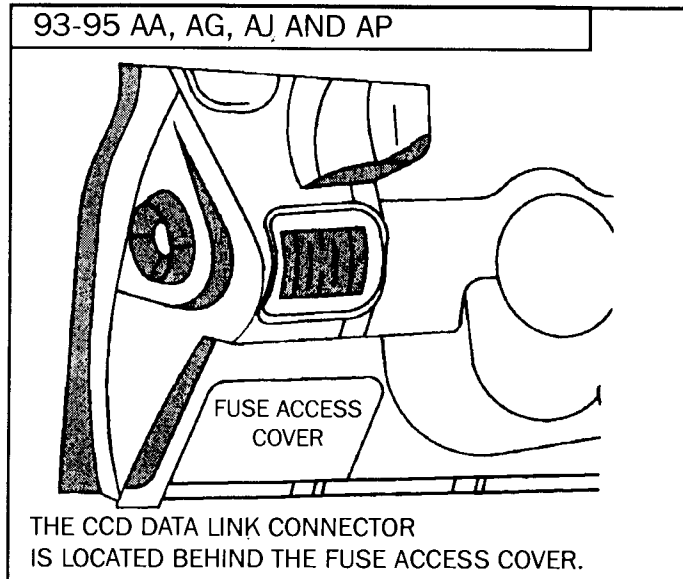
### CCD DATA LINK CONNECTOR

In 1995 the CCD data link connector was replaced by an 8 pin black connector. The previous 6 way scan tool connector will still link up.

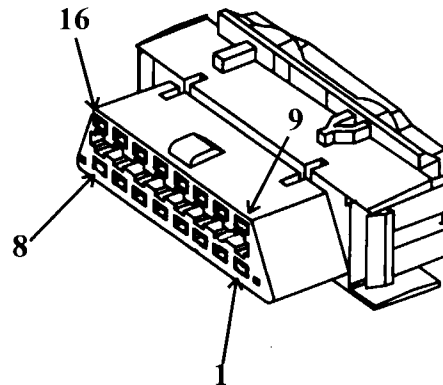
95-97 JA, JX  
96-97 NS  
96-97 LH

- 3...Serial Data Bus (+) (2.5 V)
- 4...Ground (0.1 V or less)
- 5...Ground (0.1 V or less)
- 6...SCI Receive
- 7...SCI Transmit/ISO 9141K
- 11..Serial Data Bus (-) (2.5 V)
- 14..TCM SCI Receive (96-97 JA, JX, NS)
- 16..Battery (12V)

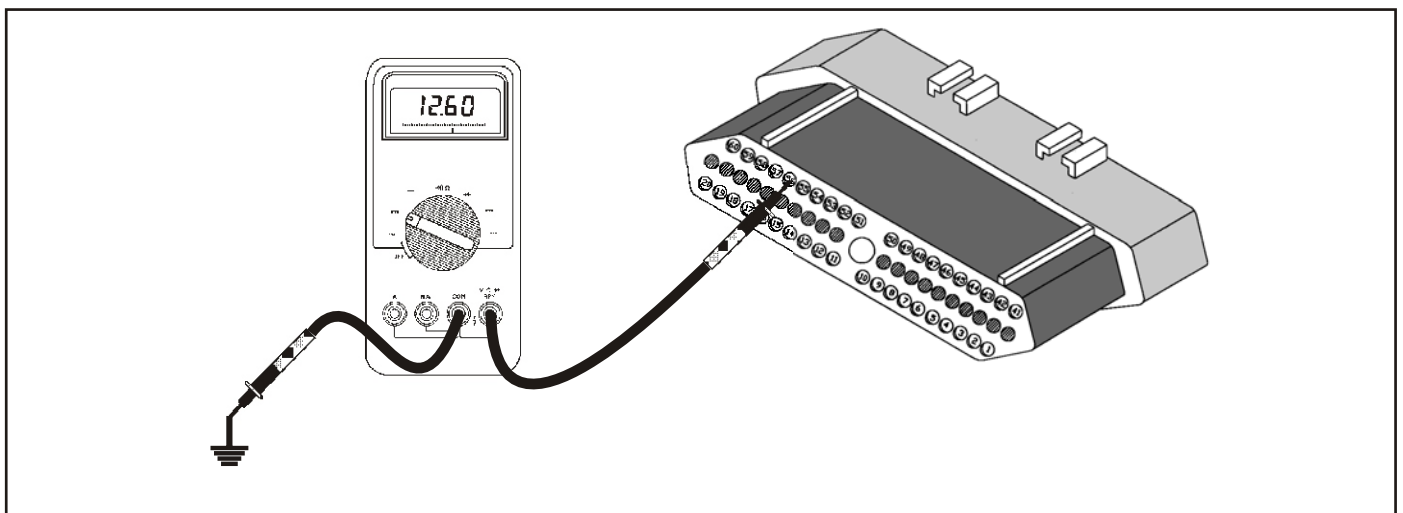
Figure 7

1. Locate the TCM (See pages 6 and 7) and carefully unplug the 60 way connector.
2. With a DVOM set to DC volts, check for battery voltage on the J11 circuit at pin 56 as shown in Figure 7. If battery voltage is seen, go to the next step. If battery voltage is not seen, go to step 4.

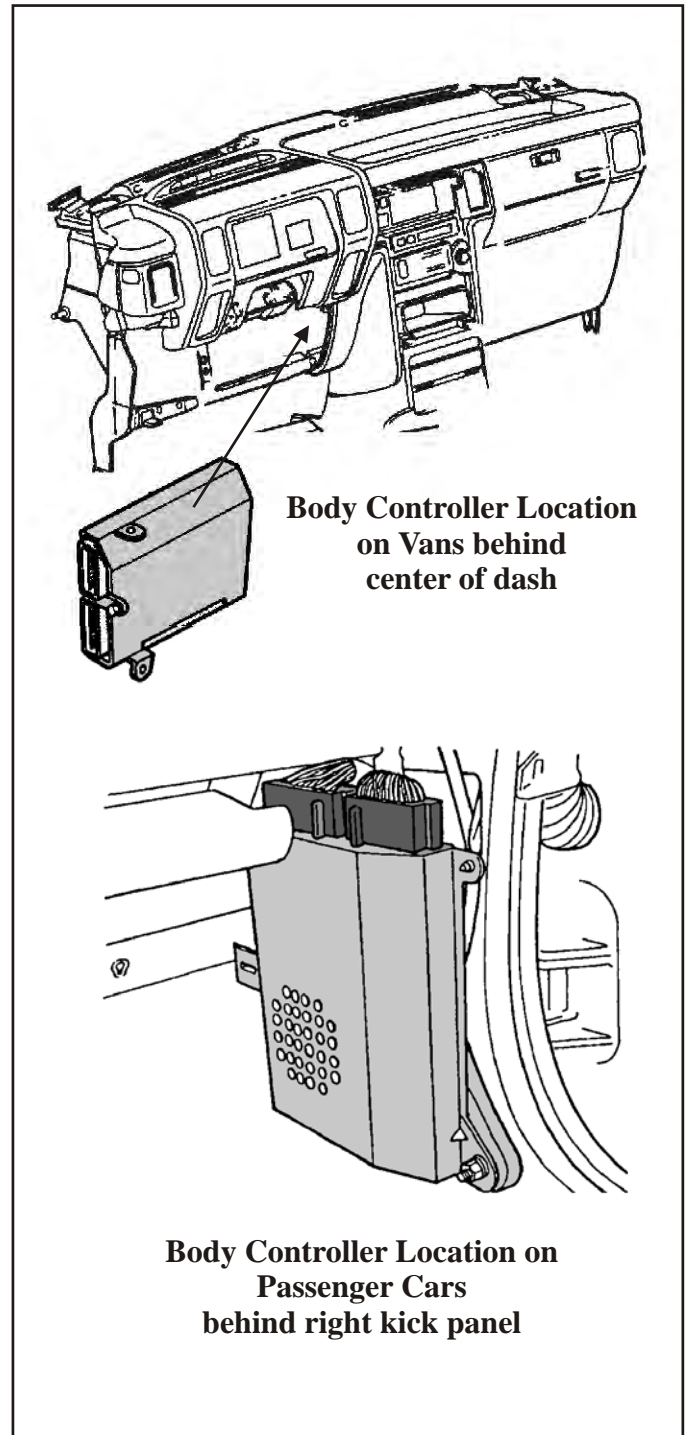
The body controllers in vans is located behind the center of the dash left of the steering column. Passenger cars have the body controller located behind the passenger side kick panel (See Figure 11).

If the vehicle is equipped with a body computer (See Figure 11 for body controller location), unplug and clean its connector. After plugging it back in, verify scanner communication. If a BUS failure still remains, the body computer may need to be replaced. There is not a sure method in determining which controller is causing the BUS failure. When a vehicle is not equipped with a body computer, it is safe to determine that the TCM is bad causing the concern. If it is equipped with a body computer, it could be either controller. However, the body computer would be the most likely cause of the problem. The reason is that the body controller is the computer controlling the voltage in the BUS system. So if there is a BUS failure, the most likely candidate would be the controller responsible for putting the voltage into the BUS system.

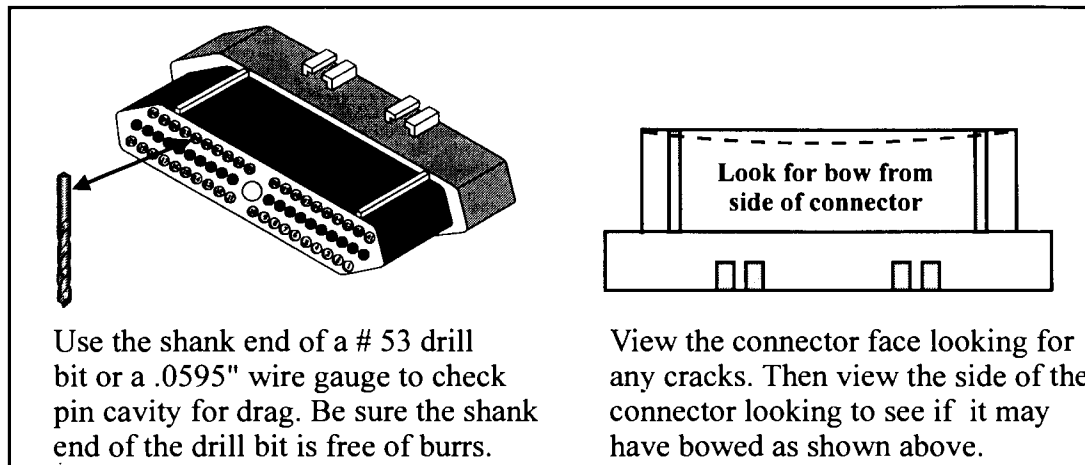
Figure 12

- Perform the *Preliminary Electrical Checks* outlined starting on page 3. Be sure to use the chart on page 5 when testing the controller's main ground wires.
- Inspect the 60 way controller connector for corrosion, distortion and/or cracks in the connector, pushed back or spread pin cavities. Particularly the power and ground wire pins (See Figure 12).
- If the above checks prove good, the controller will need to be replaced.

- Unplug the 60 way connector and check for pin drag at the # 56 cavity using the shank end of a # 53 drill bit or .0595" wire gauge as shown in Figure 12. Repair if necessary.

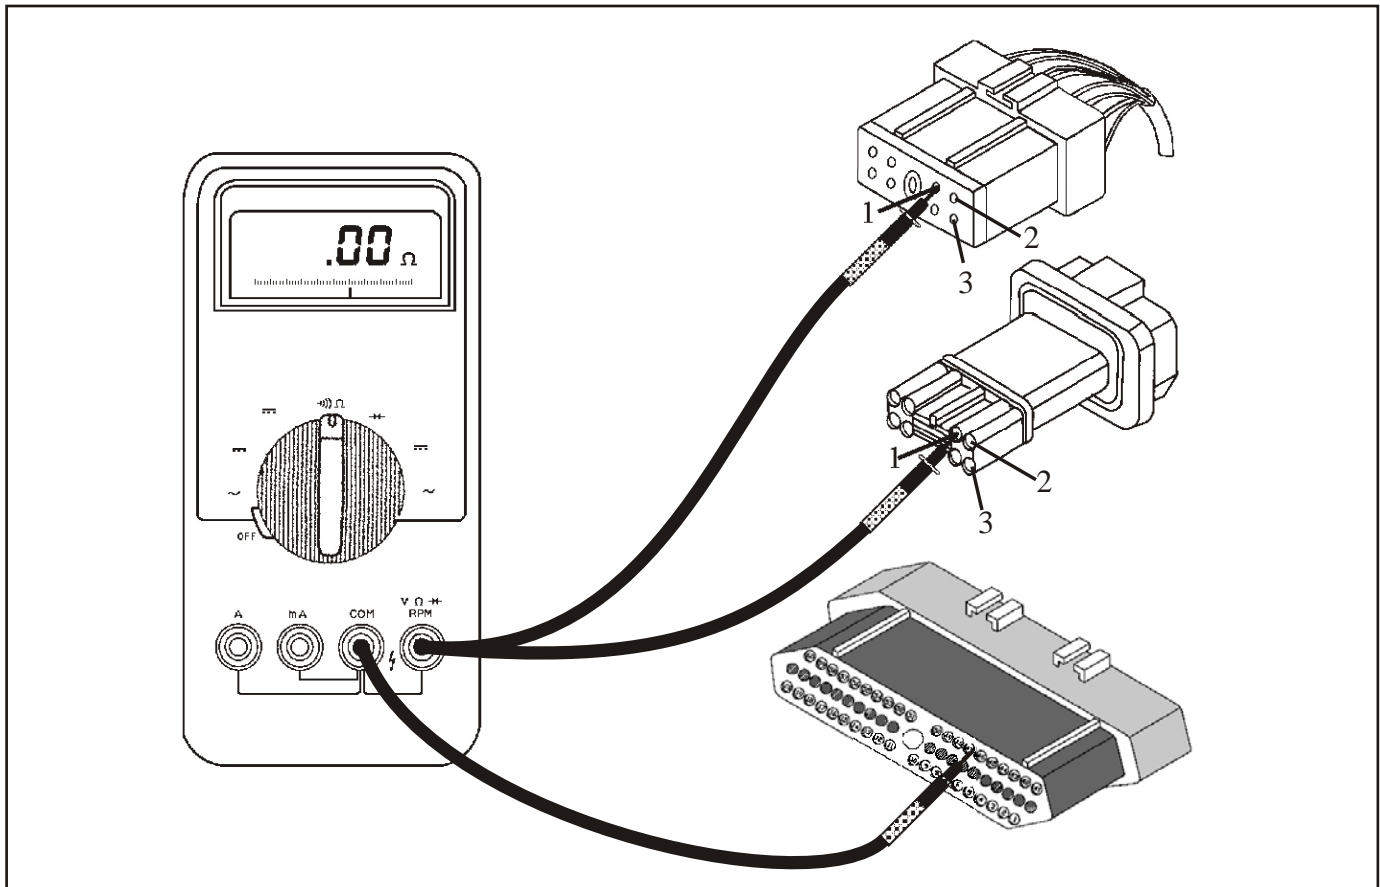
Figure 31

PRESSURE SWITCH	SOLENOID BODY CONNECTOR	TCM CONNECTOR
Low/Reverse Pressure Switch Wire -	2	50
2/4 Pressure Switch Wire -	1	47
Overdrive Pressure Switch Wire -	3	9

*Special note: 2/4 & L/R Pressure Switch codes could occur due to incorrect placement of check balls in the valve body.*

- A continuity check should be made across the following appropriate wire from the solenoid connector to the TCM connector (See Figure 31):

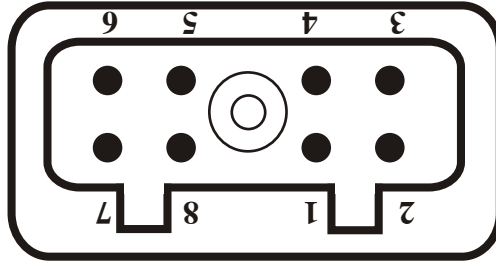
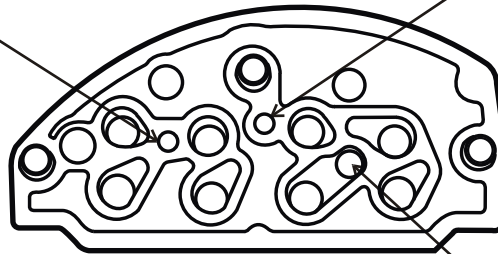
Figure 33

## 41TE SOLENOID BODY RESISTOR AND PRESSURE SWITCH CHECK

EACH PRESSURE SWITCH HAS ITS OWN RESISTOR IN THE CIRCUIT WHICH RANGE BETWEEN APPROXIMATELY 270-330 OHMS @ 68° F EACH RESISTOR SIMILAR IN RESISTANCE. FOR EXAMPLE:  
2 MEASURE 270 AND 1 MEASURES 330 - NO GOOD

2/4 PRESSURE  
SWITCH PASSAGE

L-R PRESSURE  
SWITCH PASSAGE

OD PRESSURE  
SWITCH PASSAGE

PRESSURE SWITCH	CONNECT OHMMETER LEADS TO PIN
O.D.	1 & GROUND (Body Base)
L-R	2 & GROUND (Body Base)
2-4	3 & GROUND (Body Base)

- If any one of the wires do not show voltage during this test, there is a break in that wire from the solenoid body to the TCM. Repair the wire.
- If voltage is seen on all three wires, inspect the solenoid body. To check the solenoid body for a 41TE see Figure 33. To inspect a 42LE solenoid body, see Figure 34.

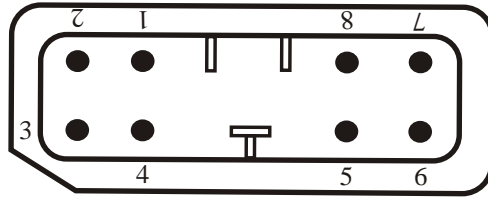
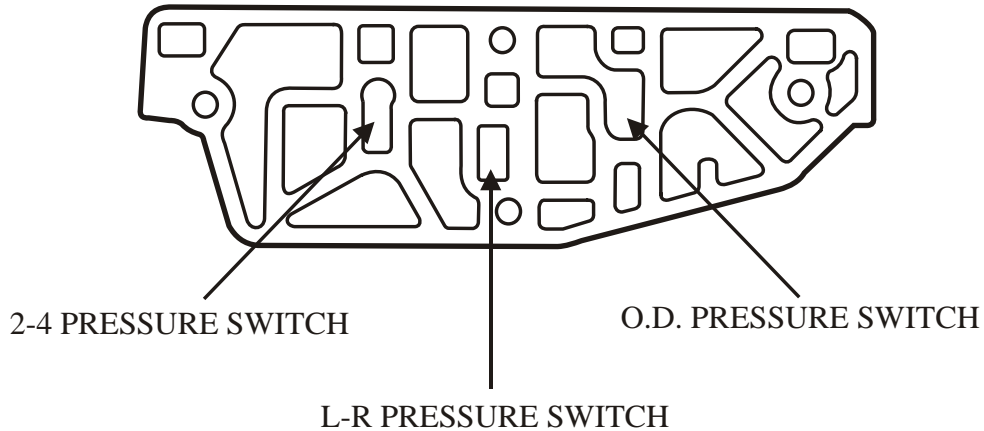
**42LE SOLENOID BODY  
RESISTOR AND PRESSURE SWITCH CHECK**

EACH PRESSURE SWITCH HAS ITS OWN RESISTOR IN THE CIRCUIT WHICH RANGE BETWEEN APPROXIMATELY 270-330 OHMS @ 68° F EACH RESISTOR SIMILAR IN RESISTANCE. FOR EXAMPLE:  
2 MEASURE 270 AND 1 MEASURES 330 - NO GOOD

RESISTOR	CONNECT OHMMETER LEADS TO PINS
2-4	4 & 1
L-R	4 & 2
O.D.	4 & 3

PRESSURE SWITCH	CONNECT OHMMETER LEADS TO PIN
O.D.	1 & GROUND (Body Base)
L-R	2 & GROUND (Body Base)
2-4	3 & GROUND (Body Base)

OHM METER SHOULD READ "NO CONTINUITY" WITH NO AIR APPLIED TO THE PRESSURE SWITCH. OHM METER SHOULD READ LESS THAN "3" OHMS . WITH 50 PSI OF AIR PRESSURE APPLIED TO THE PRESSURE SWITCH.

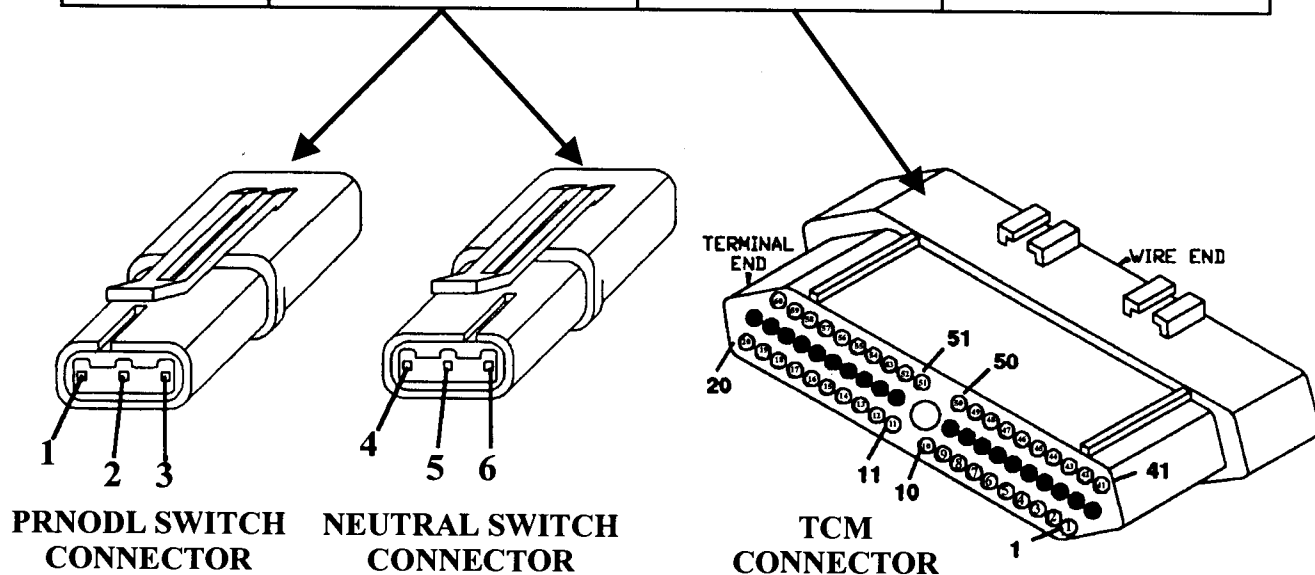
CIRCUIT NAME	PRNODL SWITCH	CONTROLLER TERMINAL #	POSSIBLE CODES
RL2/T01	1	1	28
NS2/T42	2	42	28
RL2/Z13	3	GROUND	28
CIRCUIT NAME	NEUTRAL SWITCH	CONTROLLER TERMINAL #	POSSIBLE CODES
RL1/A21	4	IGNITION FEED	28
NS1/T41	5	41	28
RL1/T03	6	3	28

- If the connectors check good, use the chart found in Figure 38 to perform continuity checks across each individual circuit.
- If all circuits have continuity, the TCM may need to be replaced. Before doing so, refer to a bulletin found on page 49.

- If a code 28 comes up due to a bad shift lever position signal and both the PRNODL and Neutral switch are known to be good, then a circuit check will have to be performed. This will require the use of an ohmmeter in order to check for continuity across each individual wire going from the switch to the controller. Use the chart and illustrations below to assist you in making the check. It has been ATSG's experience that the majority of open circuits have been traced down to bad connectors. Chrysler has a connector repair kit available for the PRNODL and Neutral Switches under part number 4638996

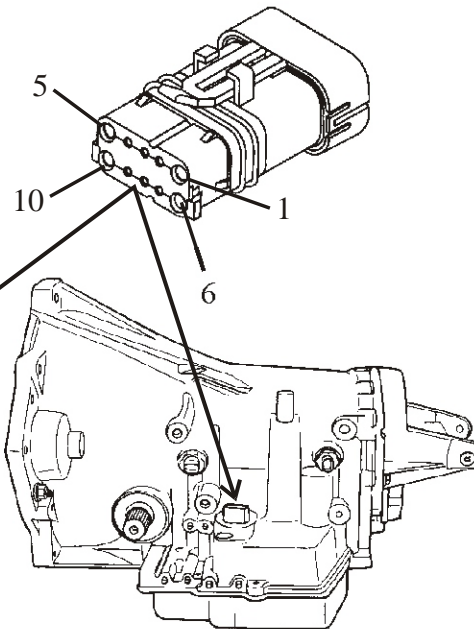
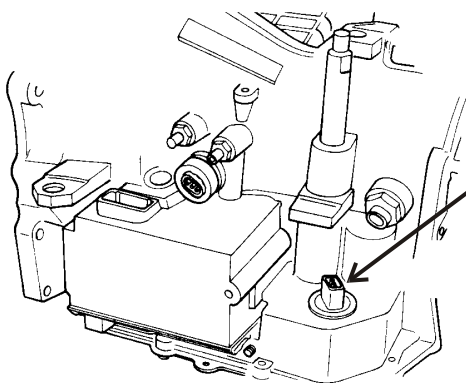
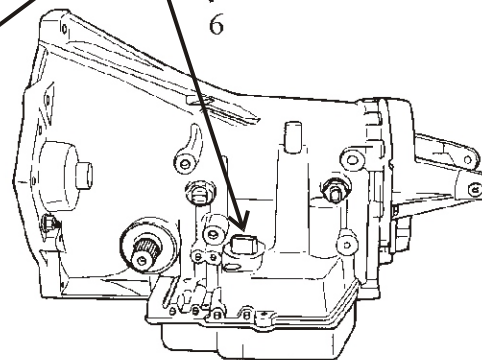
RANGE	T42 (C2)	T41 (C1)	T3 (C3)	T1 (C4)
P	CL	CL	CL	OP
R	CL	OP	OP	OP
N	CL	CL	OP	CL
OD	OP	OP	OP	CL
3	OP	OP	CL	OP
1	CL	OP	CL	CL

OP = SWITCH IS OPEN  
CL = SWITCH IS CLOSED

### TRANSMISSION RANGE SENSOR TRS

**41TE**

**42LE**

- A scanner can be used to observe the OPEN/CLOSED state of the C1/T41, C2/T42, C3/T3 and the C4/T1 circuits. This can be especially helpful in determining which exact circuit is malfunctioning. Refer to Figure 40 for the OPEN/CLOSED status chart and circuit identification.

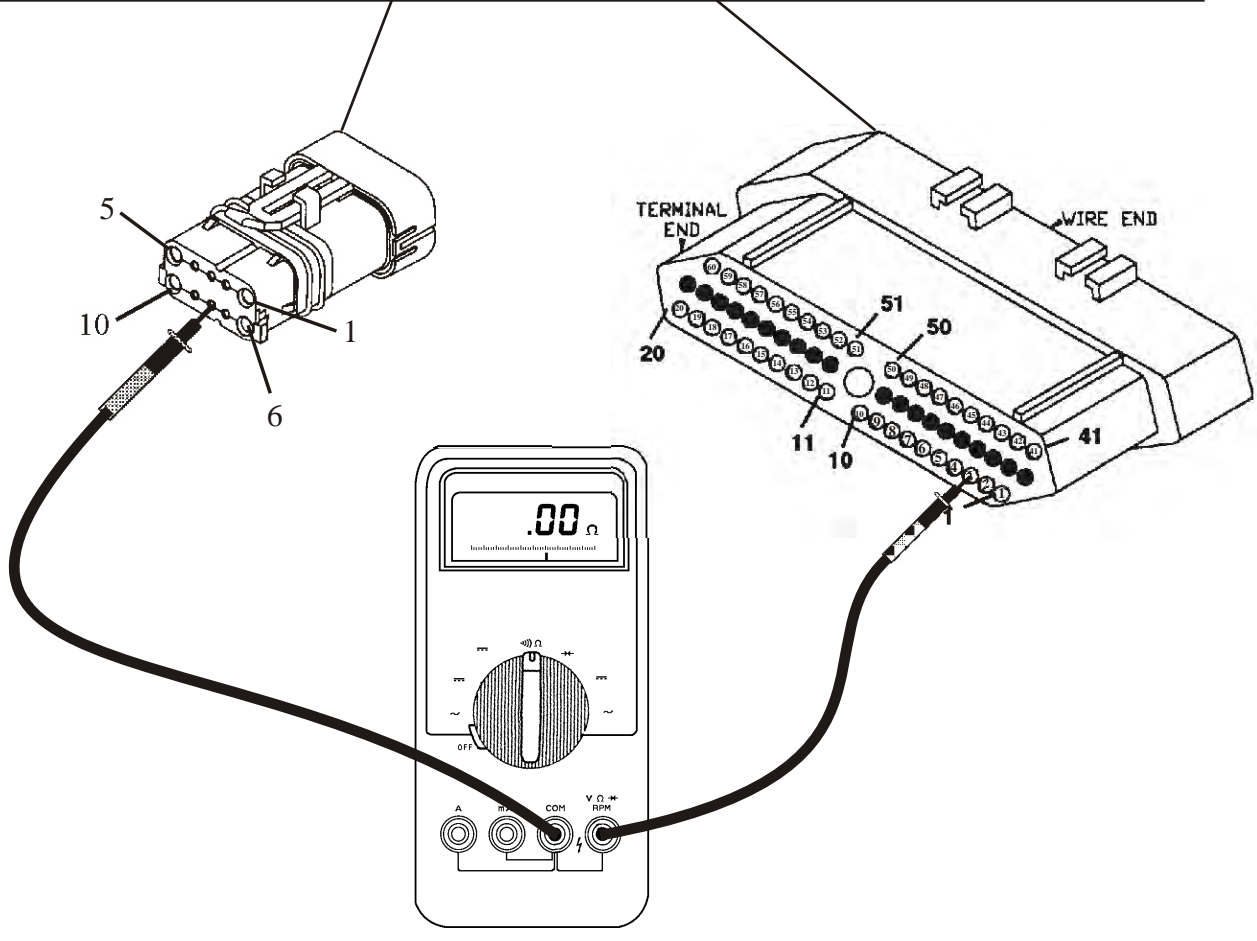
CIRCUIT NAME	TRANSMISSION RANGE SENSOR	CONTROLLER TERMINAL #	POSSIBLE CODES
C1/T41	5	41	28
C2/T42	9	42	28
C3/T03	8	3	28
C4/T01	7	1	28

- Once the circuit which malfunctioned has been identified, a continuity check should be made on that circuit. Use the chart found in Figure 41 to assist in identifying the specific circuit or circuits in question. For example, if the scanner reveals that the T3 (C3) circuit does not close when the selector lever is placed in Park, 3 or 1, that specific circuit will need to be checked. In the chart below circuit T3 is the wire which runs from the number eight cavity in the TRS connector to the number three cavity in the TCM connector.

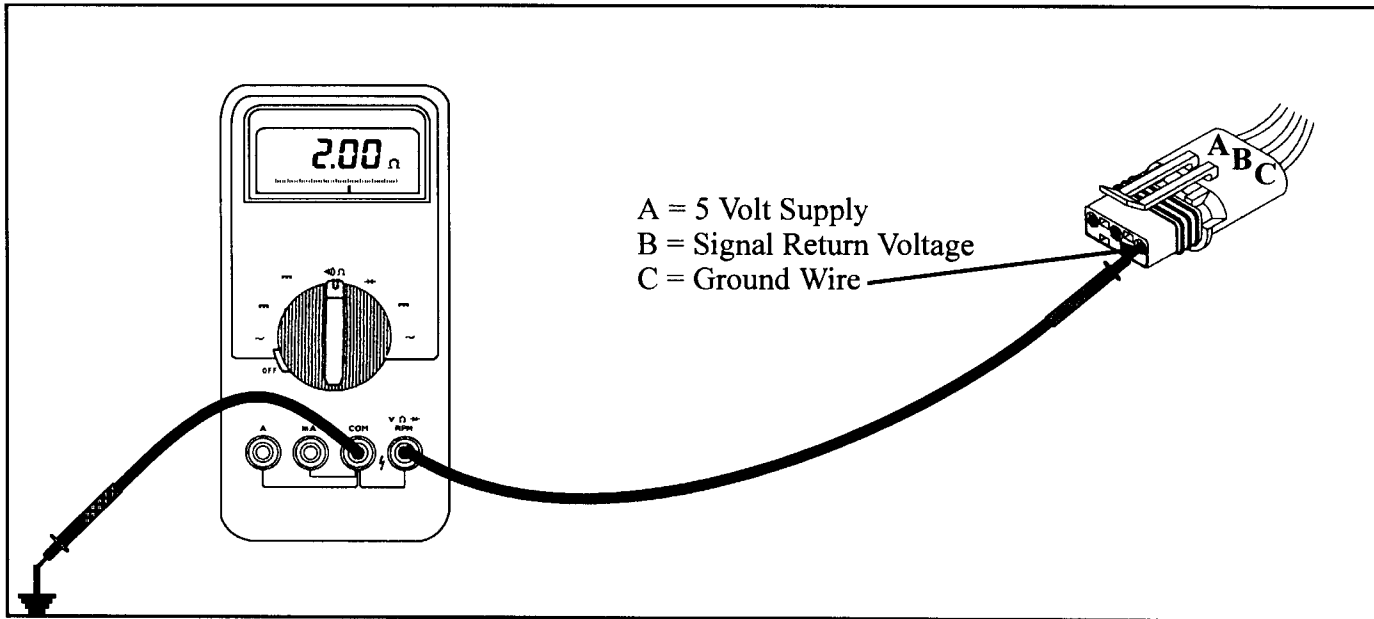
Figure 45

- With a meter set to ohms, place the negative lead to the negative post of the battery and the positive lead to terminal C in the TPS connector (See Figure 45). Approximately 0 to 5 ohms should be seen. If the resistance is greater than 5 ohms or the meter displayed an open circuit, the ground wire will need to be repaired. A quick and simple method would be to splice into the wire with another wire and run it to a good known ground (See Figure 46). If the ground wire is good and the TPS is still malfunctioning, go to the next step.

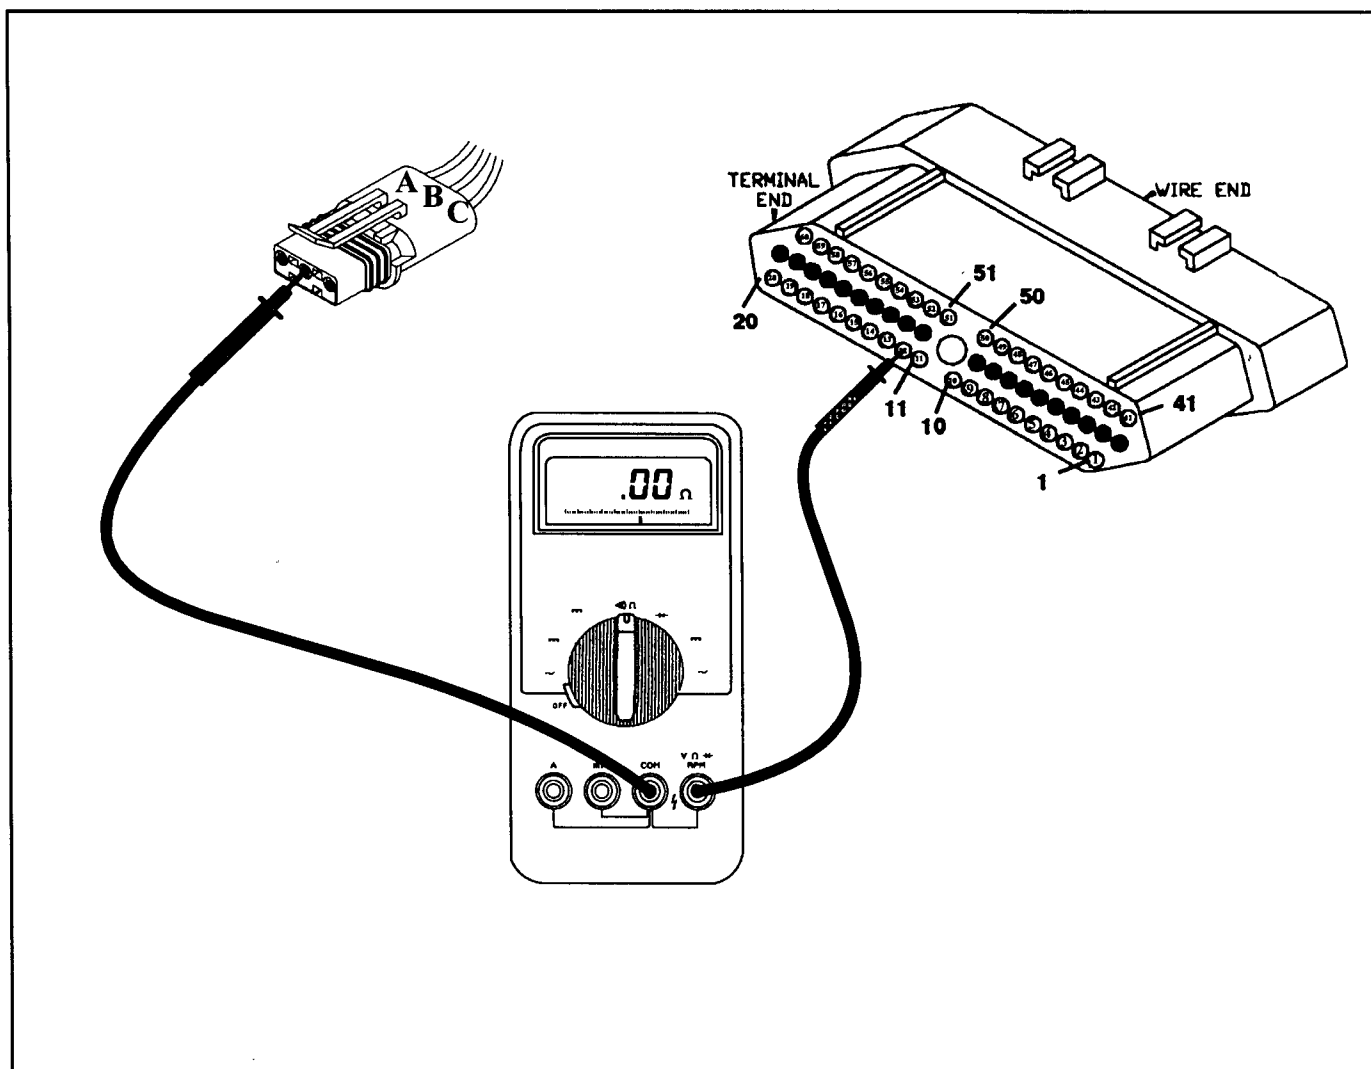
Figure 47

- Unplug both the TCM and TPS. Perform a continuity check from terminal B in the TPS connector to terminal 12 in the TCM connector (See Figure 47). If continuity is not seen, repair the severed wire. If continuity is seen, replace the TPS.

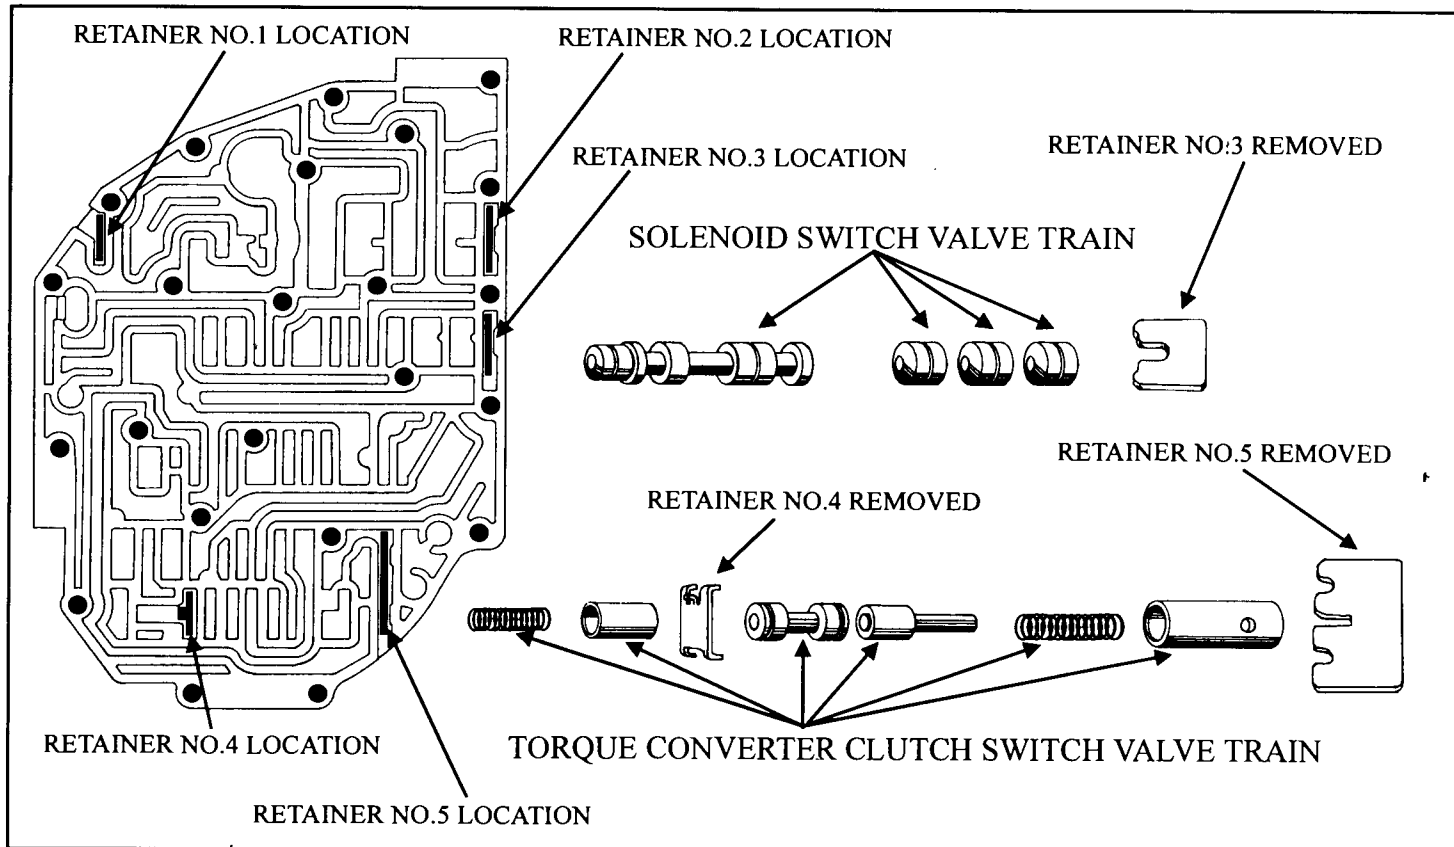
Figure 48

- Use a scanner to observe the Shift Lever Position. If OD is displayed while in the Reverse position the PRNODL switch may be defective. Refer to pages 45 to 52 for step by step diagnosis.
- Inspect the valve body for a stuck Solenoid Switch Valve or a missing # 3 retainer (See Figure 48).

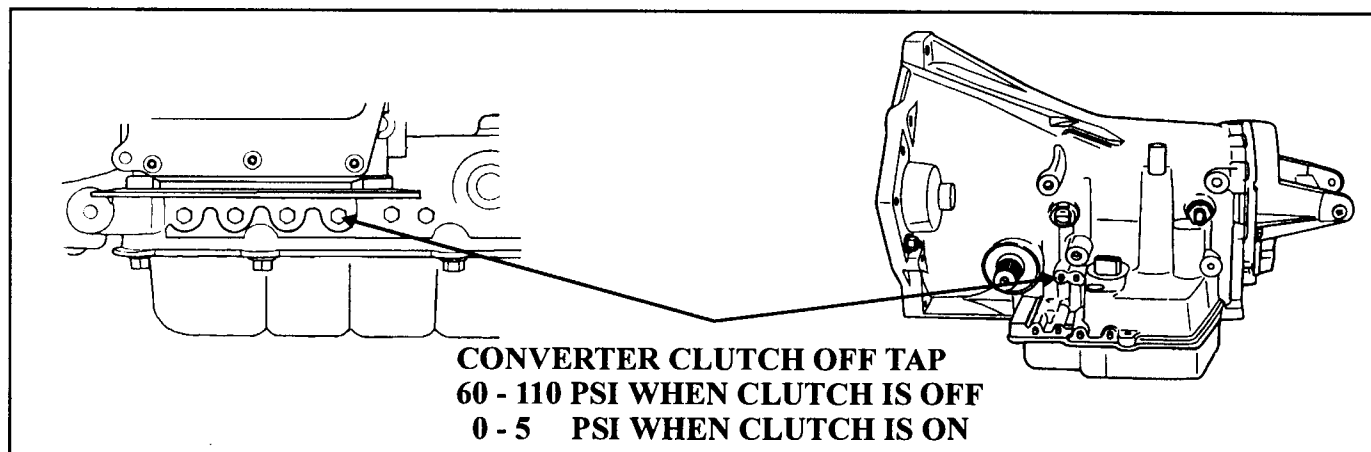
Figure 50

- Record and clear all codes with a scanner via the diagnostic BUS connector. Use the scanner to then observe both engine RPM and Turbine Shaft RPM. Install a pressure gauge onto the converter clutch off tap (See Figure 50). Take the vehicle for a road test. When the scanner indicates full lock up, both the engine RPM and Turbine Shaft RPM should read the same. The pressure gauge should also drop to 5 psi or less. The following results would indicate the different possibilities.

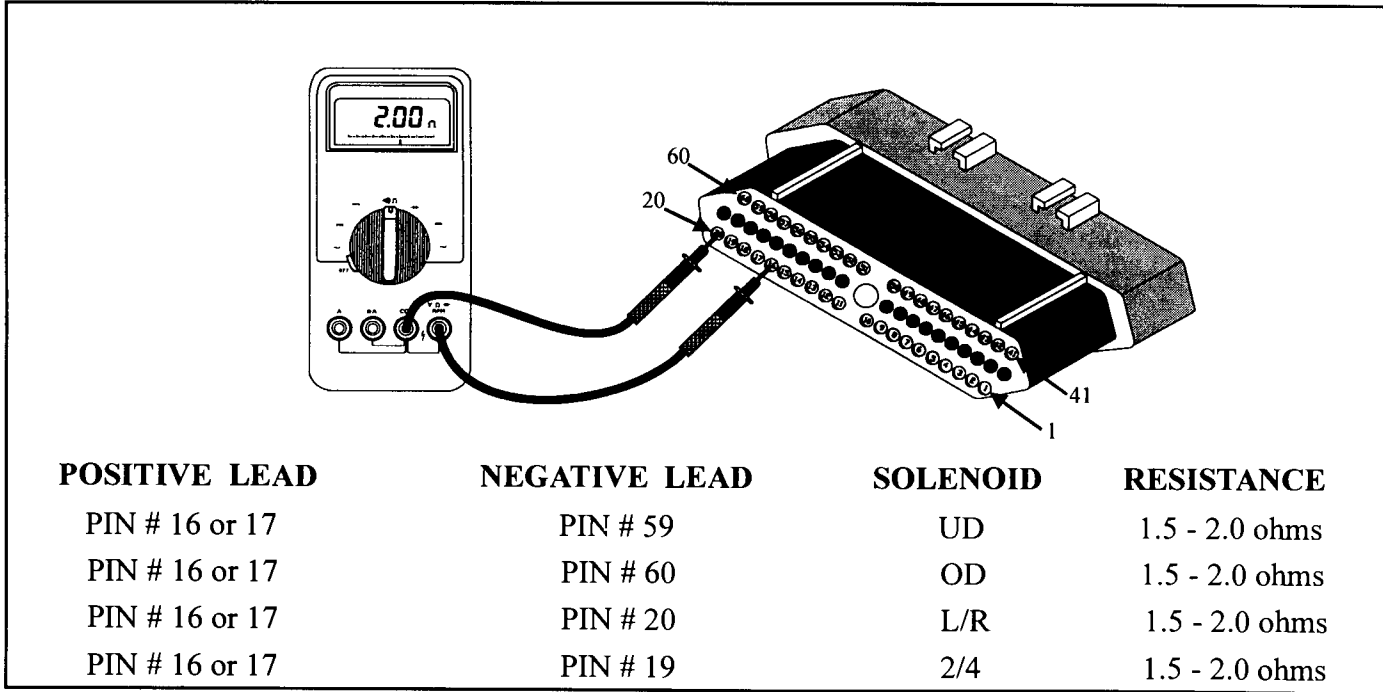
Figure 51

- Unplug the TCM's 60 way connector. Using a DVOM check the resistance of all four solenoid circuits by placing the positive lead onto pin 16 or 17 as seen in Figure 51. With the negative lead, carefully touch pins 19, 20, 59 and 60 one at a time. Each solenoid should measure approximately 1.5 to 2.0 ohms. If the solenoid providing the code reads considerably higher or lower from the other three solenoids, change the solenoid body. If all the readings are the same, wiggle the solenoid wires with the meter still attached and see if the readings behave erratic. If so, the solenoid connector is bad and will need to be replaced with part 4419476.

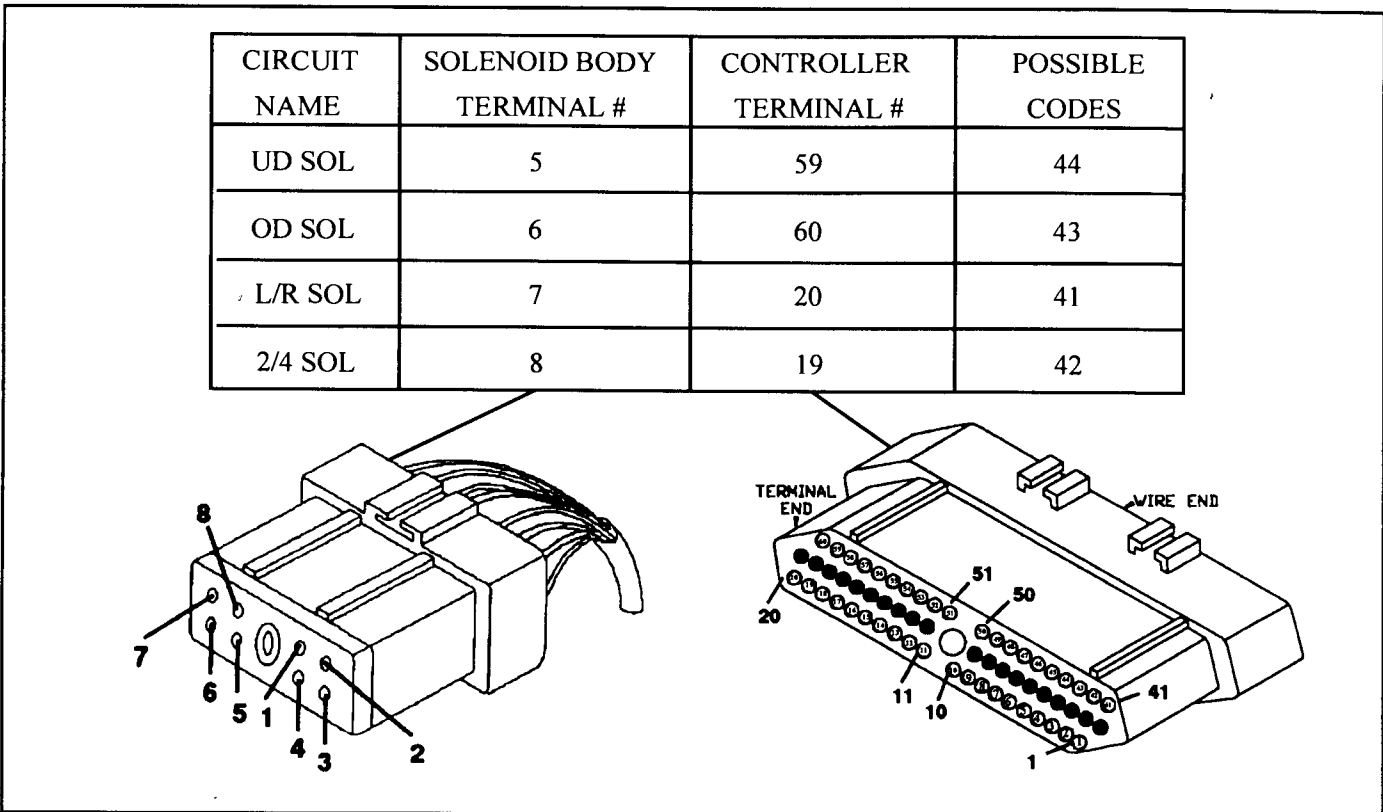
- If when performing the above check an open is seen on one of the solenoid wires, use Figure 52 to perform a continuity check on the wire in question. If it is determined that the wire is severed, a new wire can be run and spliced in outside the harness.

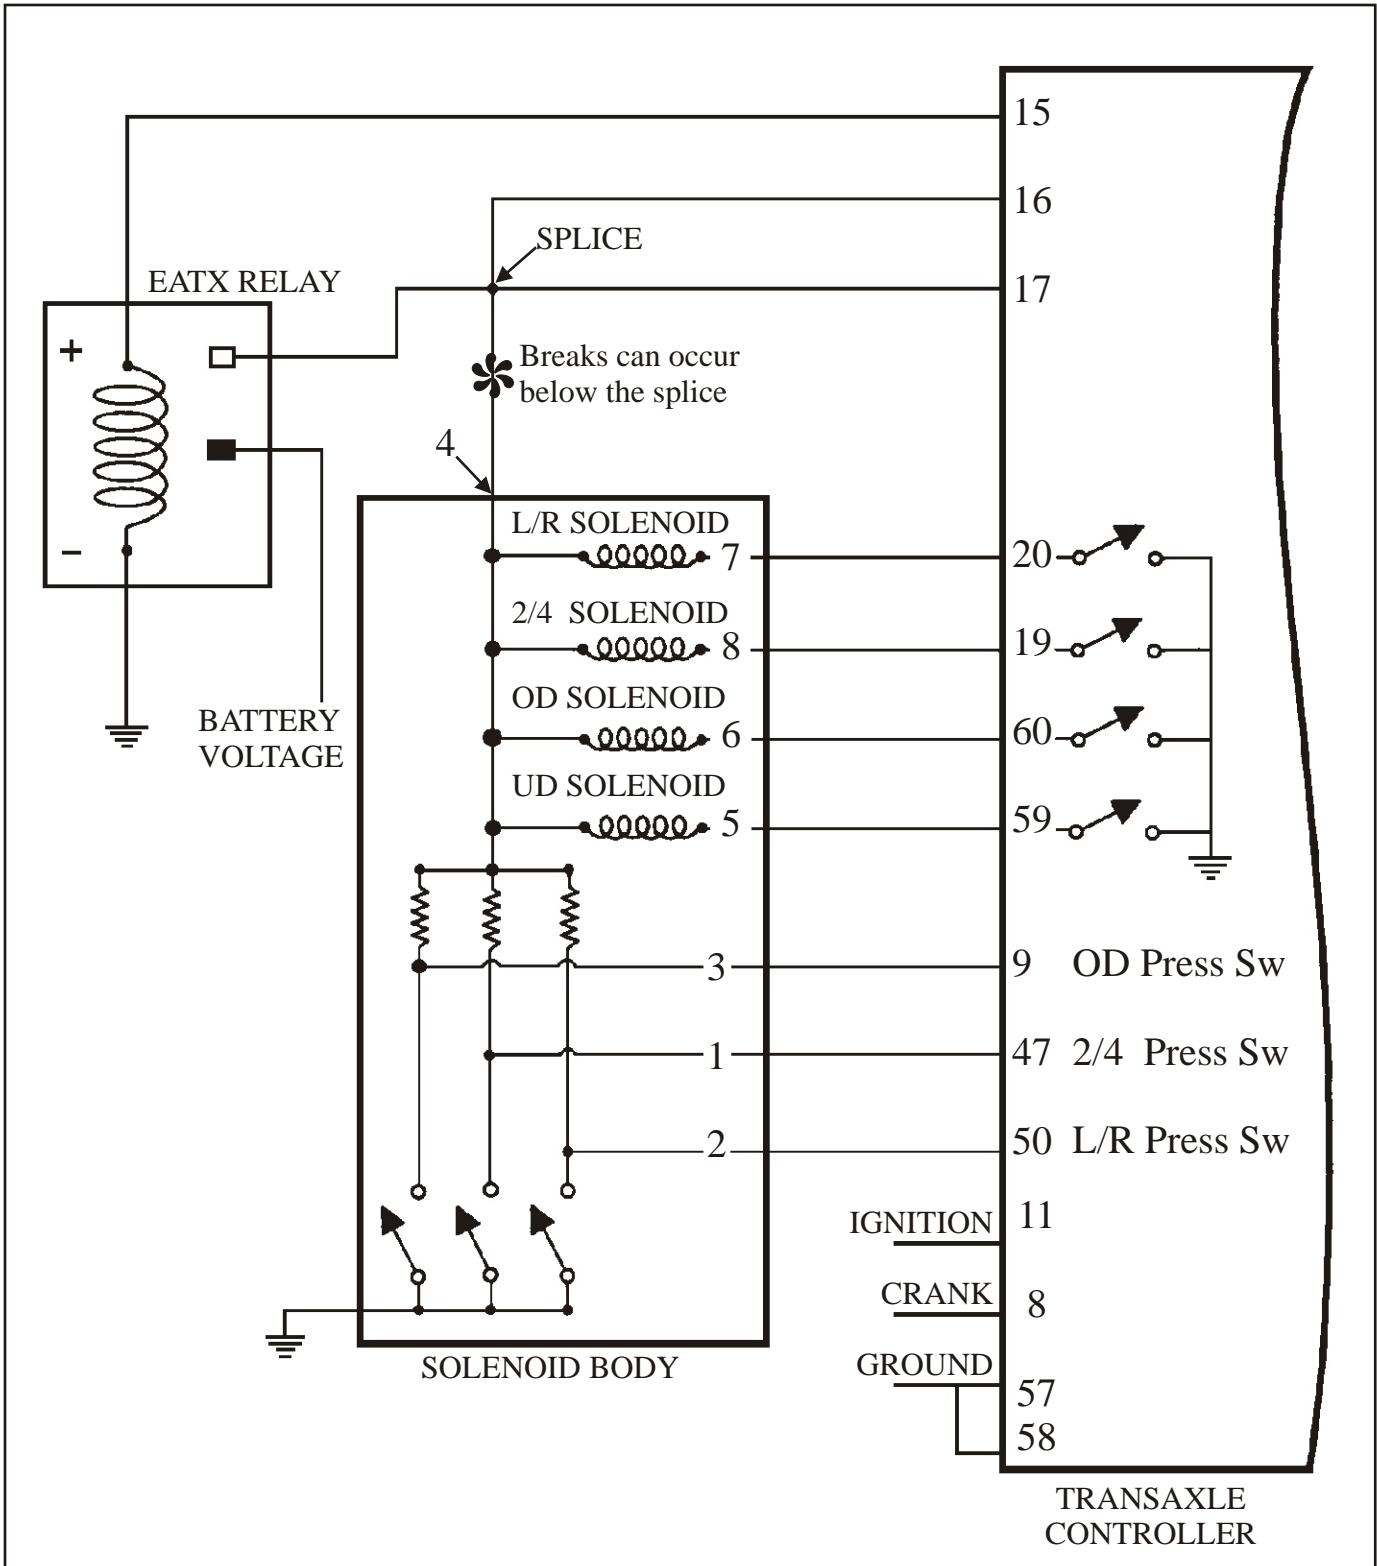
Figure 53

- If when making the above checks and the meter reads infinite on all solenoids, the power wire going to the # 4 pin in the solenoid body has been known to break below the splice as shown in Figure 53. Check for continuity between terminal 16 in the TCM connector to terminal 4 in the solenoid body connector.
