# 41TE & 42LE CODE BOOK

## 41TE & 42LE DIAGNOSTIC CODE BOOK INTRODUCTION

The Chrysler 41TE and 42LE Diagnostic Code Book is designed to provide the technician with a step by step diagnostic approach to each and every transaxle code available from 1989 to 1998 model year. This manual can be used in companion with any type of scanner utilized in retrieving these codes from the controller. As an aid to the technician, component location is recognized throughout the manual.

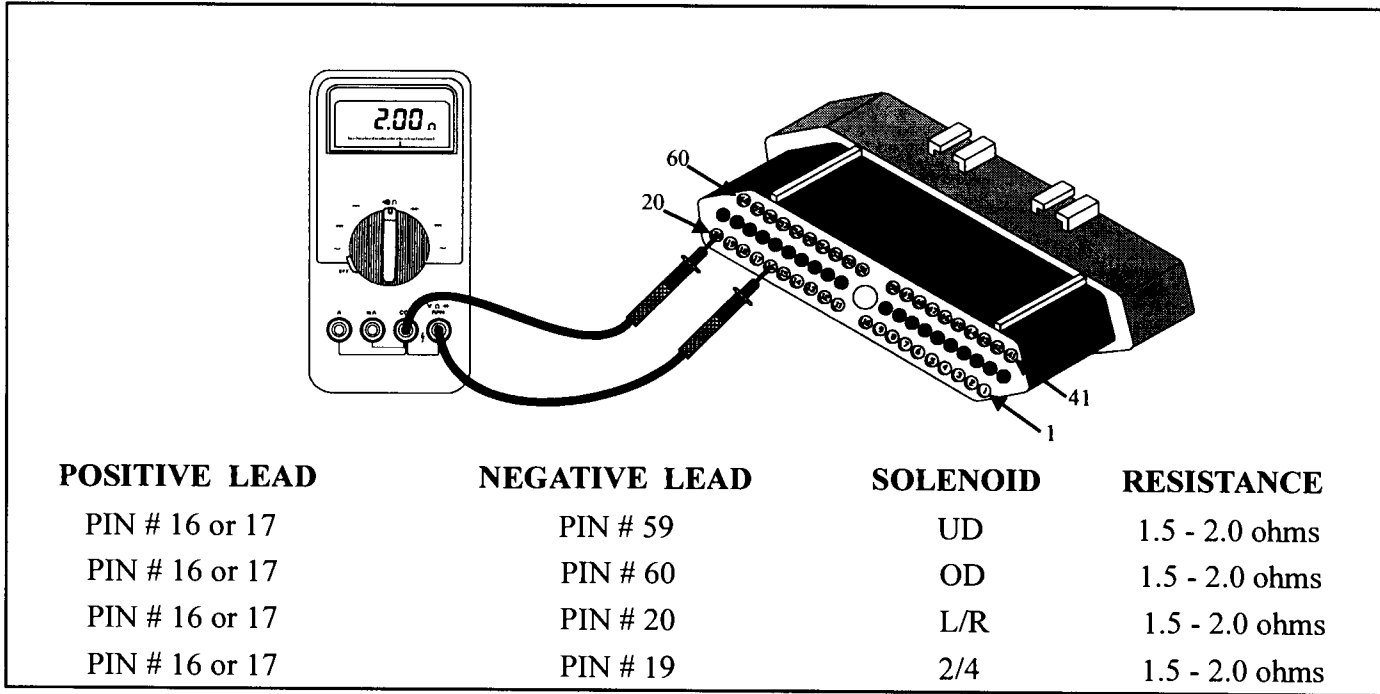
Figure 54

- Unplug the TCM's 60 way connector. Using a DVOM check the resistance of all four solenoid circuits by placing the positive lead onto pin 16 or 17 as seen in Figure 54. With the negative lead, carefully touch pins 19, 20, 59 and 60 one at a time. Each solenoid should measure approximately 1.5 to 2.0 ohms. If the solenoid providing the code reads considerably higher or lower from the other three solenoids, change the solenoid body. If all the readings are the same, wiggle the solenoid wires with the meter still attached and see if the readings behave erratic. If so, the solenoid connector is bad and will need to be repaired.

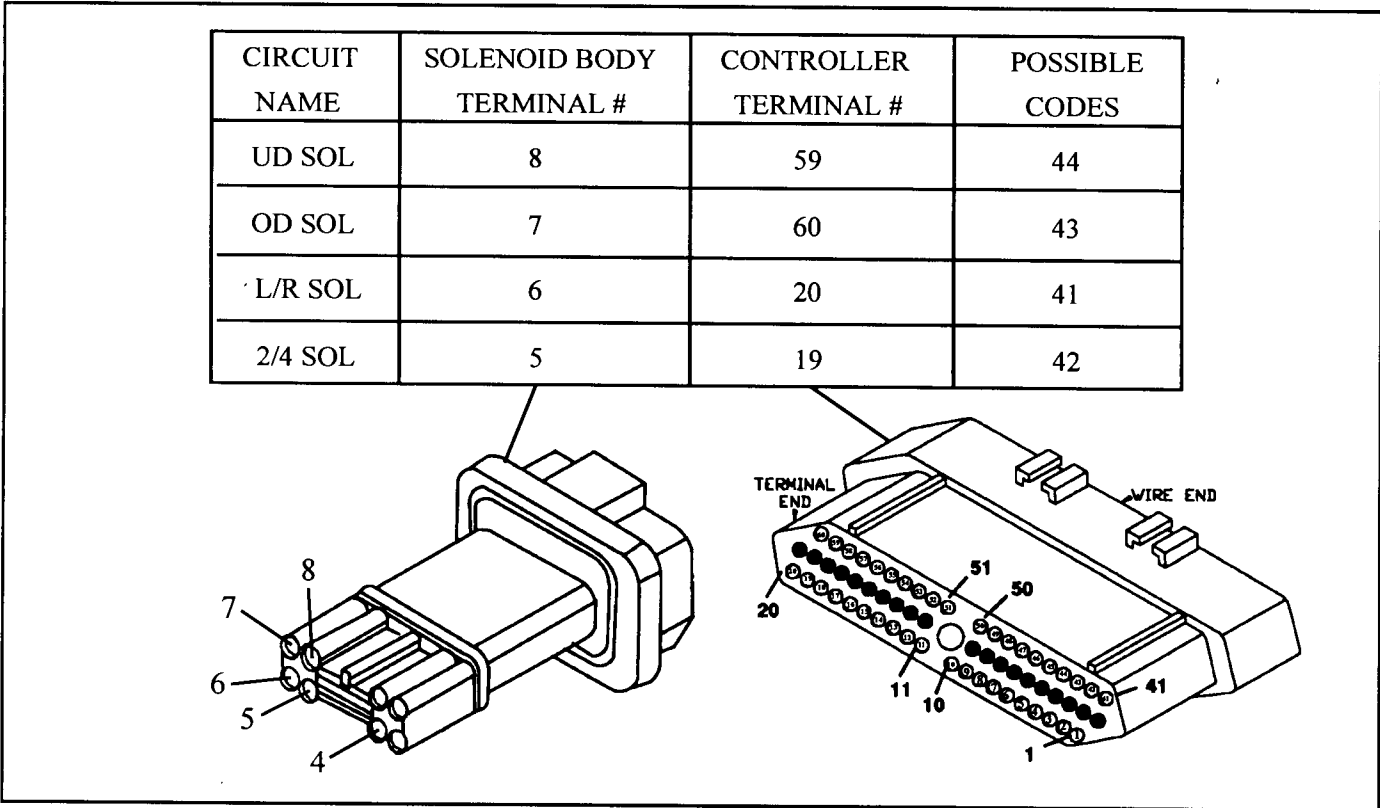
- If when performing the above check an open is seen on one of the solenoid wires, use Figure 55 to perform a continuity check on the wire in question. If it is determined that the wire is severed, a new wire can be run and spliced in outside the harness.

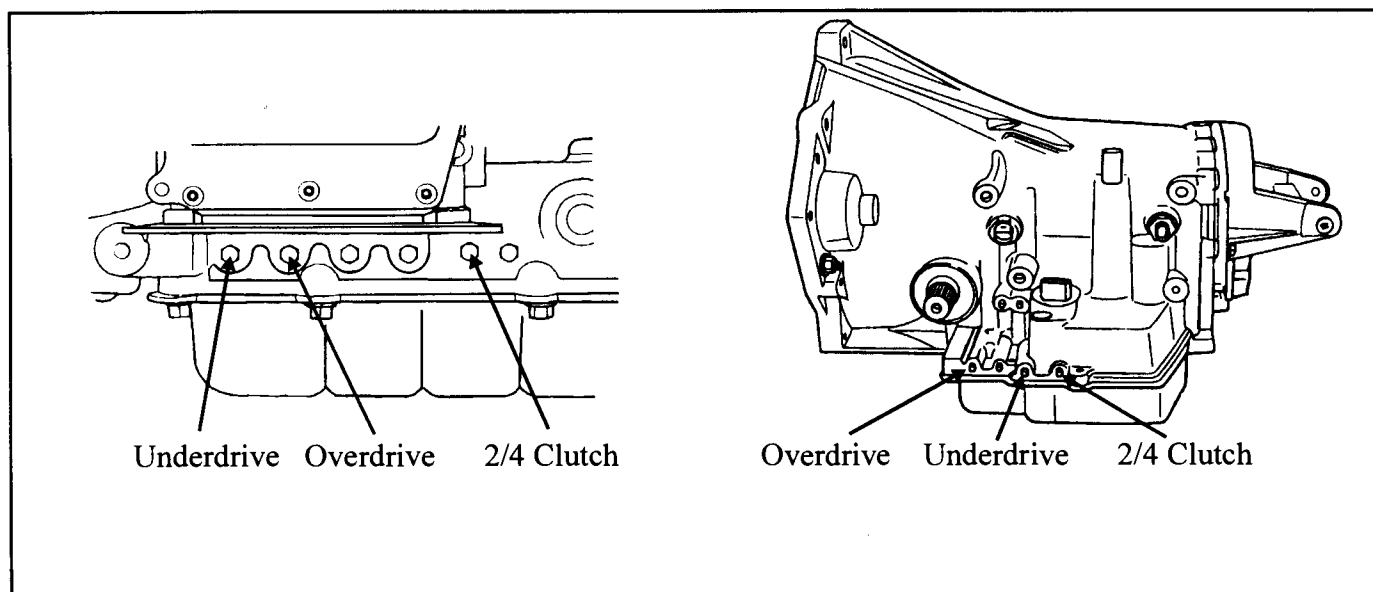
Figure 56

- With the pressure specifications given on page 65, the UD, OD and 2/4 hydraulic circuits should be checked with a pressure gauge (See Figure 56). The 2/4 clutch pressure should be checked in 2nd gear. 120-145 psi should be seen and 0 psi in first and third. Since the transaxle is experiencing a 3-4 shift abort, the full 75-95 psi may not be seen at the 2/4 tap when attempting to go to fourth and should be considered as normal. If the pressure in the 2/4 clutch circuit is substantially low in second gear or pressure is seen in first or third, this hydraulic circuit needs to be investigated.

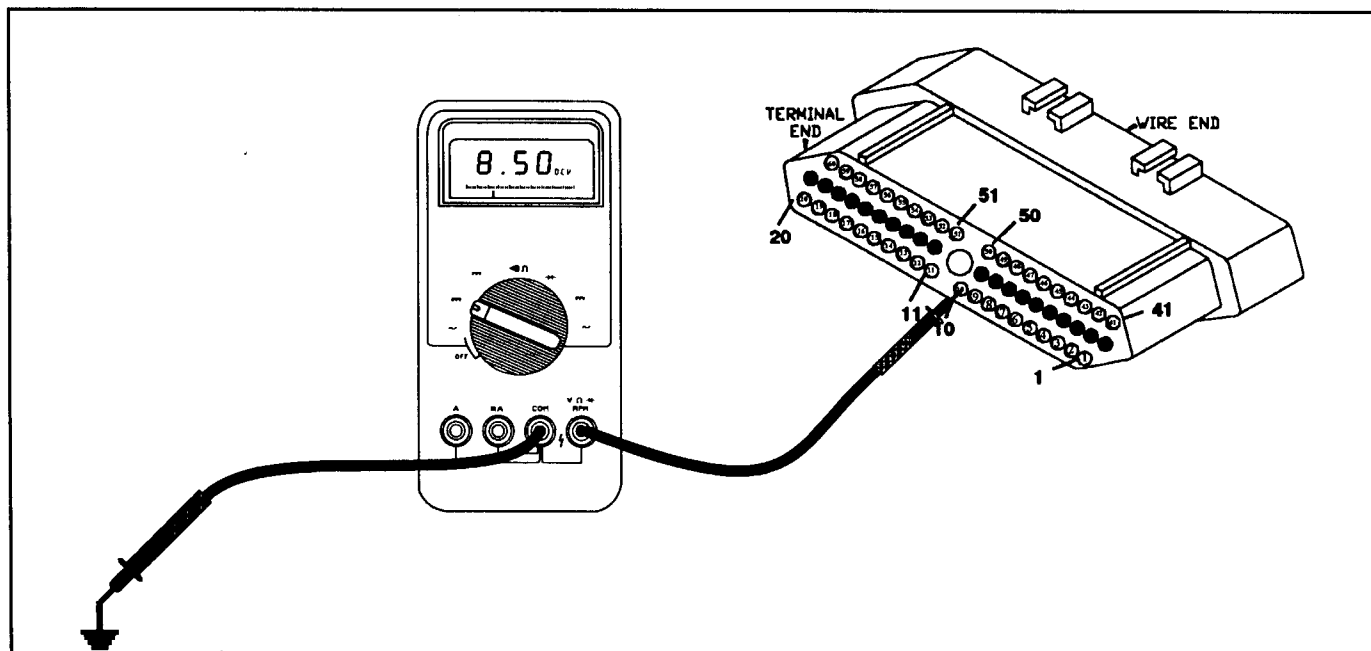
Figure 57

- Unplug the TCM connector with the ignition off. Once disconnected, turn the ignition on and check terminal 10 for 7 to 10 DC volts (See Figure 57). If 7 to 10 volts is observed, replace the TCM. If there is not, go to the next step.

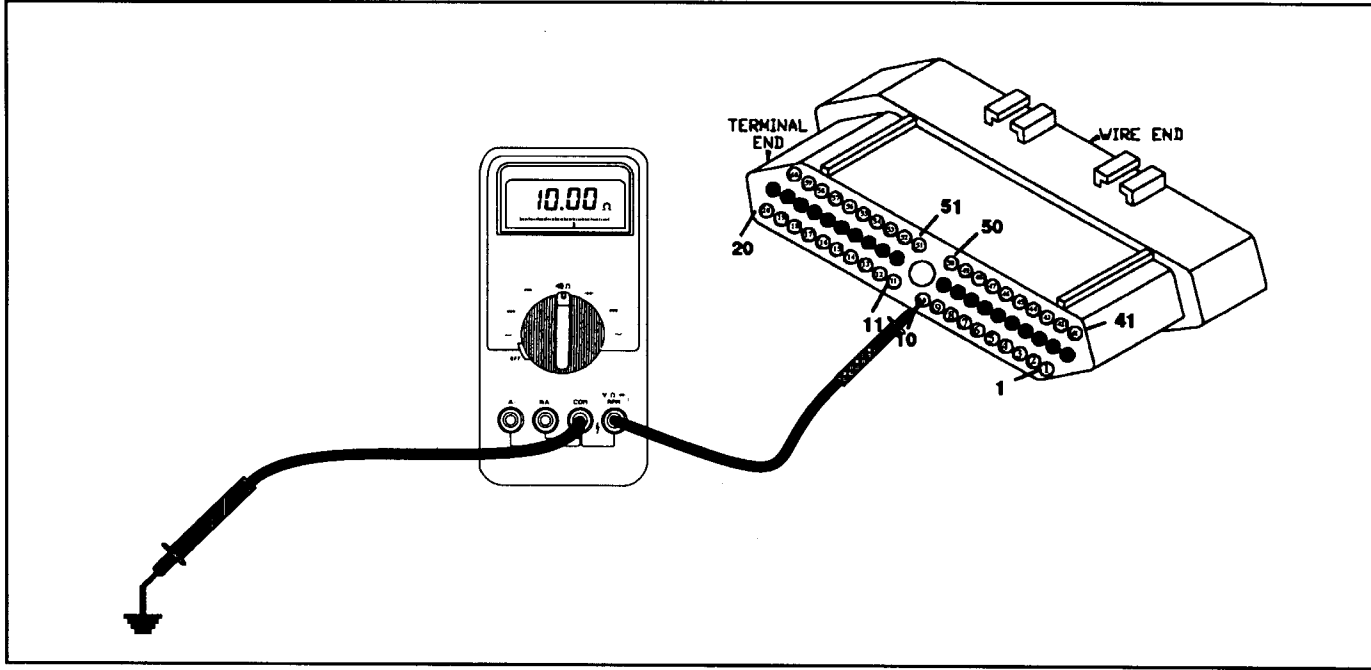
Figure 58

- Turn the ignition off. With the meter still on terminal 10, change to an ohms setting (See Figure 58). If the resistance is below 5 ohms, the wire is shorted to ground and will need to be repaired or replaced. If resistance is above 5 ohms, go to the next step.

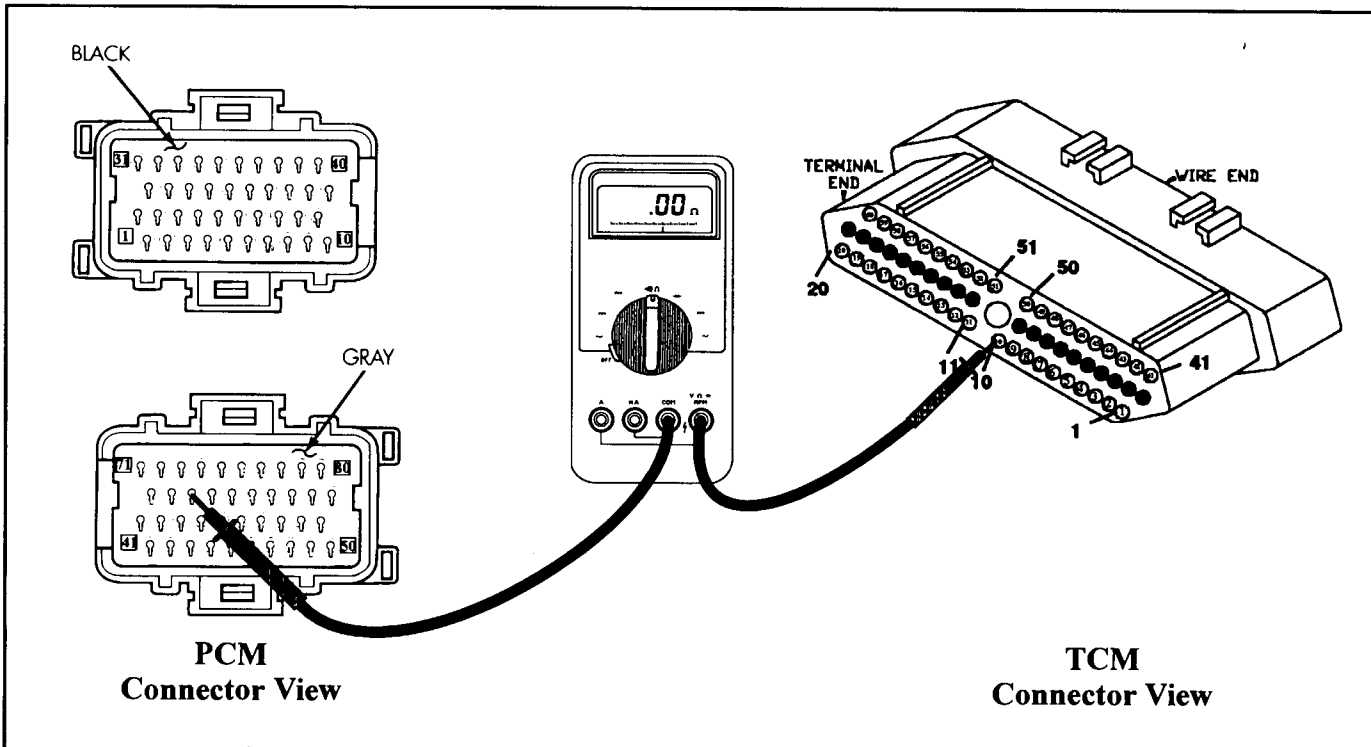
Figure 59

- Keep the ignition off and unplug the PCM and perform a continuity check across the wire. Place one meter lead to cavity 63 in the PCM connector and 10 in the TCM connector (See Figure 59). If resistance is below 5 ohms change the PCM. If an open is seen, repair or replace the severed wire.

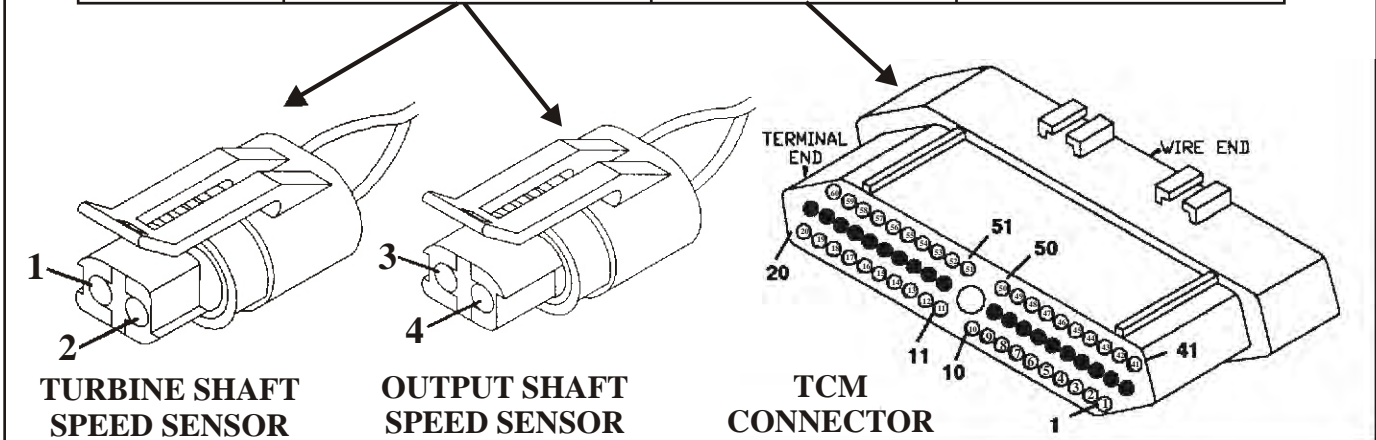
- If an open is observed, use Figure 61 to perform individual continuity checks on each wire. Repair the open wire if necessary. If continuity is seen on each wire, check connector cavities. RPM Sensor Connector repair kit part number is 4419478. See page 25 for the TCM connector check. If connectors are good,

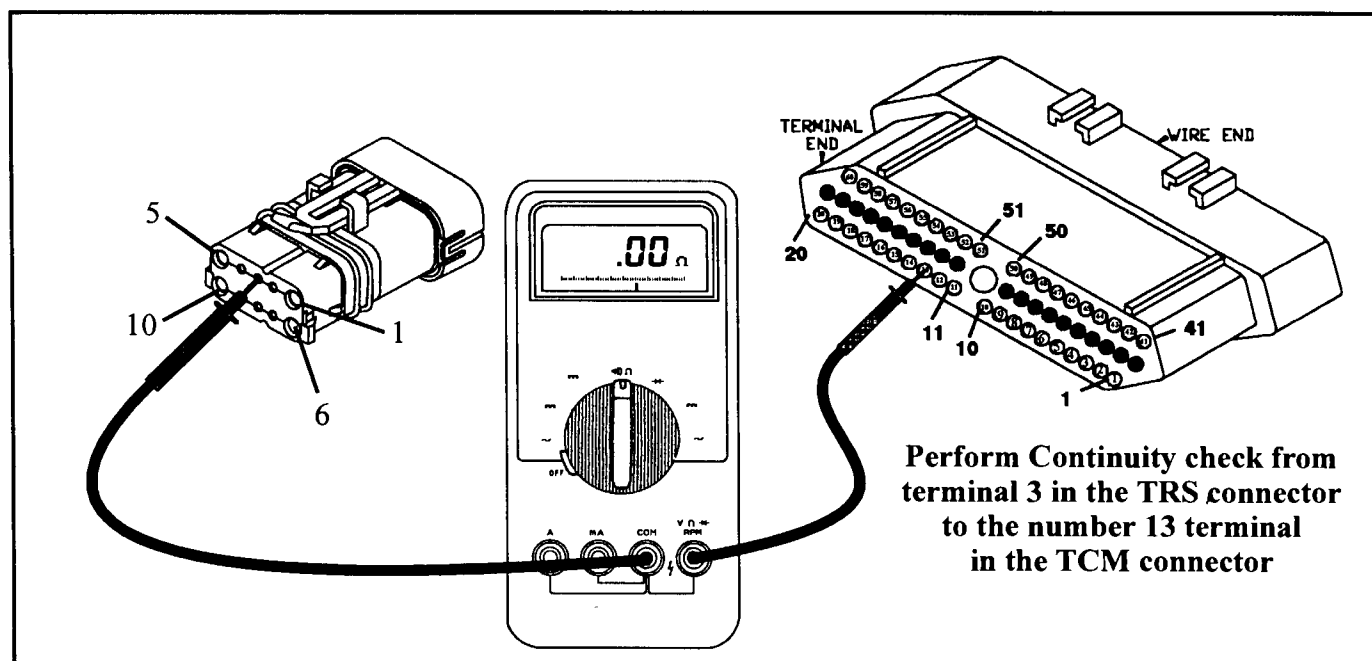
Figure 62

- 1996 and later vehicles have a Transmission Fluid Temperature Sensor built into the Transmission Range Sensor. The ground wire for this sensor is shared with the Turbine and Output RPM sensor at pin 13 in the TCM connector. Should this ground wire become severed, a code 58 and 72 may be set. A continuity check can be performed by placing one meter lead to terminal 3 in the TRS connector and terminal 13 in the TCM (See Figure 62). For further TFT sensor checks, refer to page 84.

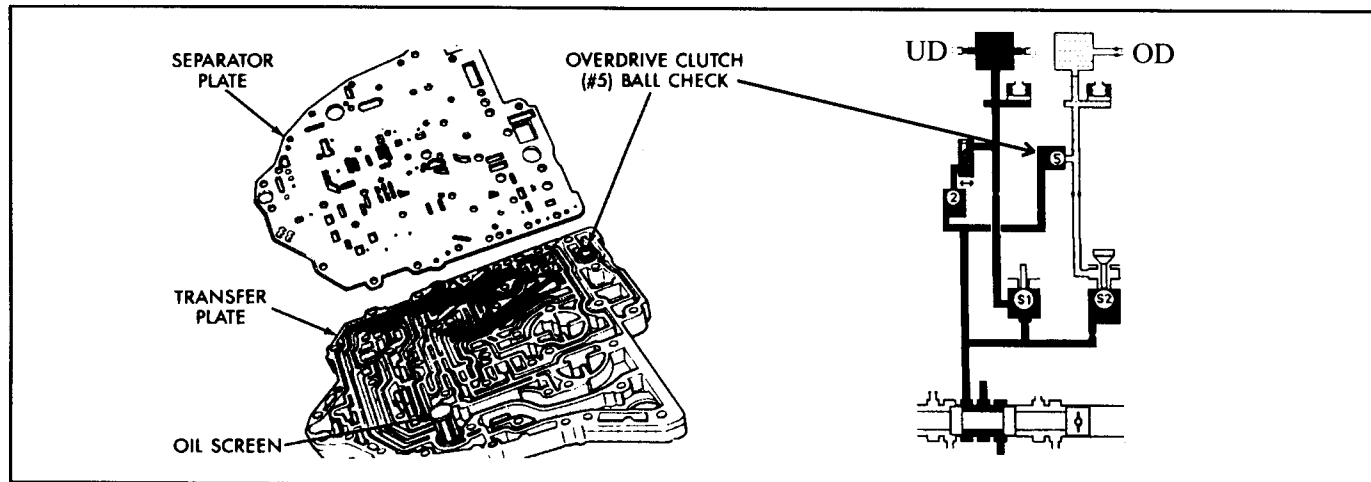
Figure 64

A low clutch volume reading in just the OD clutch circuit has been commonly caused by a defective O ring on the # 5 check ball capsule in the transfer plate as shown in Figure 64. This blocks controlled line pressure from entering the OD clutch circuit. If the O ring or the capsule itself fails to hold back this pressure, the low OD clutch volume reading will vary depending upon the severity of the leak. If the leak is slight, most of the oil will exhaust past the OD solenoid and the OD clutch volume may appear to be normal. As the leak gets worse, the OD solenoid is flooded and the OD circuit becomes charged with oil causing below minimum CVI. *Note: The # 5 check ball capsule has been eliminated in late model 41TE's and all 42LE's.*

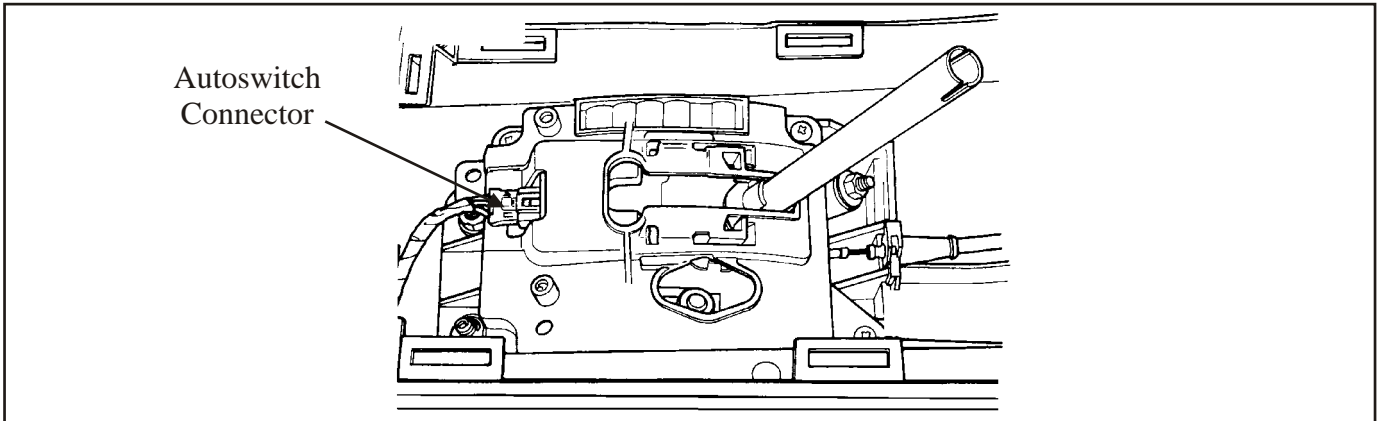
Figure 66

- Locate and unplug the Autostick Switch in the center console (See Figure 66). Using a volt meter, turn the ignition ON and place the negative lead to ground. With the positive lead check for battery voltage at pin 1 in the Autostick connector (See Figure 67). If voltage is seen go to the next step. If voltage is not seen, check for a blown fuse. LH vehicles check fuse # 17, all others check fuse # 11. If the fuse is good, the wire from the fuse to pin 1 is severed and will need to be repaired or replaced.

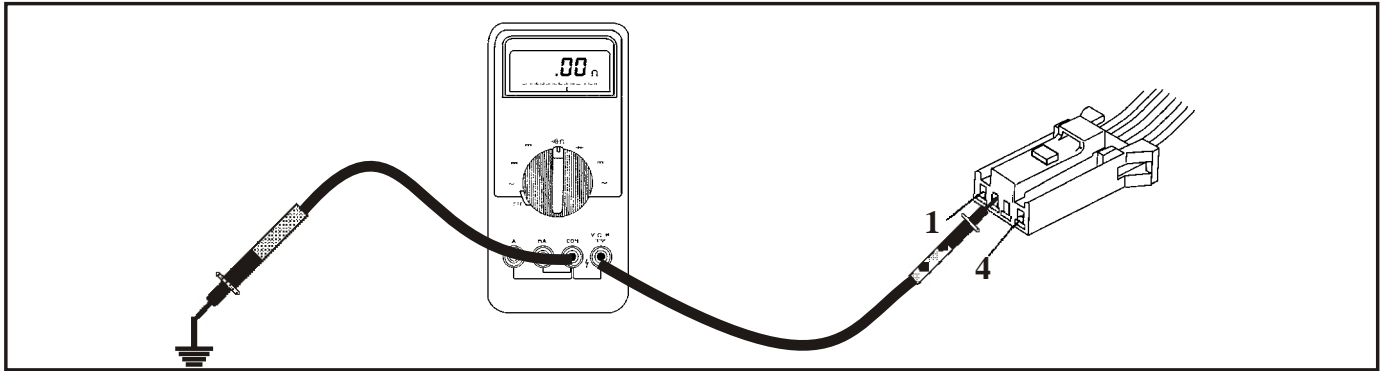
Figure 68

- Turn the ignition off and change the meter to read ohms. Keep the negative lead to ground and place the positive lead into terminal 2 of the Autostick connector (See Figure 68). If continuity (5 ohms or less) is observed, go to the next step. If continuity is not seen, the ground wire is severed or corroded. Repair or replace the wire.
- Unplug the TCM and perform a continuity check from terminal 3 in the Autostick connector to terminal 5 in the TCM (See Figure 69). If continuity is seen, move to the next step. If continuity is not seen, the wire is severed. Repair or replace the wire.
- Perform a continuity check from terminal 4 in the Autostick connector to terminal 44 in the TCM (See Figure 70). If continuity is seen, move to the next step. If continuity is not seen, the wire is severed. Repair or replace the wire.

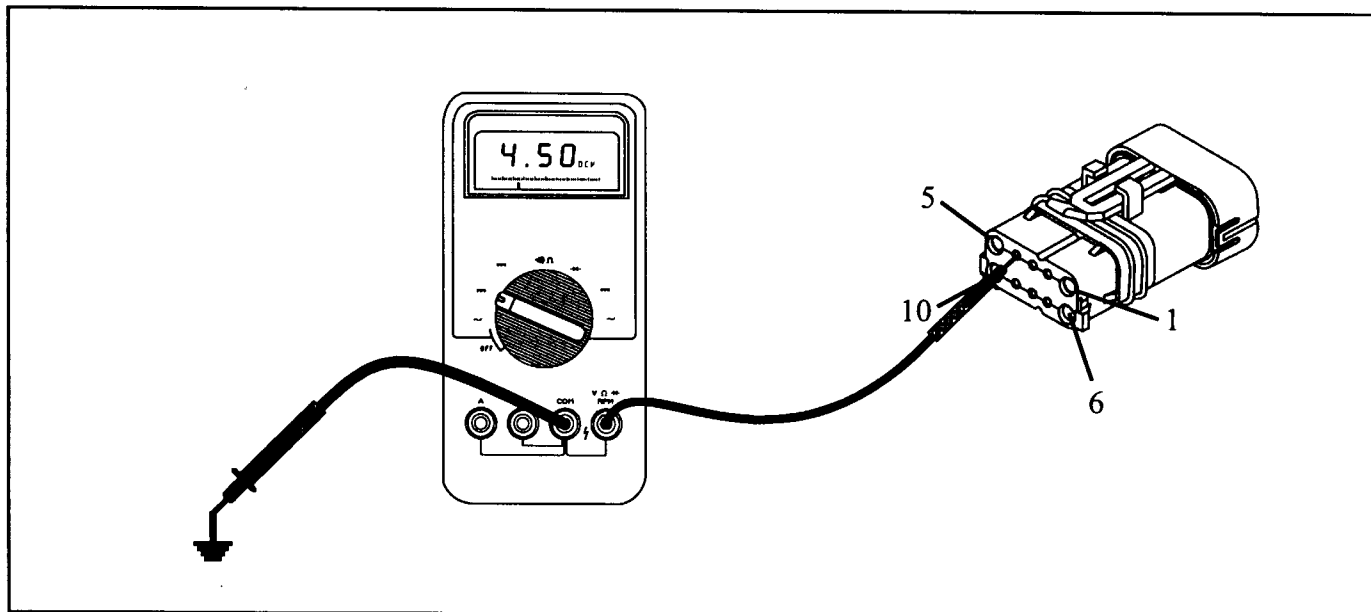
Figure 73

- Unplug the TRS connector. Place the ignition to the "ON" position. With a volt meter placed to DC volts, put the negative lead to a good known ground. With the positive lead, check terminal 4 for voltage (See Figure 73). If voltage is above 4.5 volts move to the next step. If less than 4.5 volts is observed, turn the ignition off and unplug the TCM. Change the meter to an ohms setting and check for continuity between terminal 54 in the TCM connector to terminal 4 in the TRS connector (See Figure 74). If continuity (5 ohms or less) is seen, replace the TCM. If continuity is not seen, repair or replace the wire.

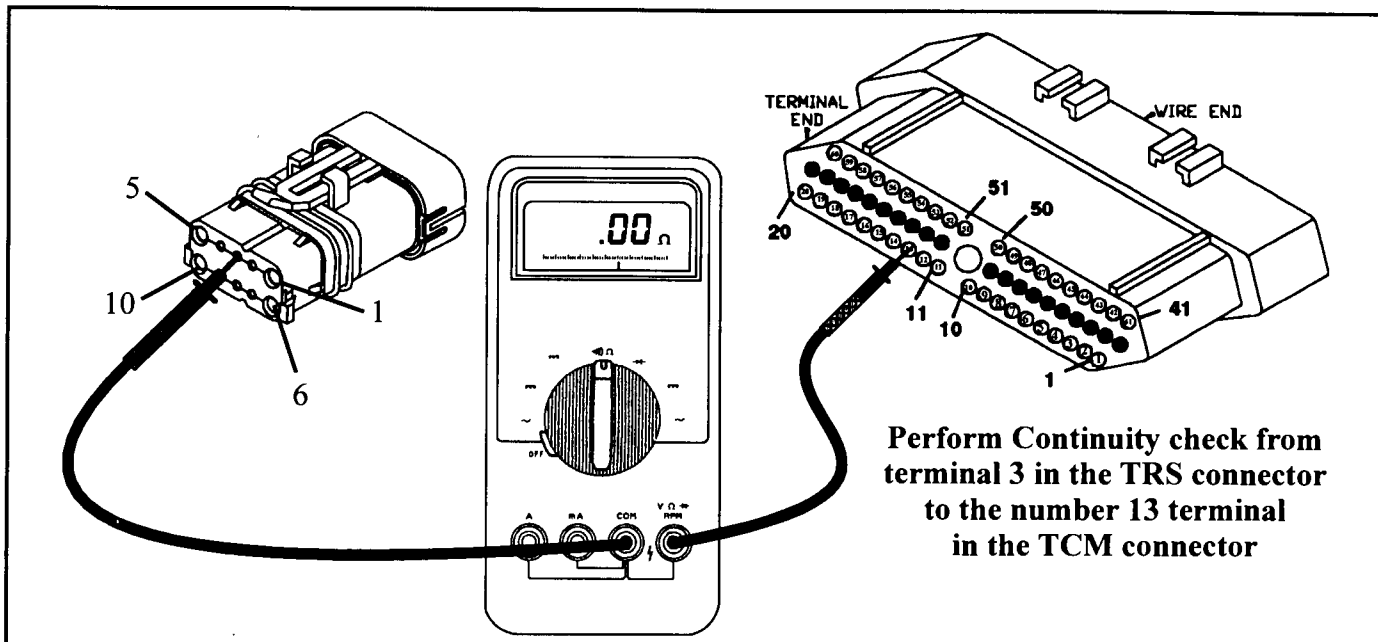
Figure 75

- Perform a continuity check on the TFT's ground wire by placing one meter lead to terminal 3 in the TRS connector and terminal 13 in the TCM as shown in Figure 75. If continuity is seen, go to the next step. If continuity is not seen, repair or replace wire. If the wire is to be replaced, the turbine and output RPM sensor also uses this wire for ground. Be sure to include them in the new wire (See Page 74).

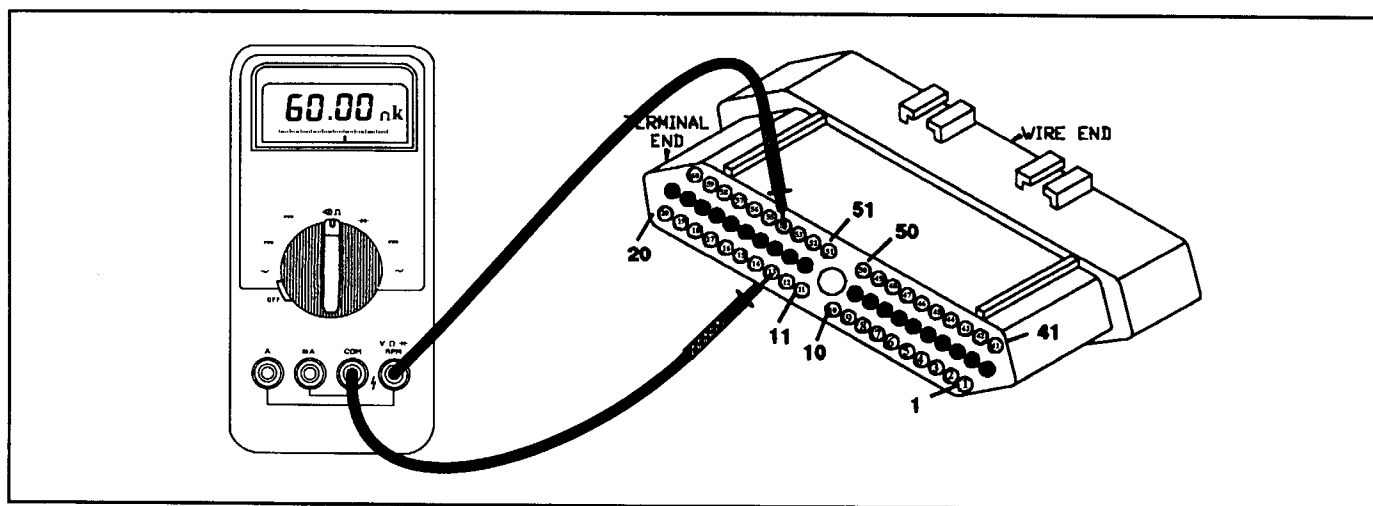
Figure 76

- Re-connect the TRS sensor and perform a resistance check on the TFT sensor from the TCM connector. Place one meter lead into terminal 13 and the other meter lead into terminal 54 (See Figure 76). The range for the sensor from cold to hot is 100,000 ohms to 150 ohms (See Table Below). If the change in resistance is proportional to the change in the transmission fluid temperature and the resistance remains within specification, change the TCM. If the resistance is out of specification or does not change in resistance proportional to temperature, change the TRS.

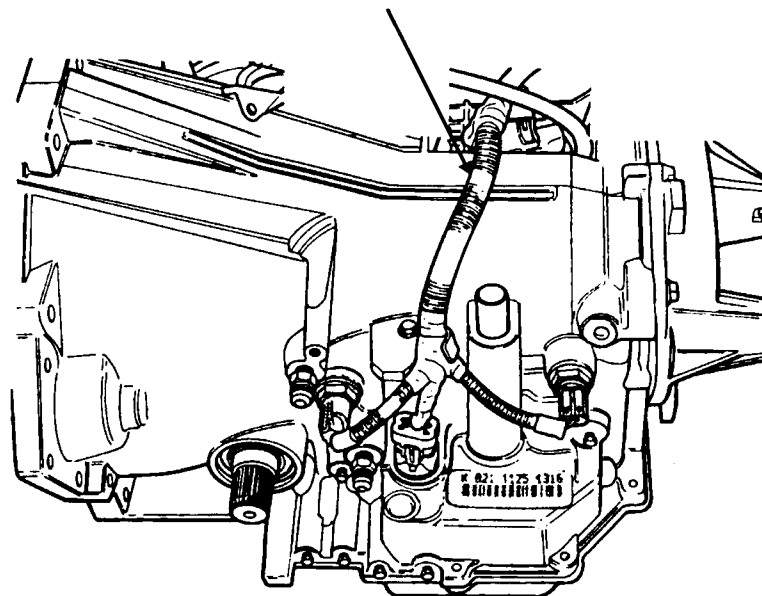
Figure 77

The 42LE transaxle has both the solenoid body and transmission range sensor mounted on the valve body. Each have their own connector coming through the case both of which are not easily accessible with the unit installed in the vehicle. To perform resistance checks of the solenoids, voltage checks on the pressure switches, resistance or volt checks on the Transmission Range Sensor (TRS) is near impossible at the case connector. The harness plugging into the solenoid body and the Transmission Range Sensor runs up to the top of the case above the bell housing where it plugs into the main vehicle harness (See Figure 77). This short wiring harness from the bell housing down to the solenoid body and TRS will allow for checks to be performed with ease. Figure 78 shows the top two connectors in this short pig tail harness. Each pin in these two connectors are numbered and identified. Should a resistance check need to be made on the solenoid body, rather than unplugging the solenoid body at the case (which could fill up with fluid if the unit is full), locate the 8 pin connector above the bell housing and unplug it. Place the positive meter lead of an ohm meter to pin 7. With the negative lead, touch pins 1, 2, 3 and 8 to obtain all 4 solenoid resistance values (See Figure 79). The chart in Figure 79 also provides checks that can be made through the 12 pin connector on the Turbine Shaft RPM sensor, the Output RPM sensor and the Transmission Fluid Temperature sensor.

SHORT HARNESS

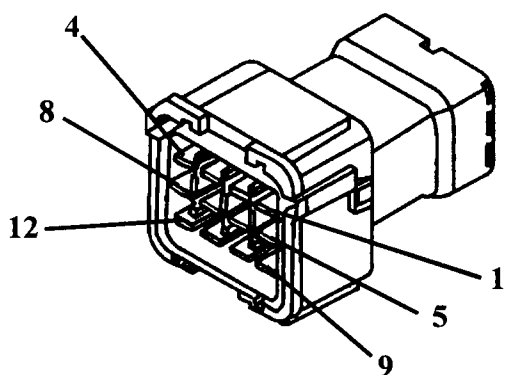
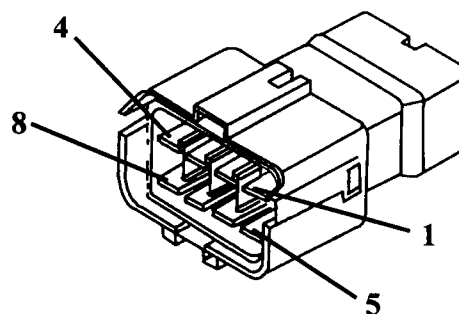
Figure 78

**12 PIN CONNECTOR  
(TRANSMISSION SIDE)**

**8 PIN CONNECTOR  
(TRANSMISSION SIDE)**

CAVITY	COLOR	FUNCTION
1	RD/BK	INPUT SPEED SENSOR SIGNAL
2	DB/BK	SPEED SENSOR GROUND
3	LG/WT	OUTPUT SPEED SENSOR SIGNAL
4	BR/YL	TRS-T1 SENSE
5	VT/WT	TRS-T2 SENSE
6	VT	TRS-T3 SENSE
7	LG/BK	TRS-T4 SENSE
8	VT *	TRANS TEMP. SENSOR SIGNAL
9	DG/OR *	AUTOMATIC SHUT DOWN RELAY
10	VT/BK	REVERSE LAMP SENSE
11	WT	FUSED IGNITION SWITCH OUTPUT
12	BK/LG	FUSED IGNITION SWITCH OUTPUT

CAVITY	COLOR	FUNCTION
1	BR	O.D. SOLENOID
2	WT	2-4 SOLENOID
3	PK	U.D. SOLENOID
4	DG	L-R PRESSURE SWITCH
5	YL/BK	2-4 PRESSURE SWITCH
6	OR/BK	O.D. PRESSURE SWITCH
7	RD	TRANS CONTROL RELAY OUTPUT
8	LB	L-R SOLENOID

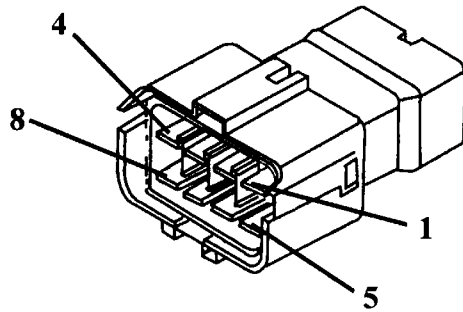
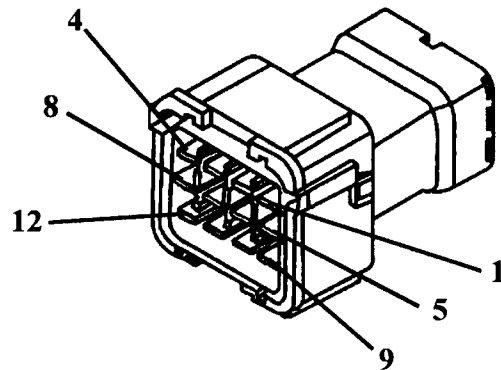
Figure 79

<u>TEST</u>	<u>POSITIVE LEAD</u>	<u>NEGATIVE LEAD</u>	<u>RESISTANCE</u>
L/R SOLENOID		8	1.5-2.0 OHMS
2-4 SOLENOID	7	2	1.5-2.0 OHMS
UD SOLENOID		3	1.5-2.0 OHMS
OD SOLENOID		1	1.5-2.0 OHMS

<u>TEST</u>	<u>POSITIVE LEAD</u>	<u>NEGATIVE LEAD</u>	<u>RESISTANCE</u>
TURBINE RPM	1		300-1200 OHMS
OUTPUT RPM	3	2	300-1200 OHMS
TEMP. SENSOR	8		VARIES (See Page 86)

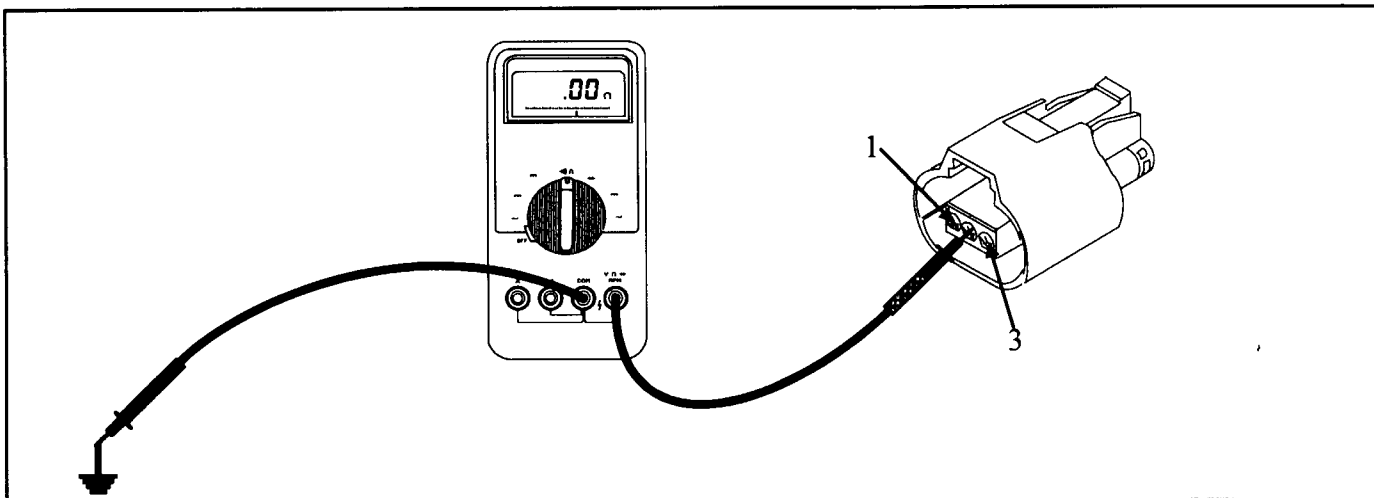
Figure 82

- Set meter to ohms and check the middle terminal for continuity as the middle wire goes to ground (See Figure 82). If continuity is seen (5 ohms or less), go to the next step. If continuity is not seen, repair or replace the wire.
- Perform a continuity check from terminal 3 in the Speed Proportional Steering Module connector to terminal 58 in the TCM connector (See Figure 83). If continuity is seen, go to the next step. If an open is seen repair or replace the wire.
- Plug the module and TCM back in and carefully back probe the # 3 wire with the meter set to DC volts. Start the vehicle and allow to the wheel to spin slowly. A 5 volts pulse should be seen. If there is, replace the Speed Proportional Steering Module. If there is not, either the TCM has not been flash with pinion factor information or the TCM is defective. Flash or replace the TCM.
